Aquatic Development Strategy

Volume 1: Technical Assessments & Probable Capitals Costs

Site Investigation Report

Site:	Balmoral & District Swimming Pool	Date visited:	30 th June 2009 FINAL ISSUE
Project:	South Grampians Council – Aquatic Facility Development Strategy	Project No:	EJ-0763
Client:	Southern Grampians Shire Council	Representative:	Mr Craig Halley
Investigation undertaken by:	Sean Stone Mike Pettigrew	Company:	Etch Architectural Solutions David Powick & Associates
Copies to:	Steve Pallas	Company:	@Leisure
Weather Conditions:	Overcast conditions, high winds and frequent showers Cold		
Pages	15 (including this page)

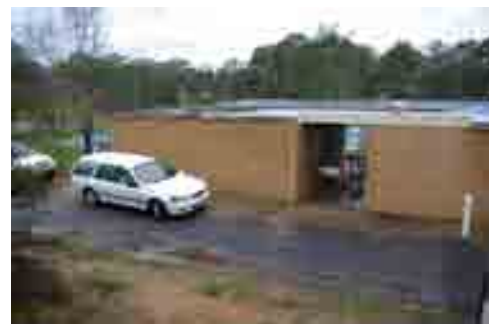
- 1) Balmoral pool – grassed (sloped) site.
- 2) Main road access clash with main pedestrian entry.

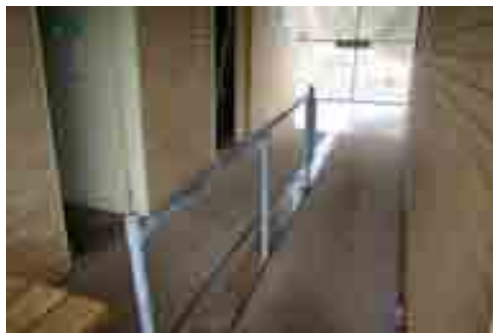
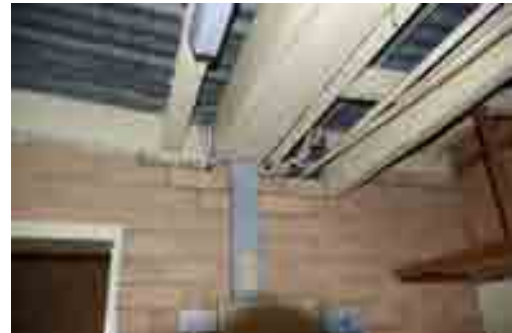
- 9) Restricted access into pool facility via entry. Acceptable for one-way pedestrian traffic only (tight for wheelchair)
- 10) No ceiling lining in office.

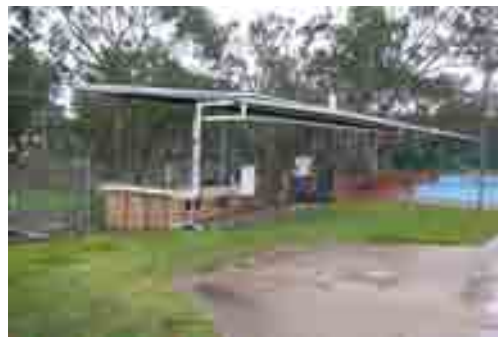
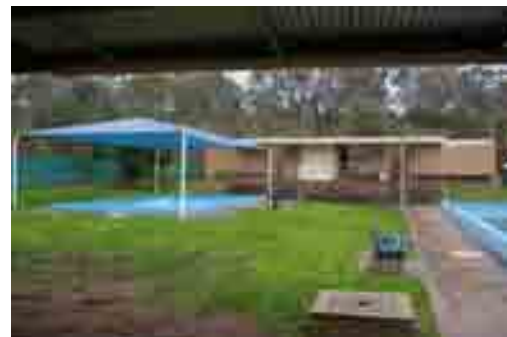
- 15) Solar heater shelter. Adjacent to the main pool.
16) Sun shade structure to toddler's pool in a reasonable condition.

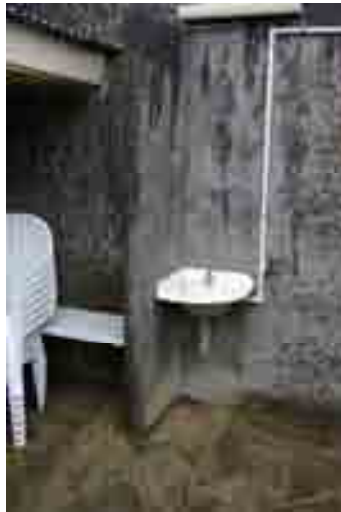
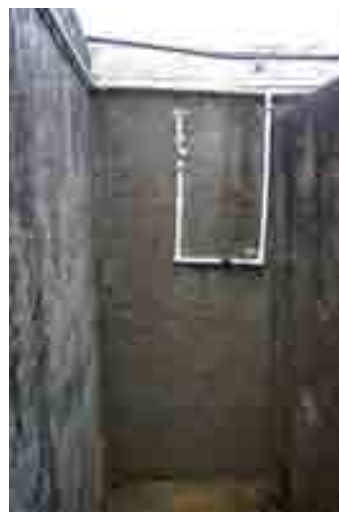
17) Typical steel basin with exposed plumbing.

18) Typical condition of showers. Shower rose may be water saving but pipe work – very poor.

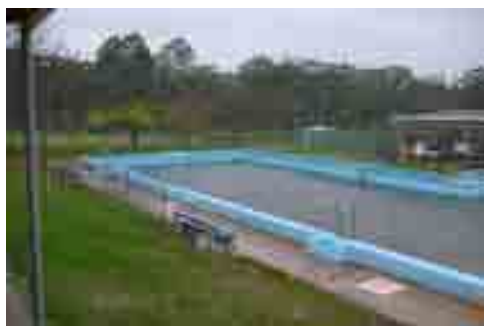
19) Main pool from change rooms.

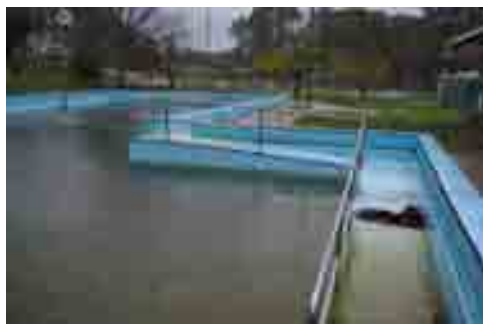
- Disabled ramp into pool does not comply to current BCA and AS 1428.1 regulations due to its width, hand rail design and no hand rail at the entry for ramp at pool concourse level (this section of ramp may be deemed a trip hazard and dangerous).

29) Main pool – disabled ramp not compliant

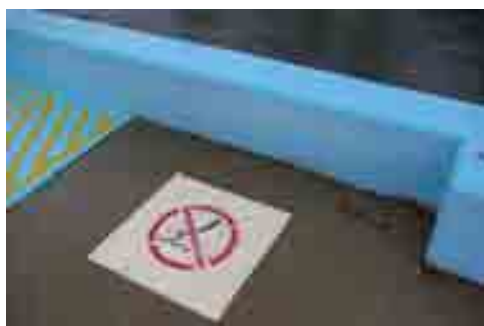
31) Typical pool signage does not comply.

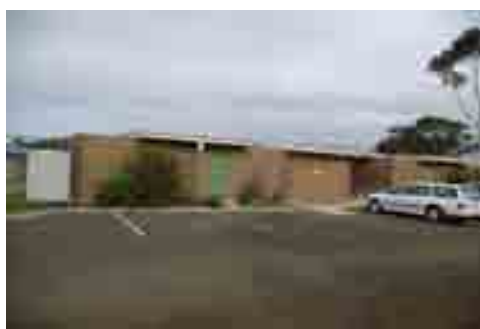
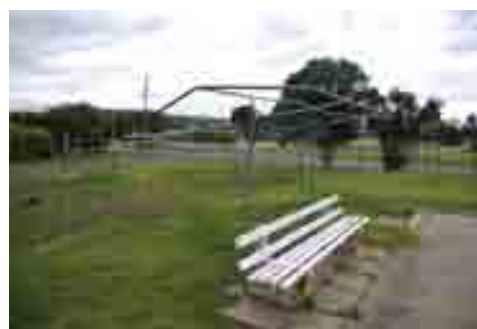
- 1) Coleraine Pool – main entry.
- 2) Typical seating and sun shading structure – located around the pool facility.

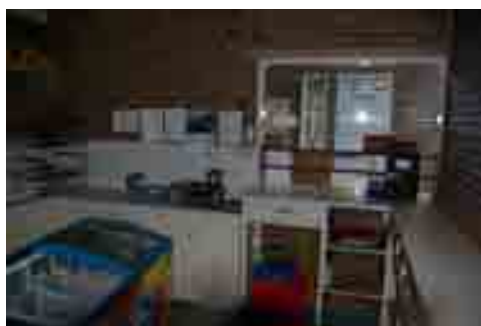
- 10) Main joinery to office / entry room. Very tired and in fair condition
- 11) Existing switchboard, reasonable condition. Current circuit breakers and RCD (safety) switch.

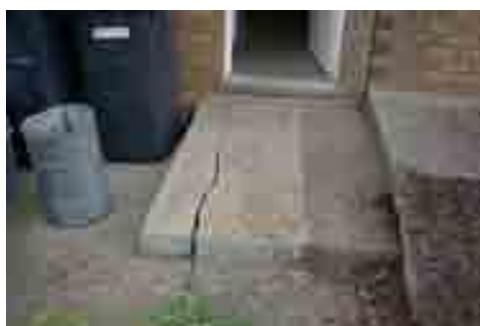
- 12) Access to first aid room – not BCA compliant. Structural crack to landing. (narrow door to room)
13) First Aid room – appears more like a store room.

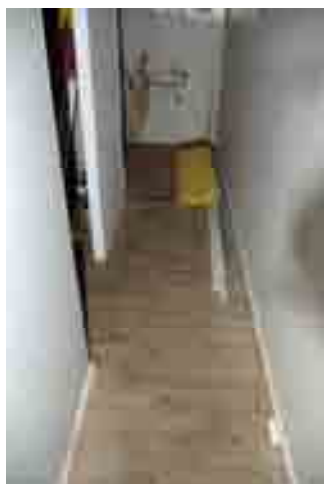
- 14) Passage way from entry door to first aid room – too narrow (max. 900mm width)
15) First Aid room – appears more like a store room.

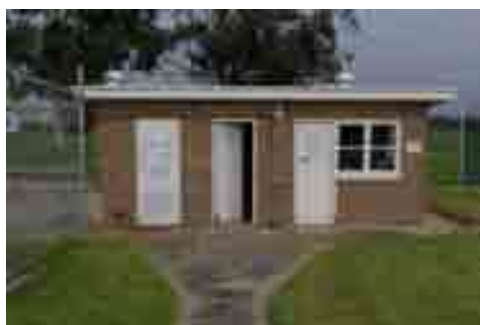
- 16) Plant room / Filtration room appears in a poor condition (internally / externally). Safety shower compliant.
- 17) External window – very poor condition and structural cracking to brickwork.

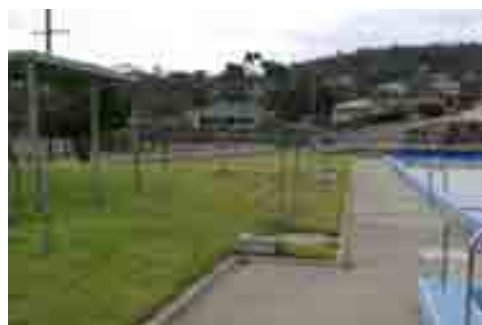
- 20) Fixed sun shade structures – along pool concourse.
21) Main toddler's pool – sun structure.

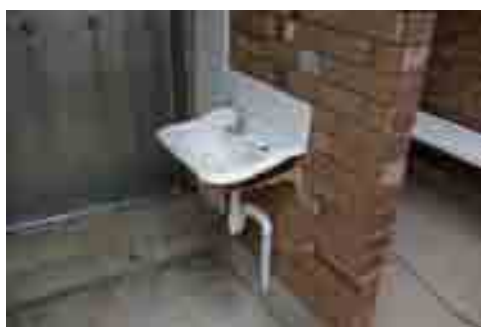
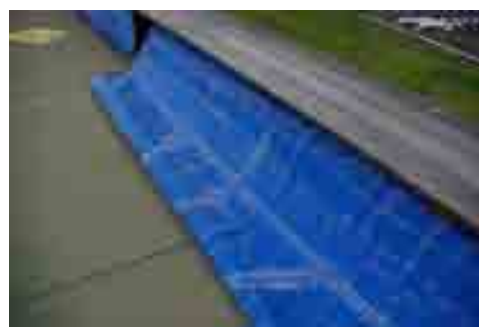
22) Typical wall mounted basin to all change rooms – wall brackets corroded.

23) Pool blanket – reasonable condition. Top coating of cover is breaking down with exposure.

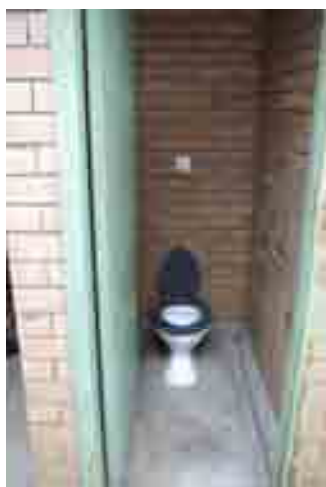
24) Pans – very narrow. Reasonable condition. Doors – corroded on frame.

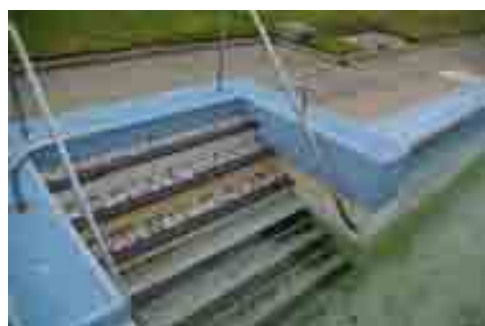
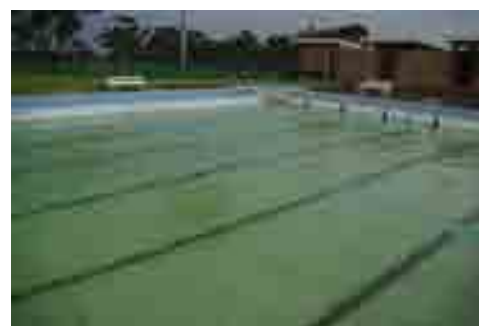
28) Steps into main pool – in good condition.

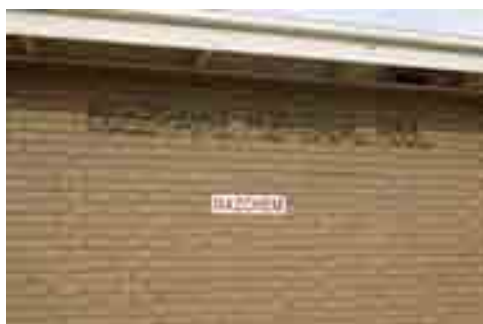
42) Main entry signage – not really inviting “HAZCHEM” versus Coleraine Swimming Pool

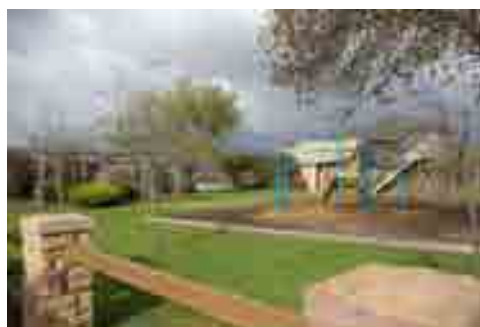
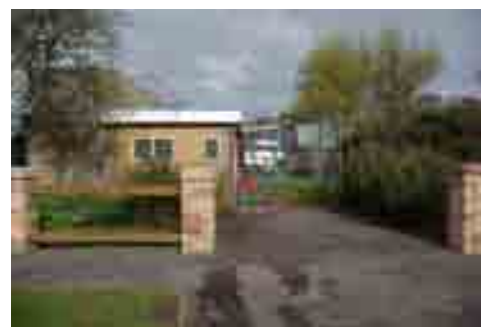
- 1) Main view to pool entry via the park and play ground (in foreground)
- 2) Direct access from highway – the plant room and delivery access. No direct link to pool from street.

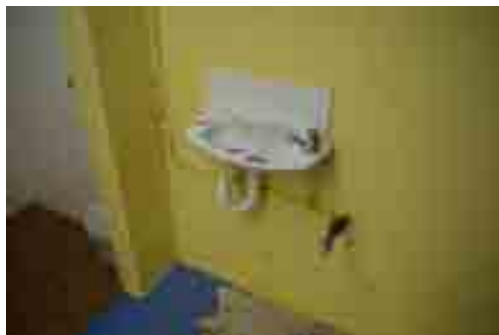
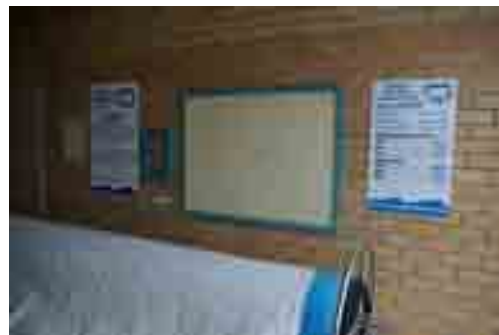
- 19) Wall mounted basin in good condition, however not compliant for disability access. Note epoxy floor coating – in poor condition under basin.
20) Pool blanket in good condition – located within entry area of pool facility.

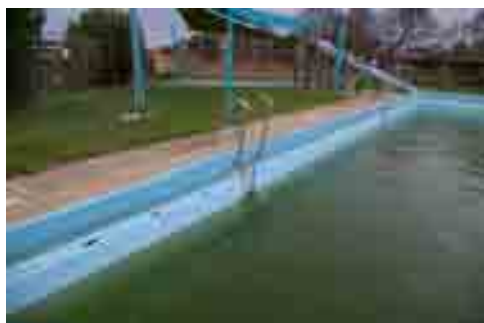
- 21) Main 25m pool in good condition. Ladder access in good condition.
22) Main 25m pool – view over pool towards the change rooms.

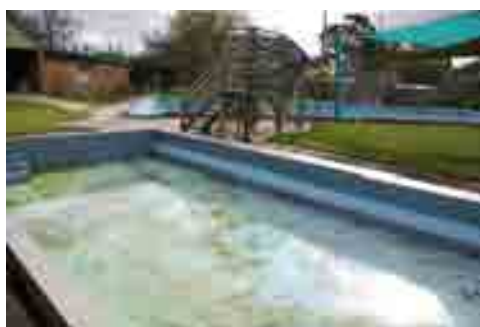
- 25) Toddler's pool with step entry.
26) Minimal signage to around pool. Stair access requires handrails (to both ends of the pool).

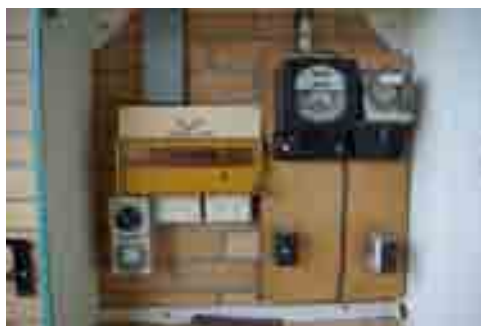
40) Backing to switchboard may contain asbestos.

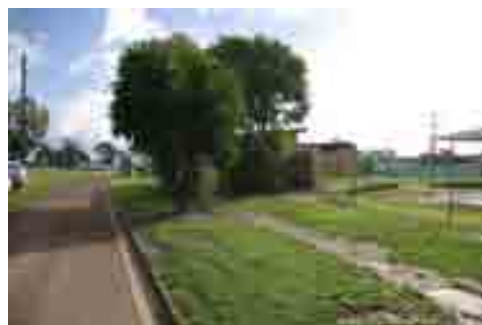
- 1) Main view from service road to main entry. No visible path to pool entry.
- 2) Adjacent Lions Club Park next to Glenthompson pool.

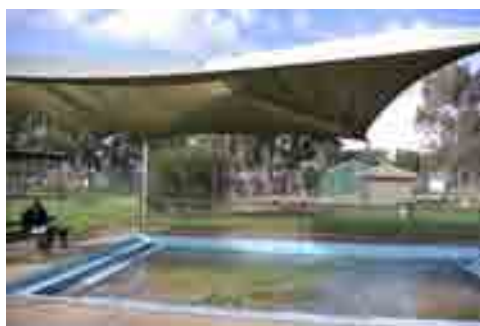
- 24) Toddler's pool with step entry.
25) Minimal signage to around pool.

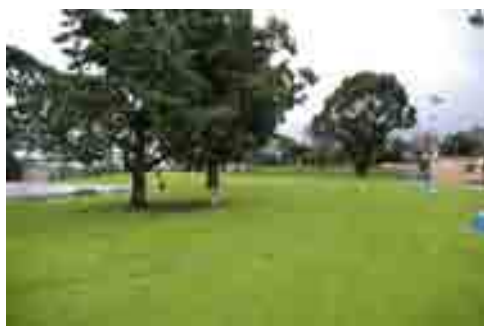
- 1) Hamilton pool – relatively flat site with significant trees located throughout – note playground in the background.
- 2) Main axis from the main entry looking over the toddler's pool, main pool to the plant room.

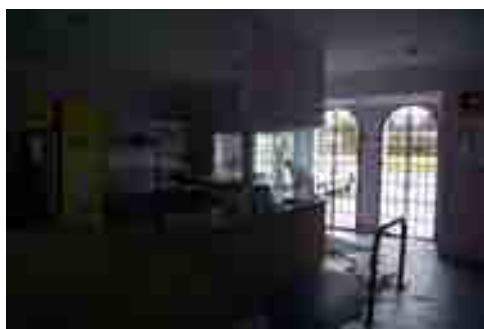
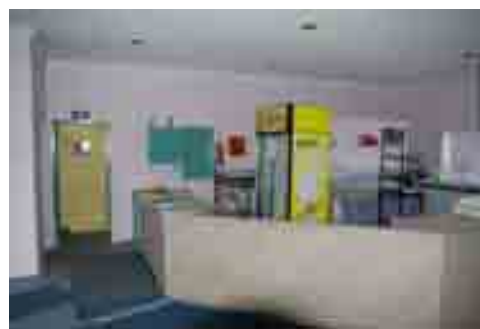
- 10) Main entry from inside the control/ reception area.
11) Typical joinery – tired and in fair condition.

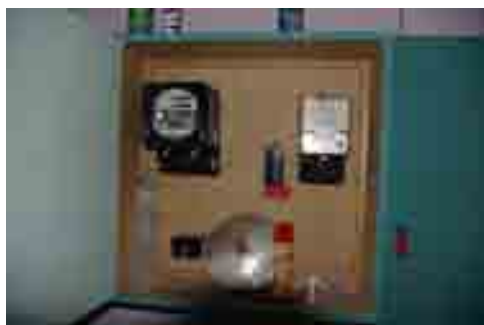
- 12) Main meter board in reasonable condition.
13) Main entry to pools from entry building – access way very low due to roller door behind.

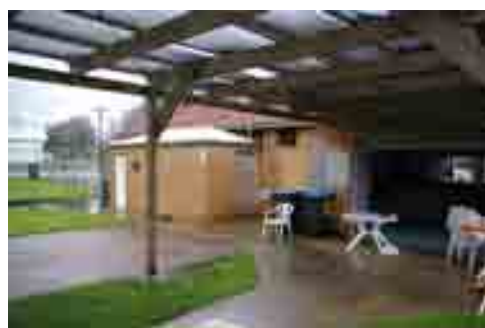
14) First aid room – not clearly accessible from pools – poor location for signage.

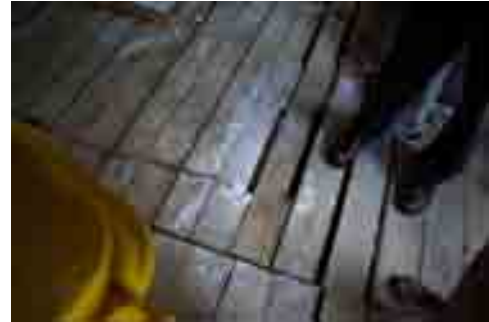
16) Evidence of sodium bicarbonate spill on timber floor and through slats.

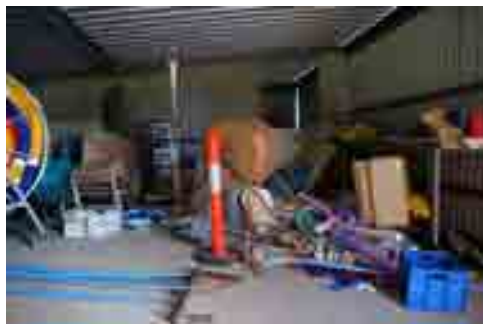
20) Store room – a dump.

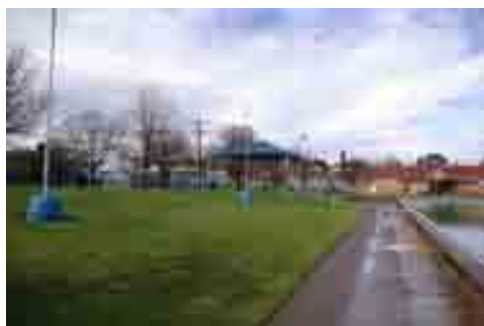
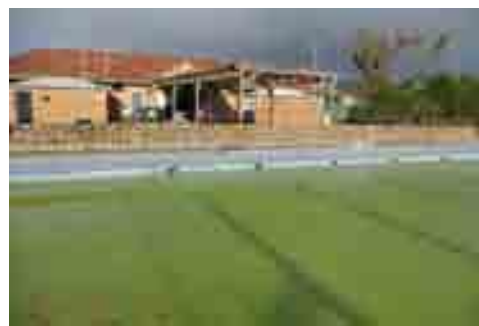
- 22) Fixed sun shade structures – along pool concourse.
23) Main toddler's pool – sun structure.

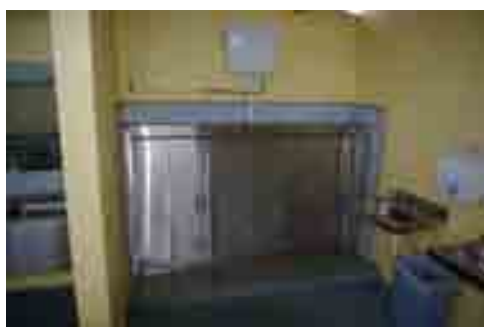
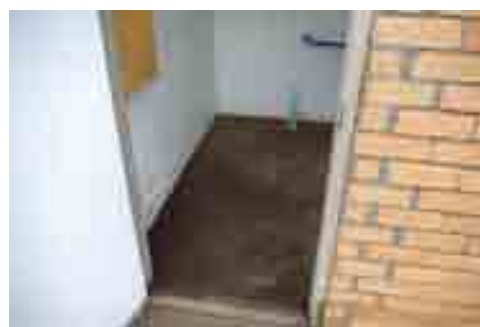
- 26) Typical urinal and wall mounted basins in male change rooms.
27) Disabled toilet – subject to flooding. Note door frame corroded at base.

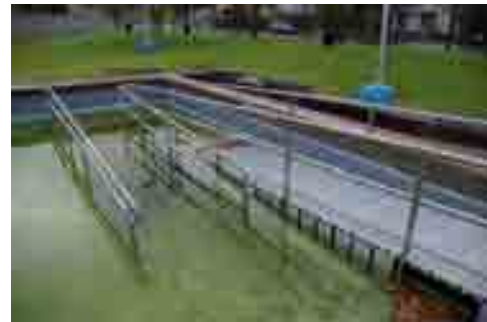
- 33) Pool concourse graded to pool ramp – not compliant.
- 34) Disabled ramp – not compliant – note potential hazard with portion of wall open.

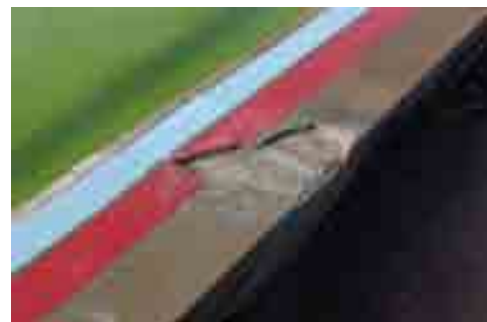
- 35) Typical access ladder – no step from pool concourse.
- 36) Portion of pool shell to be repaired.

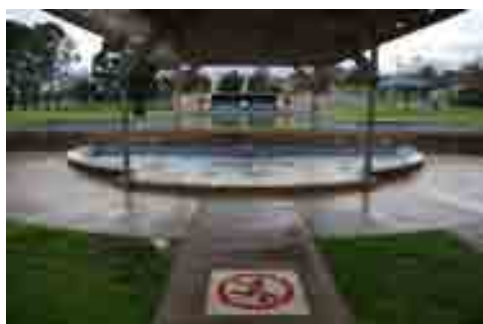
- 37) Toddler's pool recommended to be removed.
38) Toddler's pool signage in fair condition.

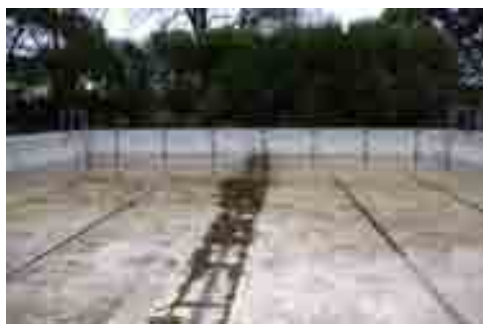
- 39) 25m pool in poor condition – recommend to be removed.

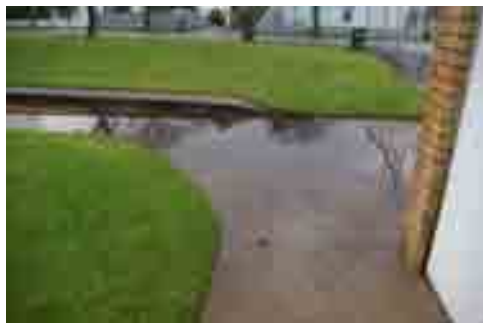
- 41) Sections of pool concourse subject to flooding.
42) Corroded pit lids.

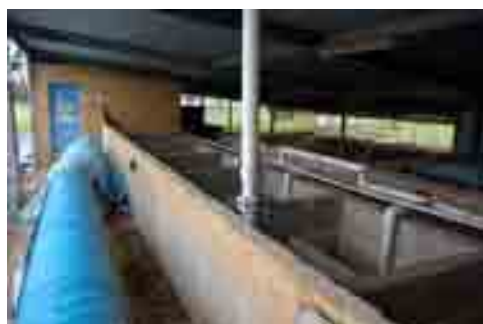
- 45) External gravity sand filters in reasonable condition.
46) Typical pipe work condition.

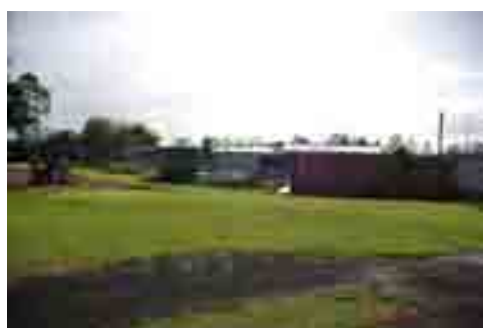
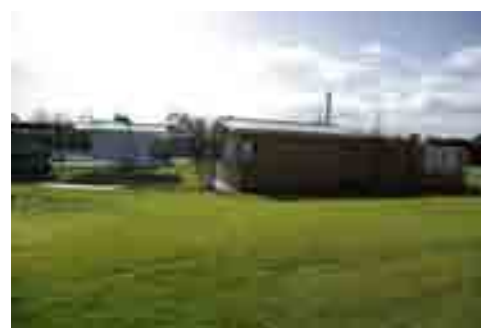
- 1) Penshurst pool – open parkland adjacent to swimming pool site (view from car park).
- 2) Main entry to pool – no clear signage or direct path from main car park.

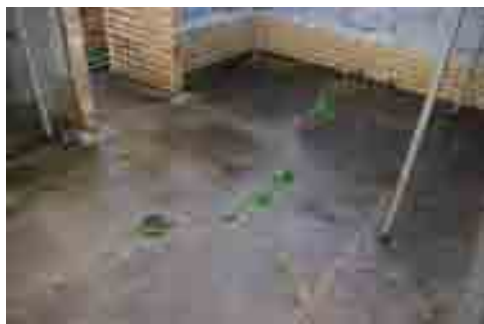
- 7) Concrete flooring to female change – cracked. Potential structural cracking and settlement to slab.
- 8) Corroded steel lintel and damaged lighting.

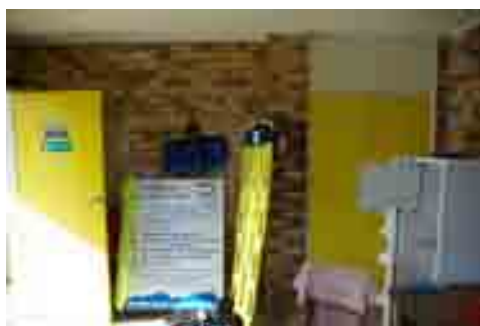
- 9) Main entry / office / first aid room & kiosk? Internally not well labelled.
- 10) External access to main office. No signage stating first aid (other than door – when closed (see above image))

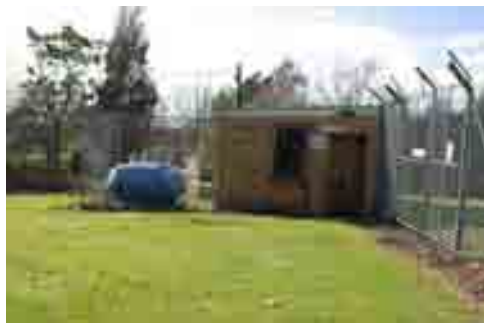
- 11) Pool plant room – with external sand filters.
- 12) Pool plant rooms internally with Hypo tank.

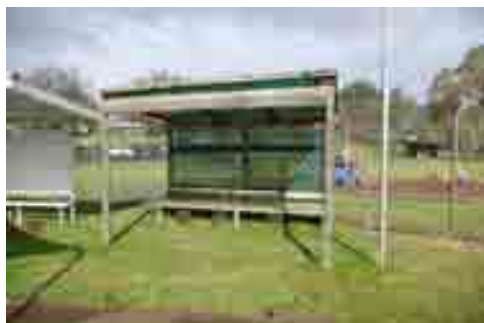
- 13) Fixed timber sun shade structures adjacent to pools – poor condition. Looks unattractive.
- 14) Sun shade structure to toddler's pool.

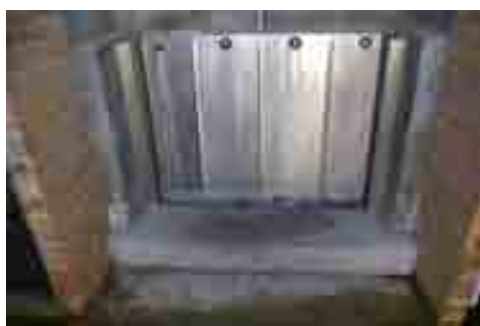
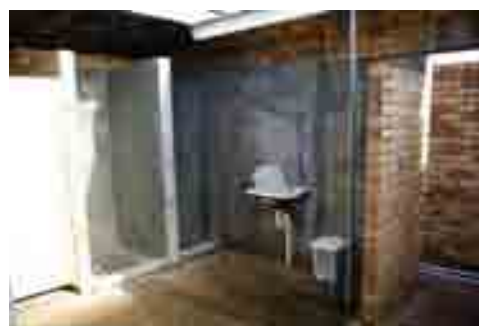
15) Corroded men's urinal.

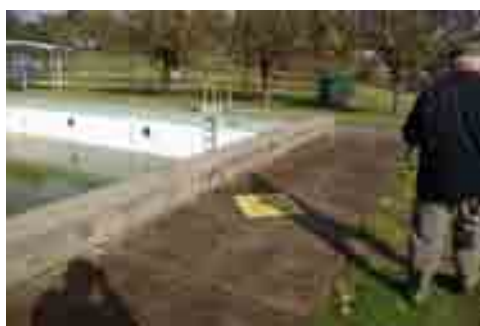
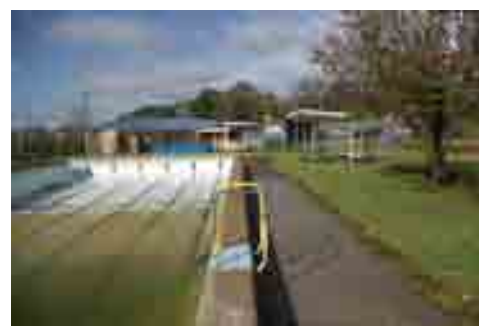
- 25) Typical signage around pool. Portion of this concourse has settled 'down' from main pool.
26) Section of pool concourse replaced with new (very recently).

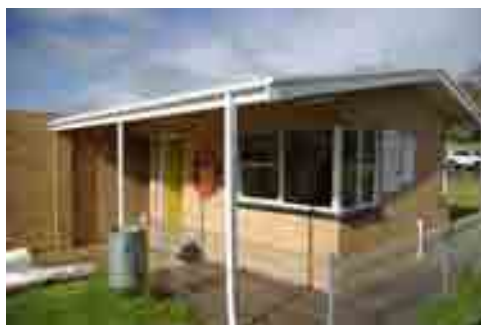
- 31) Restricted access adjacent to entry – too narrow for wheel chair or two-way pedestrian access.
32) Pavement from toddler's pool to change rooms too steep as gradient appears excessive to BCA.
