## Aquatic Development Strategy

## Volume 1: Technical Assessments & Probable Capitals Costs

## Site Investigation Report

Site:	<b>Balmoral &amp; District Swimming Pool</b>	Date visited:	30 <sup>th</sup> June 2009 FINAL ISSUE
Project:	South Grampians Council – Aquatic Facility Development Strategy	Project No:	EJ-0763
Client:	Southern Grampians Shire Council	Representative:	Mr Craig Halley
Investigation undertaken by:	Sean Stone Mike Pettigrew	Company:	Etch Architectural Solutions David Powick & Associates
Copies to:	Steve Pallas	Company:	@Leisure
Weather Conditions:	Overcast conditions, high winds and frequent showers Cold		
Pages	<b>15 (including this page)</b>

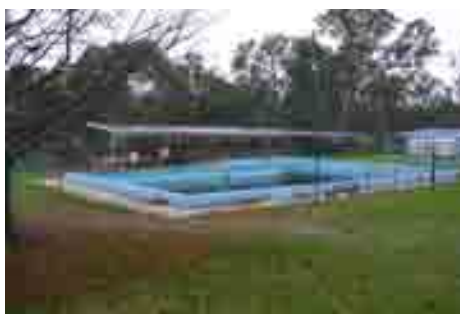
- 1) Balmoral pool – grassed (sloped) site.
- 2) Main road access clash with main pedestrian entry.

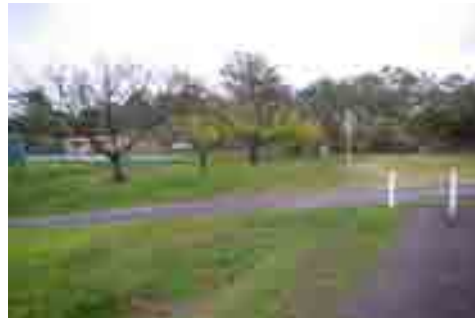
- 3) Main view of pool from main road (from township) – no visible signage.
- 4) Permeable car park at rear of pool facility – no designated disabled car spaces.

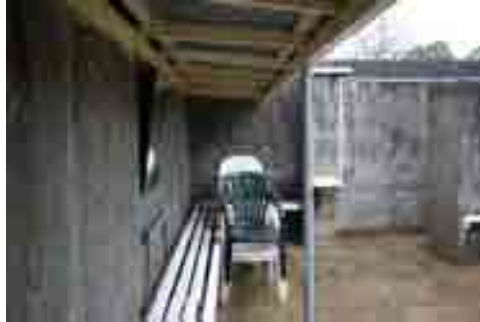
- 5) Typical condition of the change rooms – exposed to the weather.
- 6) Rendered concrete wall finish and exposed concrete flooring.

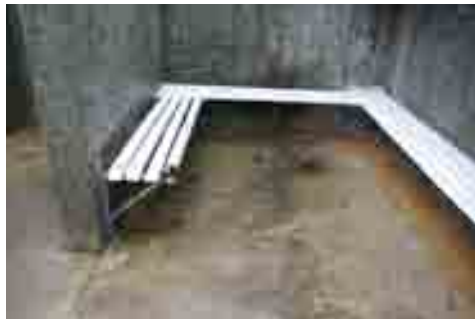
- 7) Typical condition of all bench seating.
- 8) Typical condition of toilet partition doors.

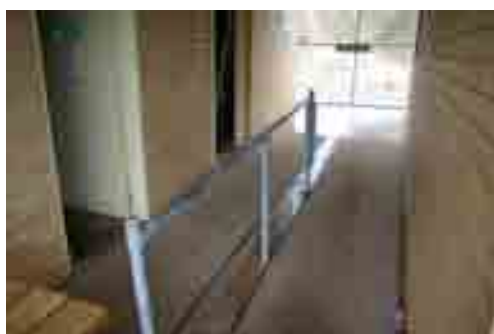
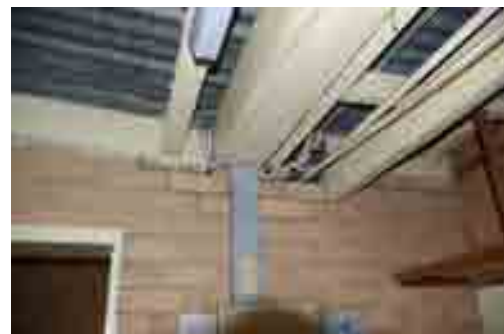
- 9) Restricted access into pool facility via entry. Acceptable for one-way pedestrian traffic only (tight for wheelchair)
- 10) No ceiling lining in office.

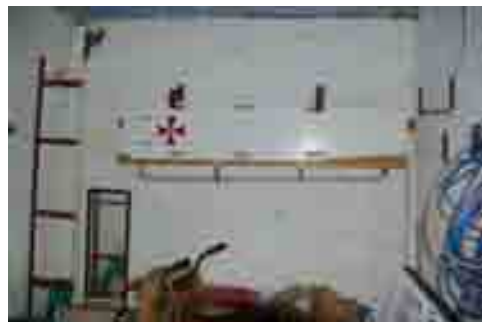
<b>Buildings – First Aid Room &amp; Store</b>						
General visual condition (see definitions below)	Poor	<b>X</b>	Fair	Reasonable	Good	
<b>Comments:</b> <ul style="list-style-type: none"> <li>• Originally first aid – now a store room. Store room observed in a complete mess.</li> <li>• First aid room not compliant to RLS Safe Pool operation guidelines FA3 and should a minimum of 15 sq.m in size.</li> <li>• No clear visibility to the pool and / or office if one pool attendant is operating the facility.</li> <li>• Signage not adequate for this room. The only signage is located on the door and can not be seen if opened.</li> <li>• No ceiling in room.</li> <li>• Brickwork in fair condition.</li> </ul>

- 11) Typical condition of the first aid room / store.
- 12) Typical condition of the first aid room / store – rubbish dump.

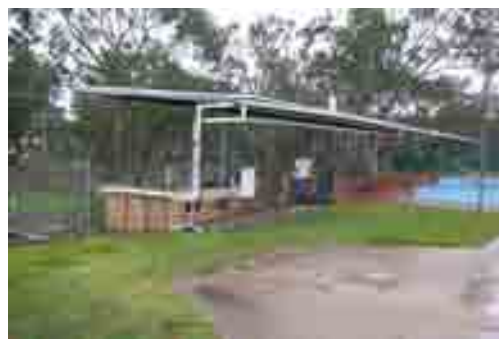
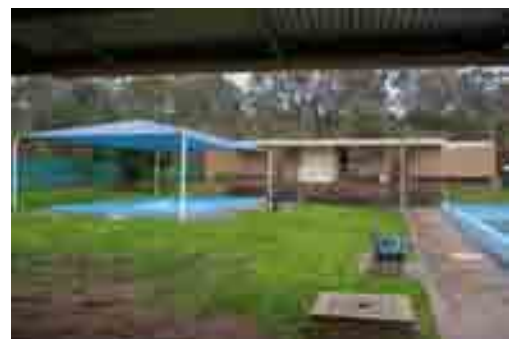
- 15) Solar heater shelter. Adjacent to the main pool.
- 16) Sun shade structure to toddler’s pool in a reasonable condition.

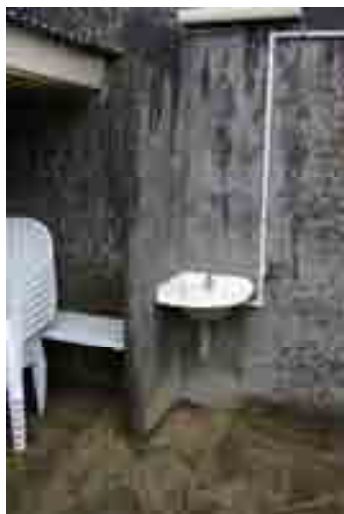
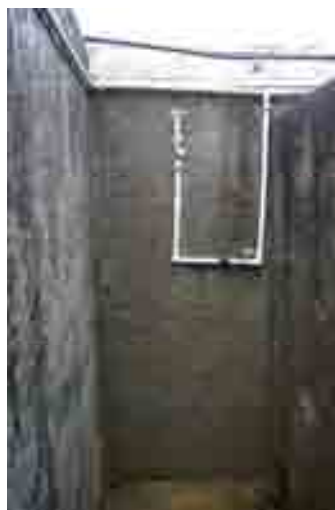
17) Typical steel basin with exposed plumbing.

18) Typical condition of showers. Shower rose may be water saving but pipe work – very poor.

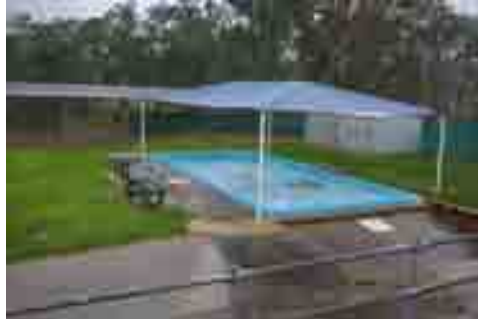
- 21) Toddler's pool – view from main entry. Note the steep gradient to the concourse paving.
- 22) Typical signage around pool. Note several steps into pool – not recommended.

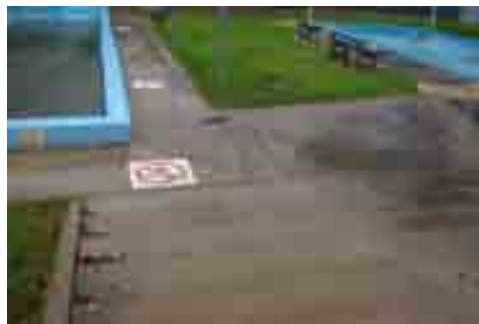
- 23) Steps from main entry to pool levels – not BCA / AS 1428.1 compliant.
- 24) Width of main pool concourse – too narrow.

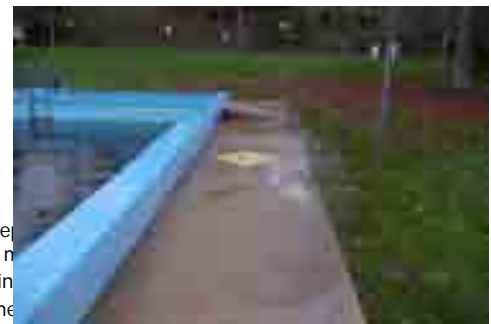
- 25) Toddler's pool – narrow pool concourse. Seating in poor condition, recommend to be replaced.
- 26) Pool concourse adjacent to toddler's pool – too steep.

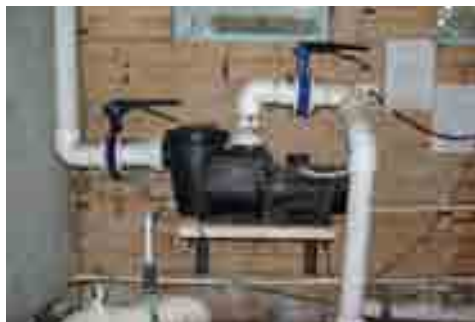
- 27) Elevated pump.

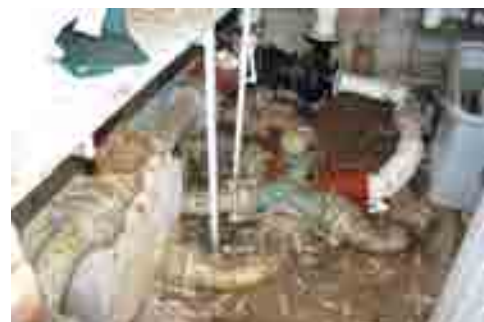
28) General pipe work in fair condition.

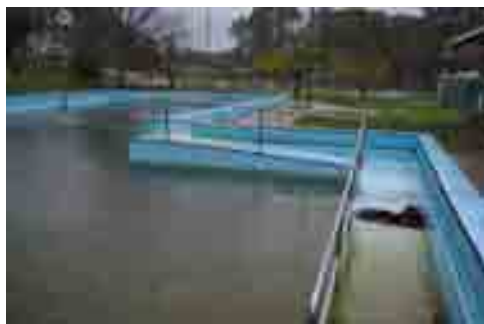
29) Main pool – disabled ramp not compliant

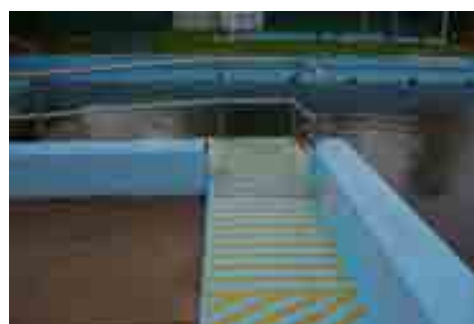
- Disabled ramp into pool does not comply to current BCA and AS 1428.1 regulations due to its width, hand rail design and no hand rail at the entry for ramp at pool concourse level (this section of ramp may be deemed a trip hazard and dangerous).

30) Section of pool ramp above water line is not BCA compliant and is deemed dangerous

- Refurbishment of the solar heating system.
  - Pool ramp to be replaced with new (so to AS 1428.1 compliant)
- Recommendations directed by David Powick & Associates for the filtration room should be implemented.

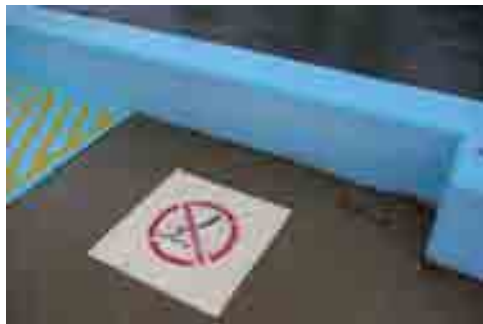
31) Typical pool signage does not comply.  
32) Main signage to the pool facility.

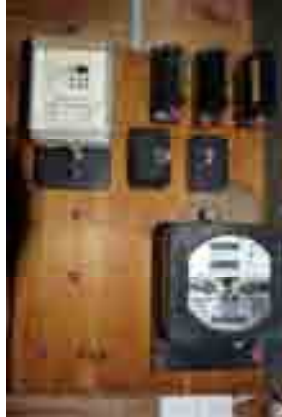
- On visual review of the electrical meter board and switch board located in the pool filtration plant room and the approximate age of the structure, it is very likely that asbestos may be located.
- On the condition of the pipe work associated within the filtration room and the age of the facility – asbestos lined pipes may have been used in its construction.

33) Switch board / meter board – may contain asbestos, due to its age and condition.

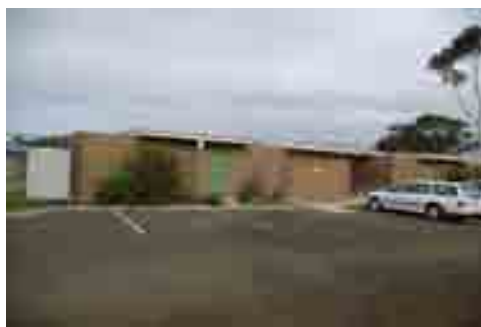
- 1) Coleraine Pool – main entry.
- 2) Typical seating and sun shading structure – located around the pool facility.

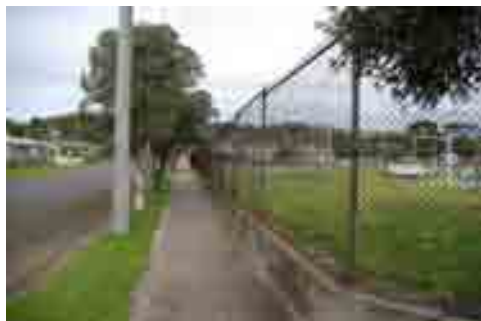
3) Pool site – visually linked to Gage Street & Mcconchie Street).

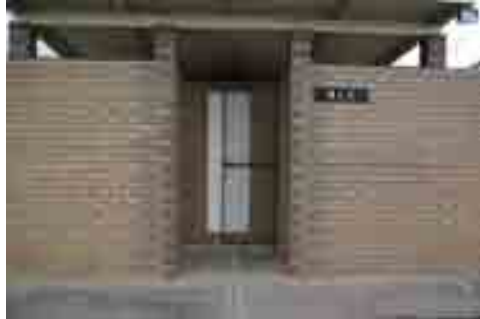
- 4) Main entry to change rooms.
- 5) Female change room – floor grading to floor waste. Structural cracks to slab evident.

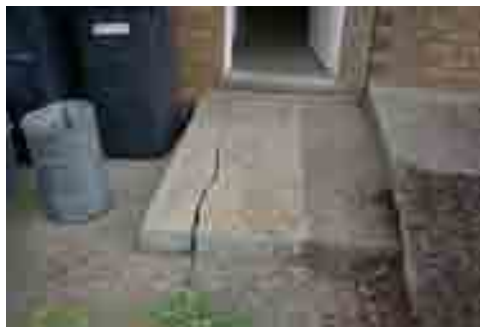
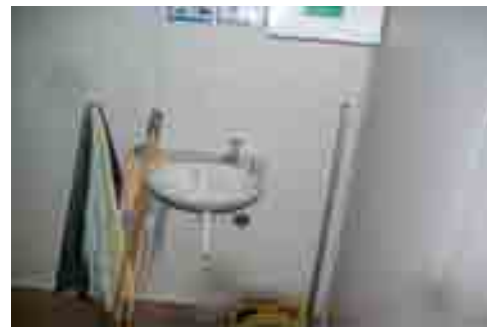
- 12) Access to first aid room – not BCA compliant. Structural crack to landing. (narrow door to room)
- 13) First Aid room – appears more like a store room.

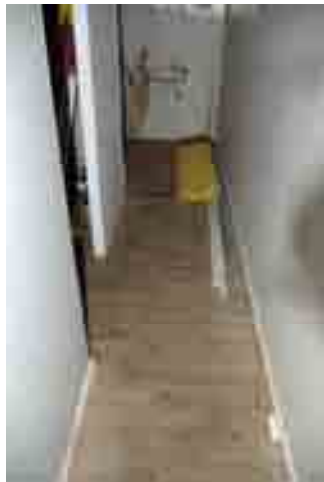
- 14) Passage way from entry door to first aid room – too narrow (max. 900mm width)
- 15) First Aid room – appears more like a store room.

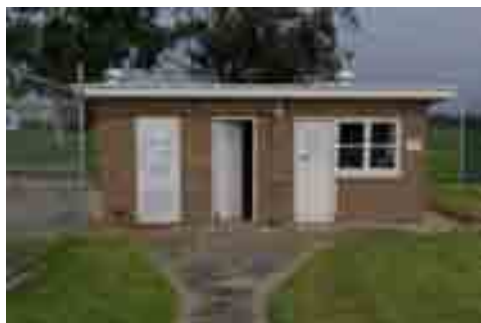
- 16) Plant room / Filtration room appears in a poor condition (internally / externally). Safety shower compliant.
- 17) External window – very poor condition and structural cracking to brickwork.

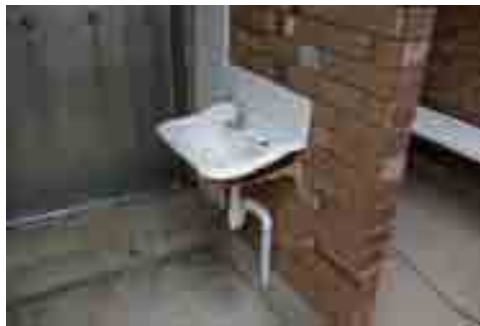
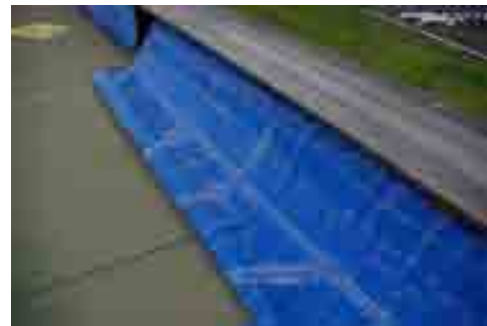
- 22) Typical wall mounted basin to all change rooms – wall brackets corroded.
- 23) Pool blanket – reasonable condition. Top coating of cover is breaking down with exposure.

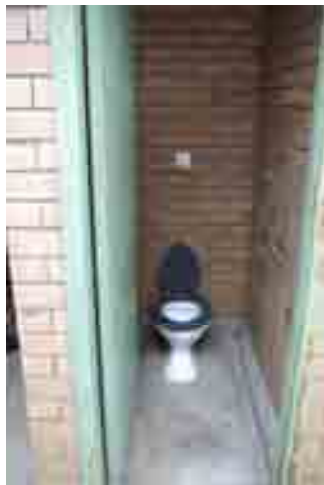
- 24) Pans – very narrow. Reasonable condition. Doors – corroded on frame.
- 25) Shower area – use of water saving shower rose – very tight in area – no partitions.

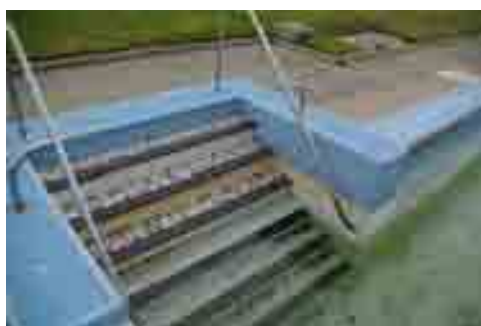
- 28) Steps into main pool – in good condition.
- 29) Main 50m pool in reasonable condition, evidence of more pool shell repairs.

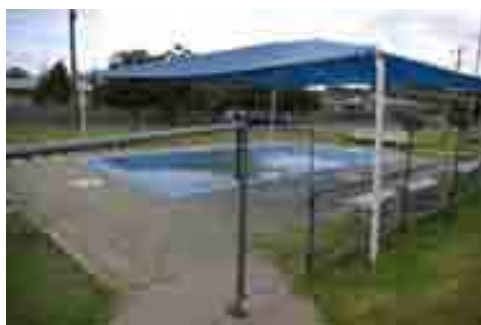
- 30) Toddler's pool and pool fence. Fence in fair condition – probably not really required.
- 31) Toddler's pool with hand rail – could be deemed a tripping hazard and should be removed.

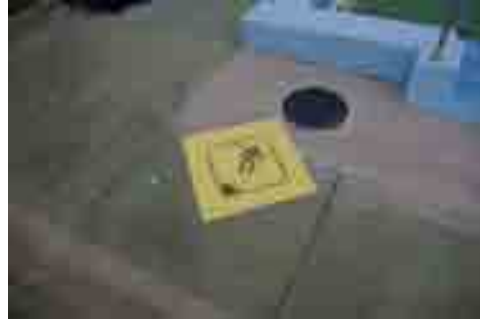
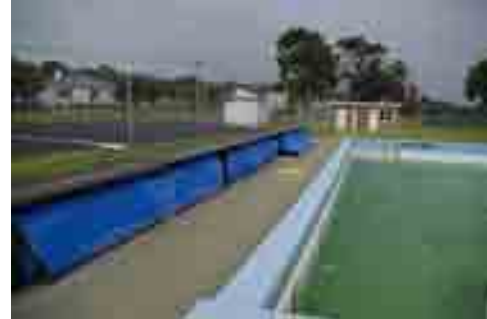
- 32) Signage to main pool concourse in fair condition.
- 33) Pool blankets – recommend being a minimum 1000mm further away from deep end for clear circulation.

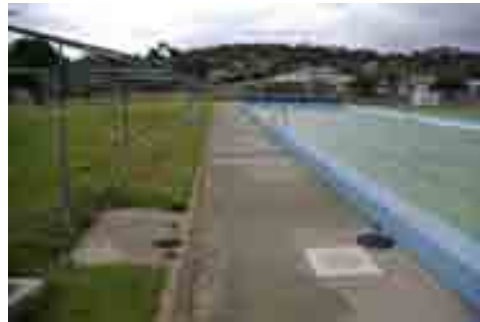
- 34) Main pool concourse in reasonable condition. Width complies with RLS minimum requirements.
- 35) Sections of the pool surface have been grinded, including around pit lids.

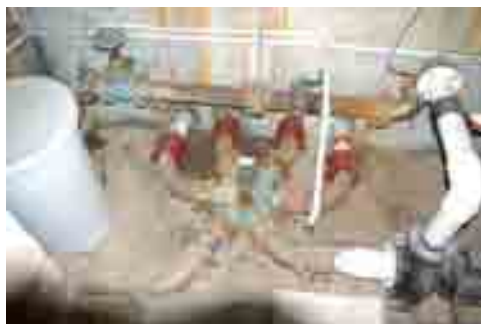
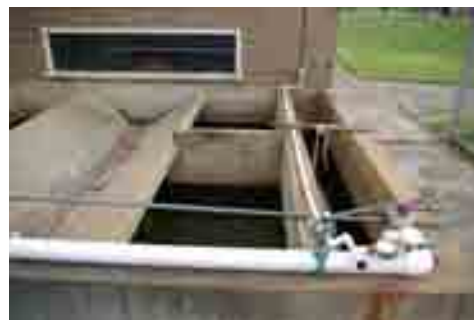
36) Typical pipe work condition.  
37) External gravity sand filters in reasonable condition.

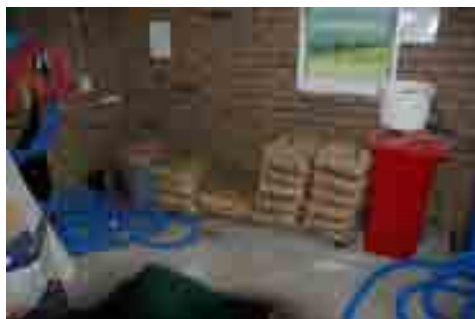
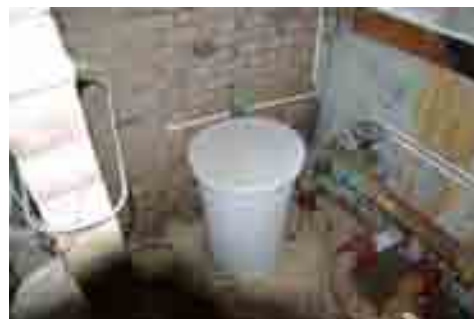
38) Typical storage condition for pool chemicals – may be deemed dangerous.  
39) Typical pipe work condition and filter.

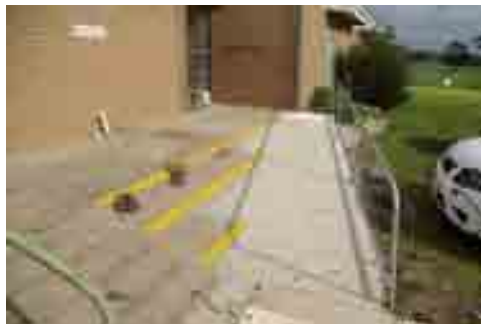
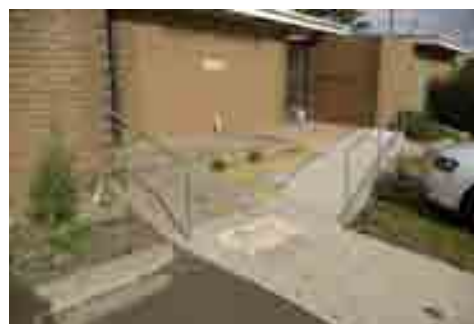
- 40) Main entry – disabled ramp not compliant. Trip hazard evident and handrail not compliant.
- 41) Ground tactile indicators not installed as per AS 1428.4 .Tactile indicators face the wrong ramp.

- Toilet cubicles not wide enough – recommend removing the brick work and replacing with nominal toilet partitions.
  - Ramp at entry not BCA (A/S 1428.1) compliant. Exposed steps to side of ramp are deemed a hazard and can be deemed a trip hazard.

- Re-grade paths from change rooms to pool concourse as grade is too steep. All graded paths to have a gradient 1:20 or be refurbished as ramps with a grade of 1:14.

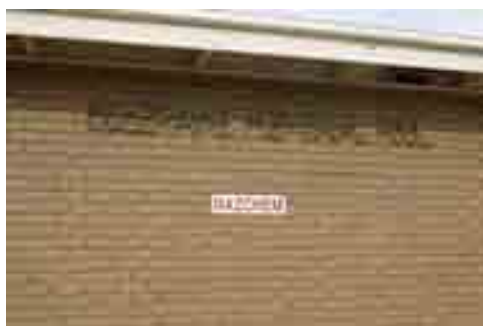
- 42) Main entry signage – not really inviting “HAZCHEM” versus Coleraine Swimming Pool
- 43) Directory signage to be replaced to comply with current requirements

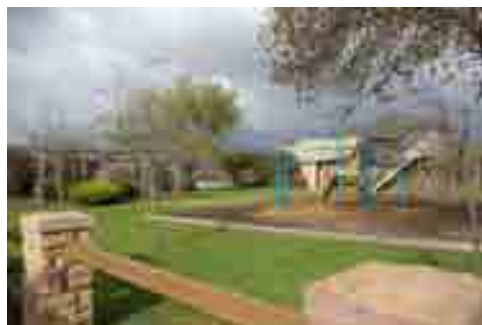
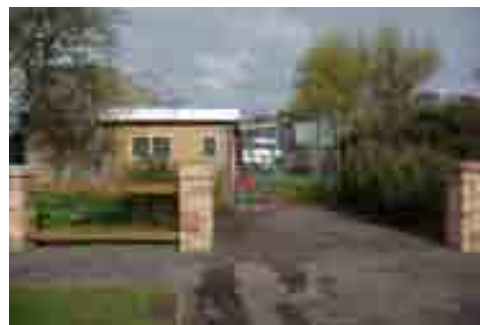
- 1) Main view to pool entry via the park and play ground (in foreground)
- 2) Direct access from highway – the plant room and delivery access. No direct link to pool from street.

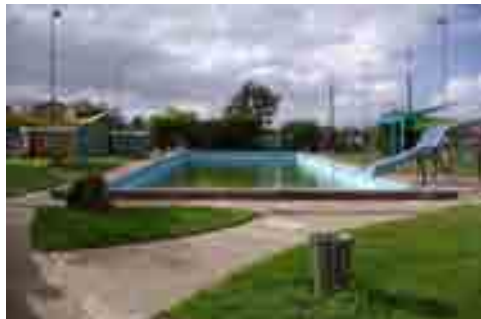
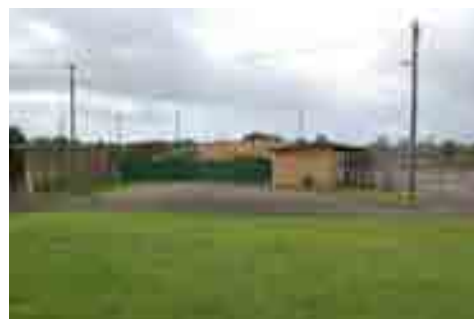
- 3) Main view of the 25m pool from the southern end of the facility- plant room in the background.
- 4) Main car park of pool also linking with Bowls & Tennis clubs.

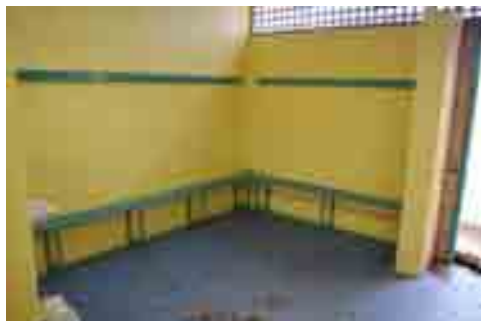
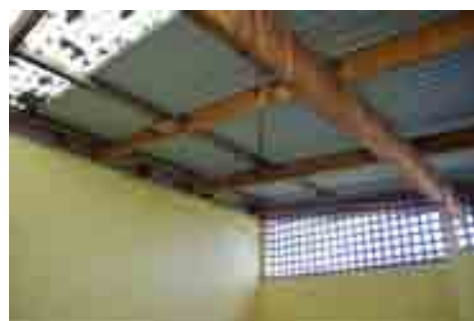
- 5) Change rooms – typical layout in good condition – epoxy paint floor treatment and typical bench slat seating.
- 6) No insulation to roof.

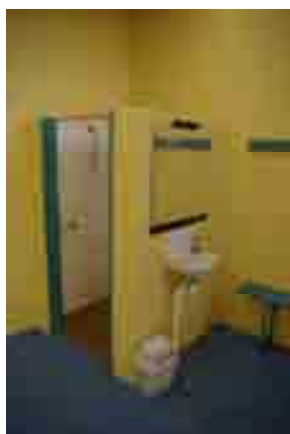
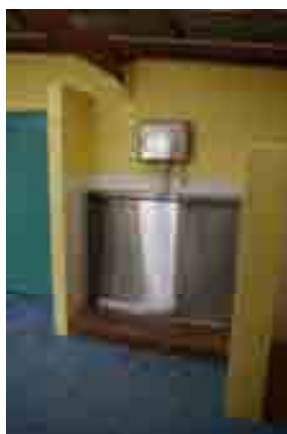
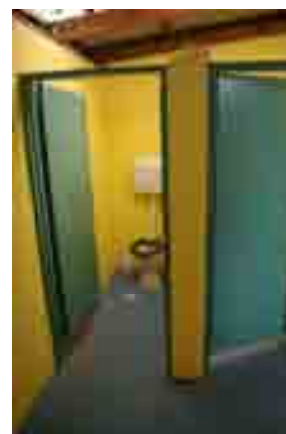
- 7) Showers too small to accommodate disabled requirements and BCA occupancy rates
- 8) Men's urinal in good condition.
- 9) Typical pan & toilet partition to change rooms.

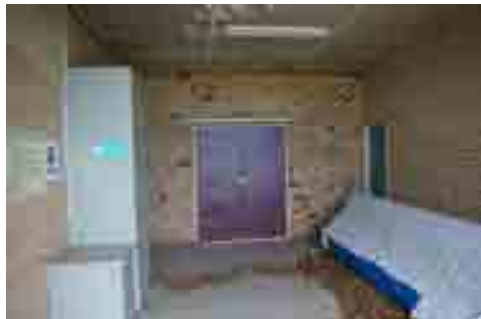
10) Main entry & first aid 'area' in large cup board – unacceptable. Exposed in main entry

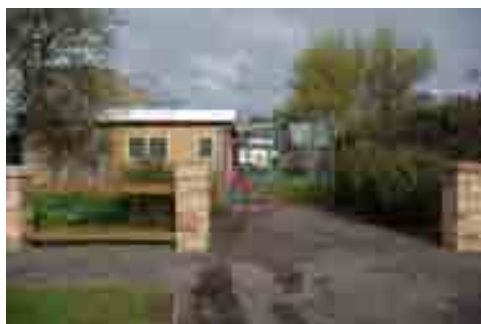
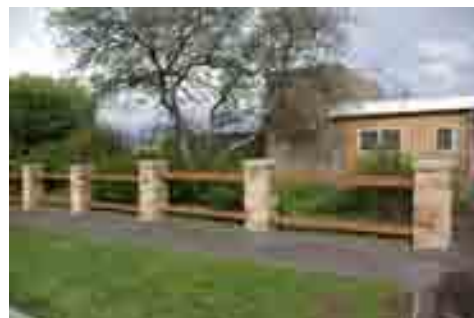
11) Pool plant room – main access from highway – signage clearly visible  
 12) Extent of sand filter above existing plant room. No visible link from highway to pool.

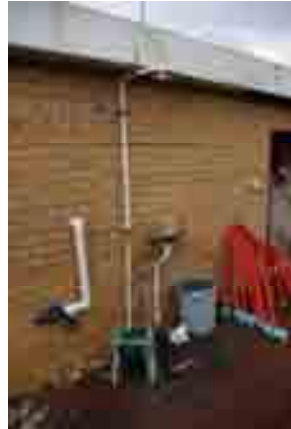
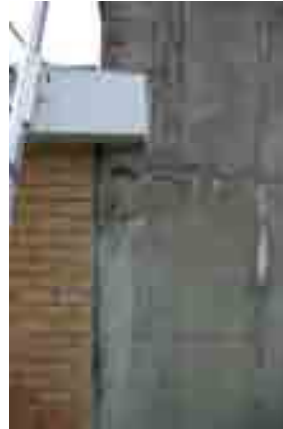
- 13) Safety shower and eye wash in close proximity to plant room entry – poor condition of roof
- 14) Gravity feed – sand filter in fair condition.

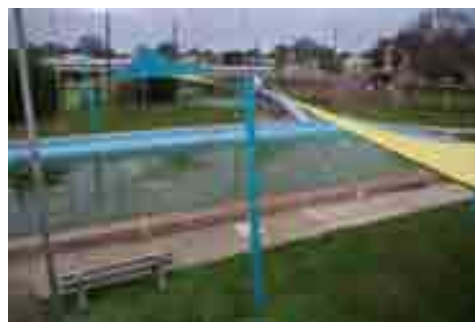
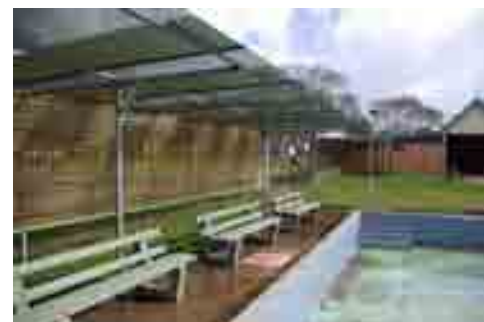
- 15) Main sun shade structures to pool facility in good condition and should remain.
- 16) Light weight – southern perimeter shading – not aesthetically pleasing

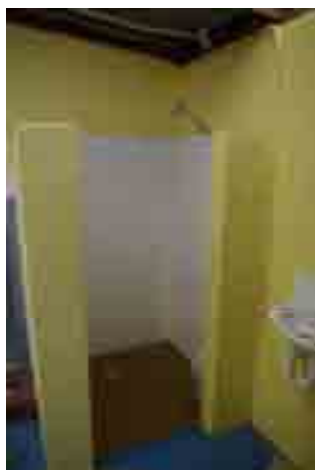
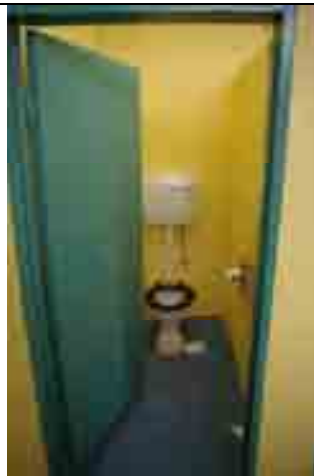
- 17) Water saving shower rose already installed. Showers in good condition – space restricted.
- 18) Typical pan and toilet partition. Note paper dispenser corroded.

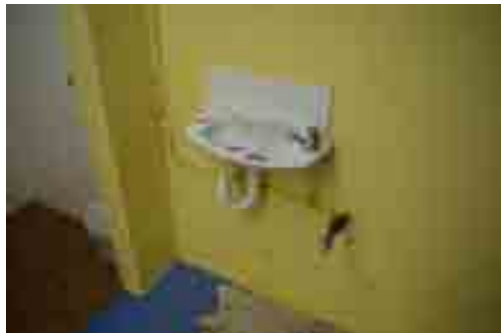
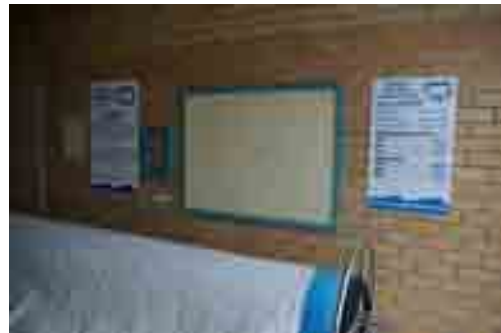
- 19) Wall mounted basin in good condition, however not compliant for disability access. Note epoxy floor coating – in poor condition under basin.
- 20) Pool blanket in good condition – located within entry area of pool facility.

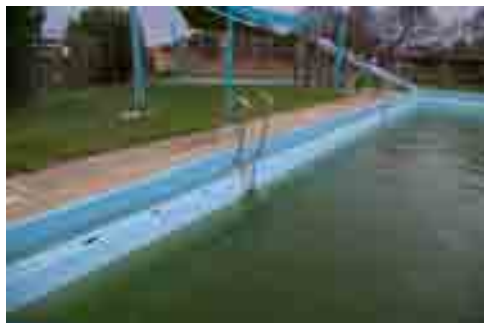
- 21) Main 25m pool in good condition. Ladder access in good condition.
- 22) Main 25m pool – view over pool towards the change rooms.

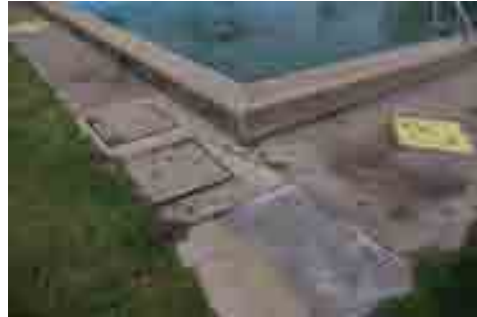
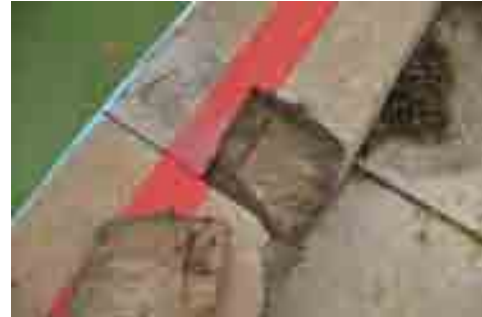
- 23) Pool signage in a poor condition. Recommend to be replaced. Pool concourse in poor condition at this corner.
- 24) Area adjacent to expansion joint where the reinforcing has been.

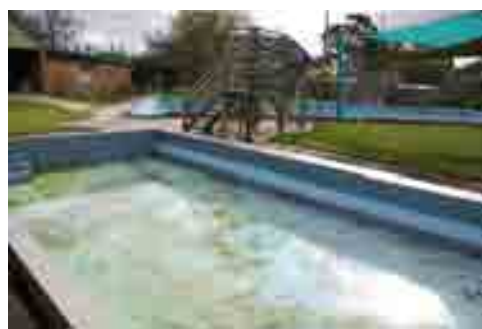
- 25) Toddler’s pool with step entry.
- 26) Minimal signage to around pool. Stair access requires handrails (to both ends of the pool).

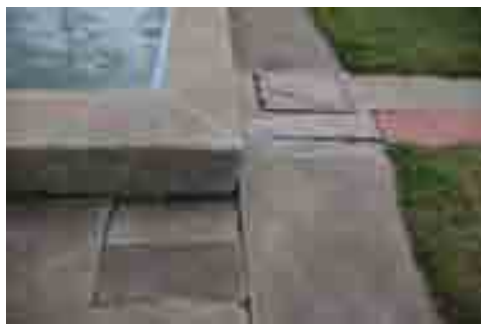
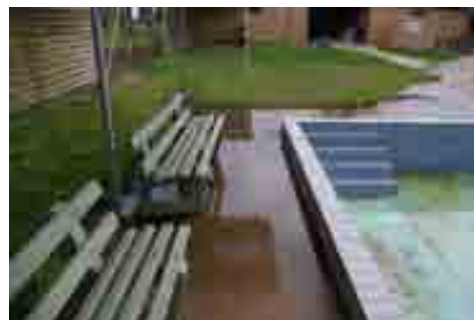
- 27) Main path – grading to main pool concourse.
- 28) Section of pool concourse recently grinded to minimise trip hazards.

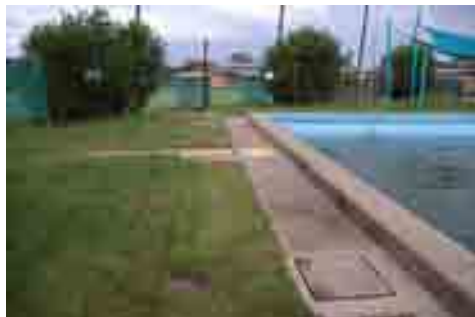
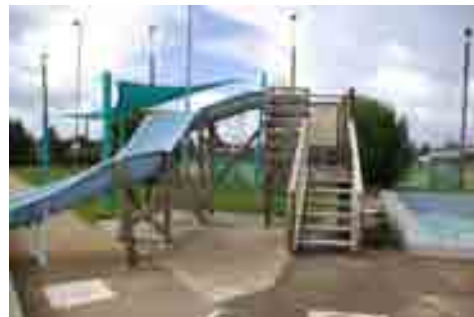
- 29) Existing light poles removed. Screened by seating. These areas restrict the pool concourse width.
- 30) Evidence of pool concourse cracking and expansion joint repairs.

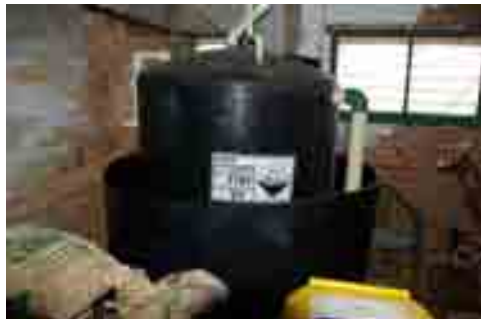
- 31) Hypo tank – restricted access around tank.
- 32) Additional chemical storage – directly adjacent to Hypo tank bund – not recommended.

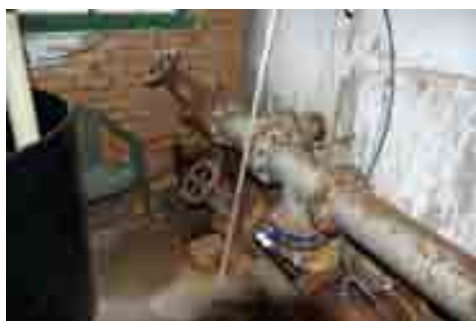
- 33) Typical condition of existing pipe work
- 34) Above ground – gravity fed sand filters – reasonable condition.

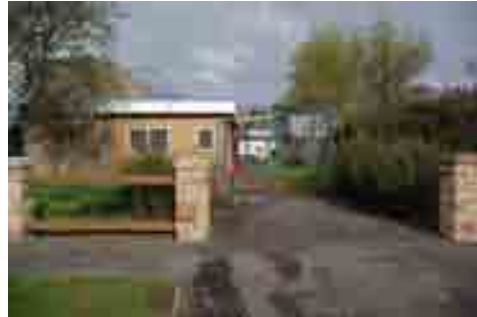
39) Main signage of pool from main highway – not inviting.

- filtration plant. It is also recommended to be moved away from main highway to allow for better visibility.
- Provide more prominent signage for this facility.

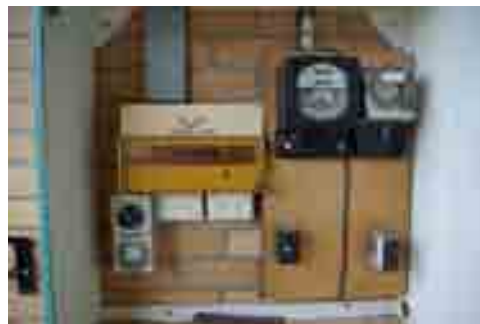
- On visual review of the electrical meter board and switch board located in the pool filtration plant room and the approximate age of the structure, it is very likely that asbestos may be located.

40) Backing to switchboard may contain asbestos.

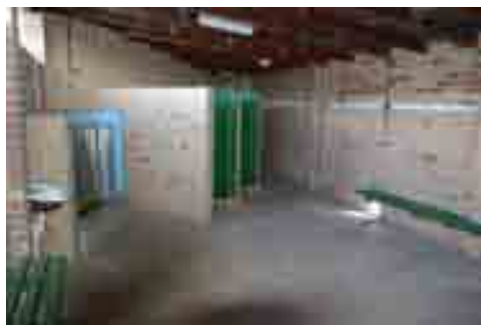
- 5) Change rooms – Male. Clean brickwork, exposed concrete slab and exposed roof (no insulation)
- 6) Corroded urinal and high step. Step is not BCA compliant.

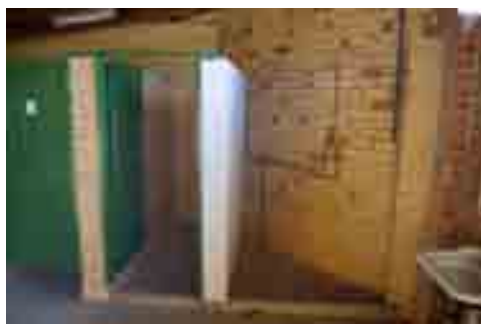
- 7) Female change – very restricted showers (with step).
- 8) Female Change rooms – very similar to male change. Very basic finishes.

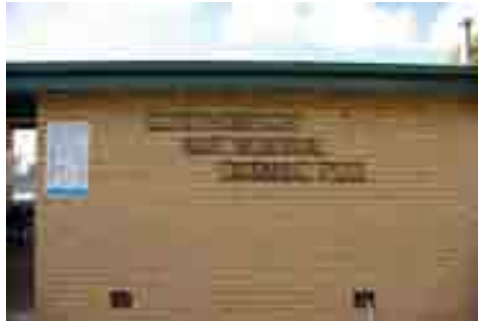
- 9) Typical signage to main entry. Not clearly visible from the street.
- 10) Typical office / entry / first aid room. Roller Door used for kiosk and no joinery.

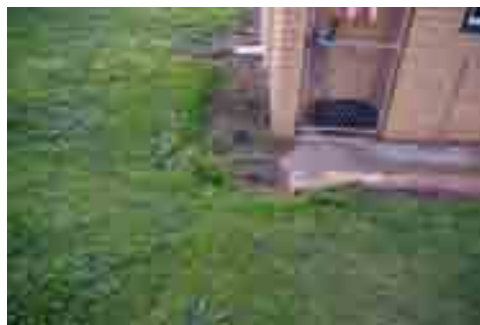
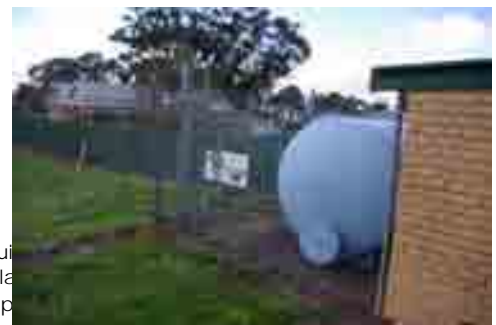
- 11) Pool plant room – main access from pool grounds and plant room. Sloped ground and no clear path from pool.
- 12) Pool plant room – with external sand filters, and main gate access.

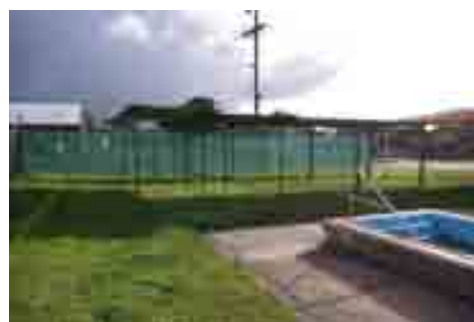
- 14) Sun shade structure to toddler’s pool.
- 15) Typical fixed sun shade structure adjacent to the main pool.

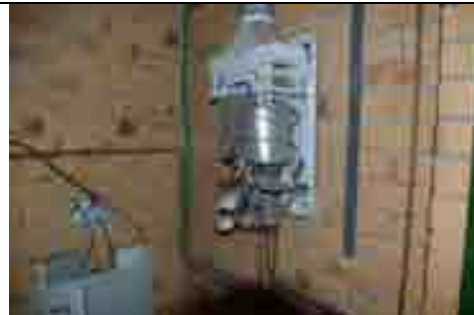
- 16) Corroded men's urinal and original cast iron / enamel basin (basins typical to both change rooms)
- 17) Gas hot water unit – not sure on its condition. General appearance – reasonable.

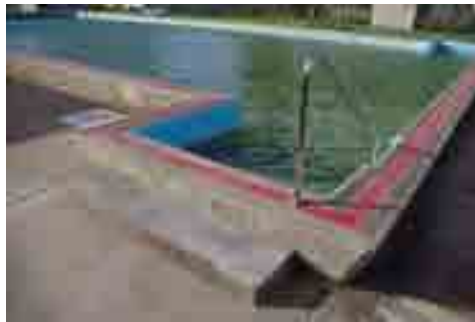
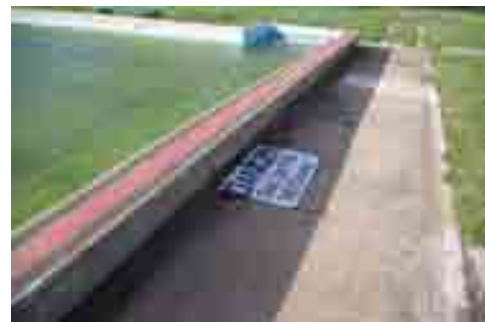
- 20) Main 25m pool in good condition. Handrail to main steps compliant.
- 21) Main 25m pool – signage around pool – reasonable condition. Recommend to be upgraded

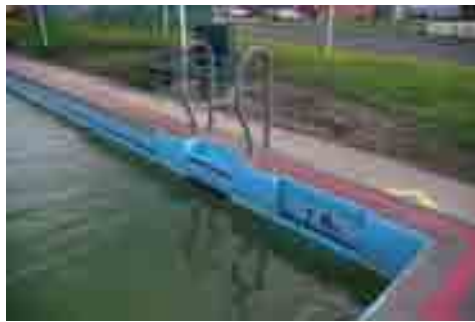
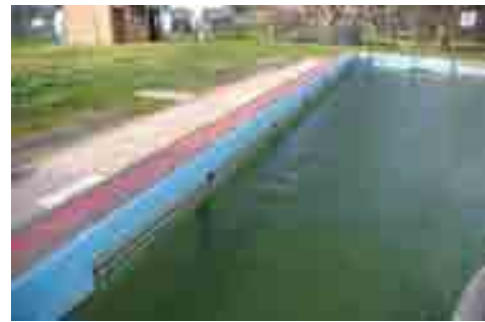
- 22) Clear pool signage. Step ladder appears in good condition.
- 23) Deep end to pool and hand rail – in good condition. Pool shell has held water (minimal water lost).

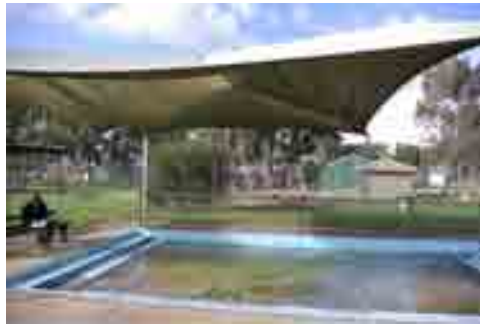
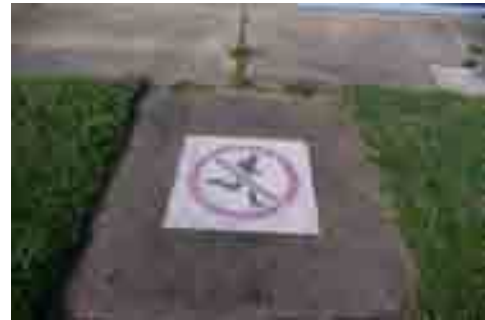
- 24) Toddler’s pool with step entry.
- 25) Minimal signage to around pool.

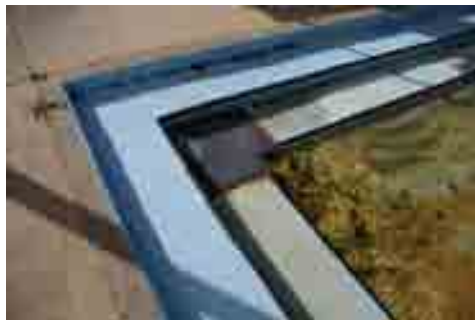
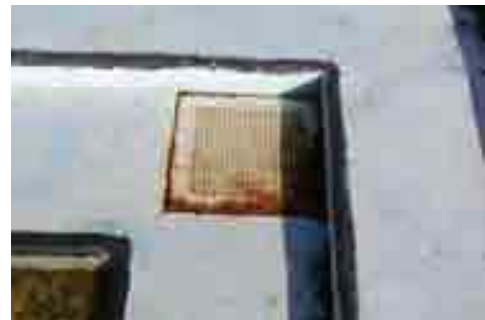
- 26) Grate plates – corroded. May create trip hazard.
- 27) Corroded plates to overflow grate to toddler’s pool.

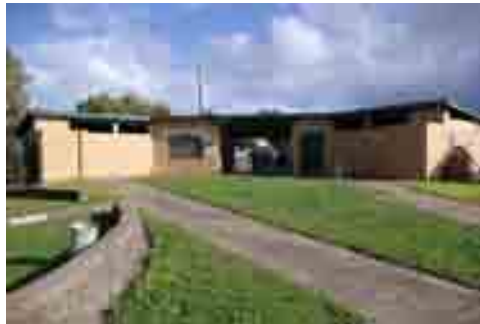
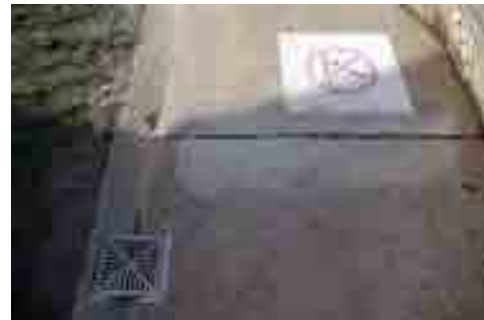
- 28) Main path – grading to main pool concourse.
- 29) Section of pool concourse recently grinded to minimise trip hazards.

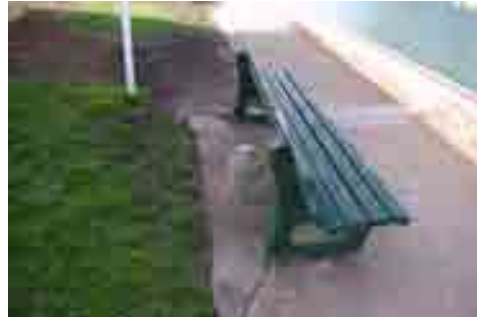
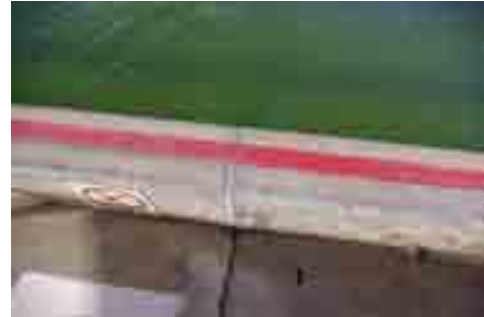
- 30) Existing light poles removed. Screened by seating. These areas restrict the pool concourse width.
- 31) Evidence of pool concourse cracking and expansion joint repairs.

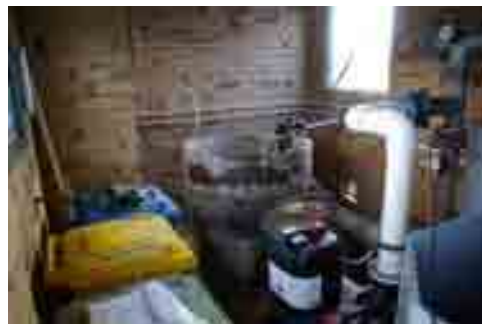
<b>Filtration Plant</b> (undertaken by David Powick & Associates)							
General visual condition (see definitions below)	Poor		Fair	<b>X</b>	Reasonable		Good
<b>Comments:</b> <ul style="list-style-type: none"> <li>The bulk storage tank for the liquid chlorine sits in a chipboard bund partly over pipe work and a pump. This bund is of no benefit at all as it could not withstand a collapse of the Hypo tank and it is too close to the Hypo tank to contain outflow from any penetration type failure. The tank should be re-positioned in a new enclosure in a bund that complies with current regulations.</li> <li>There is no automated control of water chemistry and this contravenes health department regulations. Automatic controllers should be fitted.</li> <li>There appears to be inadequate flow to the toddler's pool. Provision to adjust the flow is not apparent and this should be addressed.</li> <li>The pump and hair and lint strainer should be replaced in the short term.</li> </ul>

- 32) Pool Filtration plant – typical chemical storage area and sump.
- 33) Main pool filter with main pump (notice half the pump is located under 'hypo – tank').

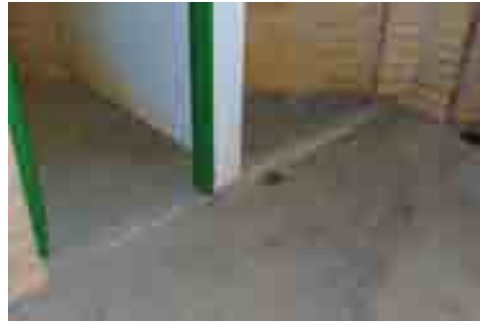
Access Conditions - Disability					
General visual condition (see definitions below)	Poor	<b>X</b>	Fair	Reasonable	Good
Comments: <ul style="list-style-type: none"> <li>• No disabled / assisted facilities are located within the facility.</li> <li>• No disabled designated car park.</li> <li>• No paved pathway from the car park to the pool facility.</li> <li>• Pathway within the change rooms and entry is too narrow. This path should be at least 1500mm wide to allow for minimum two-way pedestrian traffic.</li> <li>• All amenity and directory signage to comply with relevant codes.</li> <li>• No disabled access into the pools.</li> <li>• No disabled access into the first aid room.</li> <li>• Toilet cubicles not wide enough – recommend removing the brick work and replacing with nominal toilet partitions.</li> <li>• Door hardware to change rooms not disabled compliant (with removable hinges, indicator bolts, self closers, door handles).</li> </ul>

- 37) Restricted access to showers – remove step.
- 38) Change area large enough to allow for refurbishment and disabled compliance.

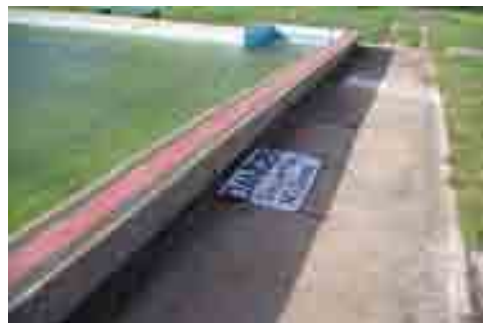
Signage						
General visual condition (see definitions below)	Poor	<b>X</b>	Fair	Reasonable	Good	
Comments: <ul style="list-style-type: none"> <li>• Typical entry signage not clearly visible from street. HAZCHEM signage very prominent – not inviting.</li> <li>• No clear signage stating first aid room.</li> <li>• Signage in fair condition. Recommend new signage around pools to comply with NARSSM.</li> <li>• Amenity signage to change rooms and first aid room is in a poor condition and does not comply with current regulations. All amenity signage is required to include Braille tactile.</li> <li>• Warning / HAZCHEM signage to plant room in a fair condition. Recommend new.</li> </ul>

- 39) Signage to store room in a poor condition. Recommend to be replaced with new.
- 40) Signage to change rooms in a poor condition.

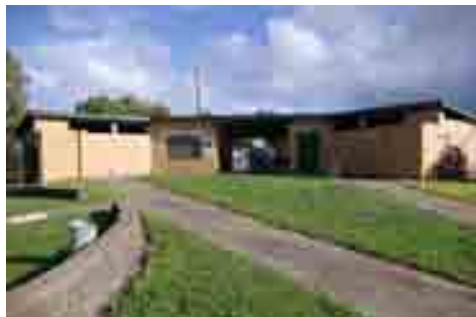
41) Signage to change rooms in poor condition.

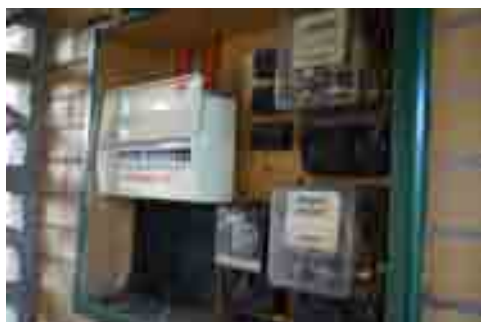
- On visual review of the electrical meter board and switch board located in the pool entry and the approximate age of the structure, it is very likely that asbestos may be located.

42) Main switch board and meter board backing may contain asbestos.

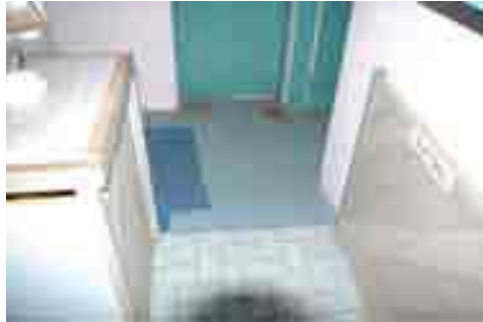
- 5) Floor into change rooms, dangerous, too steep and no colour variance (typical to both.)
- 6) Female change room – typical view showing ‘private’ change areas and slat bench seating.

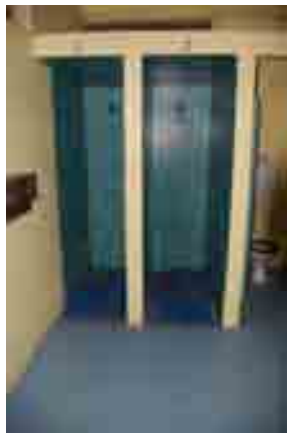
- 7) Typical showers – no door and too narrow.
- 8) Exposed hot water unit in both change rooms – may be deemed dangerous.
- 9) Typical change room entry – note cannot really see variance in floor slope.

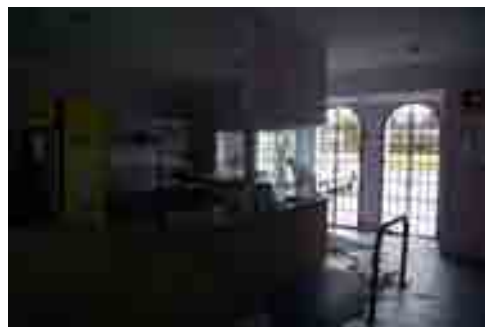
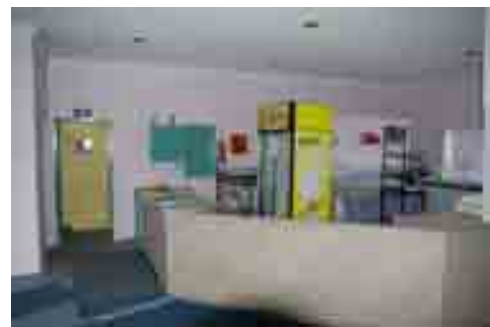
- 10) Main entry from inside the control/ reception area.
- 11) Typical joinery – tired and in fair condition.

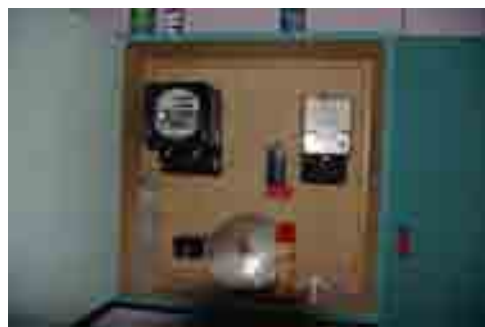
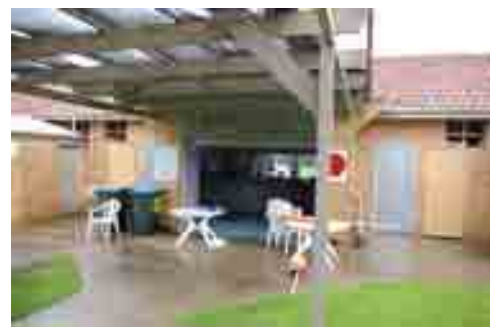
- 12) Main meter board in reasonable condition.
- 13) Main entry to pools from entry building – access way very low due to roller door behind.

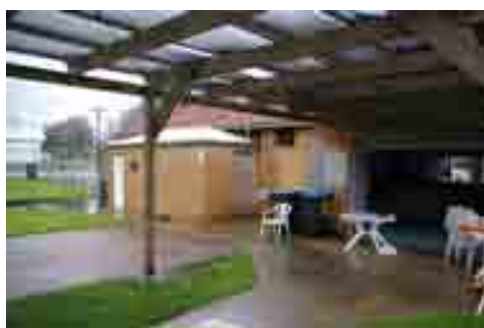
14) First aid room – not clearly accessible from pools – poor location for signage.

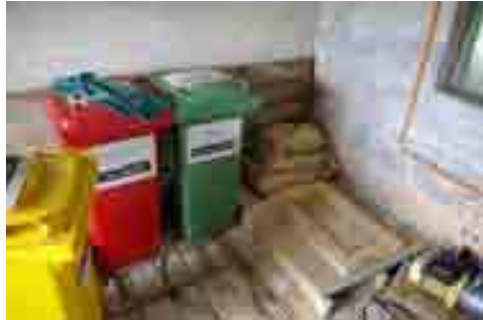
Buildings – Plant Room & Store Room							
General visual condition <i>(see definitions below)</i>	Poor	<b>X</b>	Fair		Reasonable		Good
Comments: <ul style="list-style-type: none"> <li>• Overall condition of the plant room is poor.</li> <li>• A mixture of masonry construction and light weight steel construction with corrugated metal sheet cladding. Appears tired and in poor condition.</li> <li>• Store rooms are a dump.</li> <li>• Safety shower not evident on site walk.</li> <li>• The timber frame window requires replacing – evidence of dry rot and several panes of glass are missing.</li> <li>• Chemical store in poor condition – sodium bicarbonate left on the ground – exposed and not cleaned.</li> <li>• Step into the pump house of the plant room – deemed not safe. No clear signage stating hazard and step risers not compliant to BCA (higher than 255mm).</li> <li>• Portion of plant room could be deemed a 'confined' space.</li> <li>• Pool blankets stored within the plant room area – appear in fair to reasonable condition.</li> <li>• Switch board and meter board within plant room in good condition.</li> <li>• Solar heating system located on the plant room roof (refer to filtration section.)</li> </ul>

- 15) Chemical store in poor condition.
- 16) Evidence of sodium bicarbonate spill on timber floor and through slats.

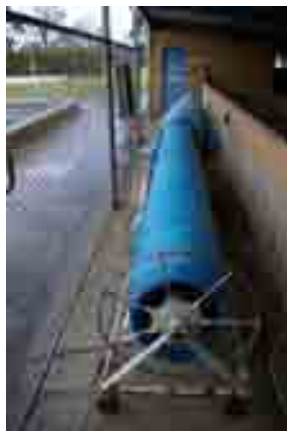
- 17) Pool blankets appear in reasonable condition.
- 18) Timber access steps – reasonable condition – poor design and construction.
- 19) Plant room switch board appears in good condition.

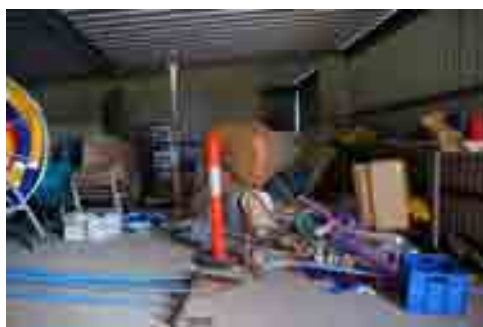
- 20) Store room – a dump.
- 21) View from 50m pool of plant room.

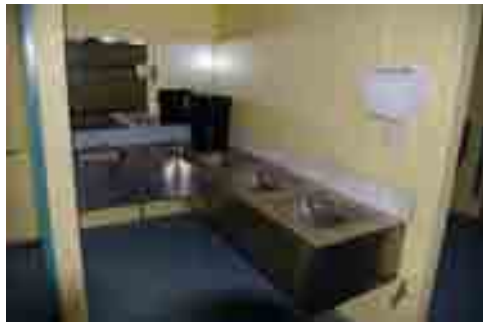
24) Stainless steel wall mounted basins to female change – too close and restricted.  
 25) Typical pan in change rooms.

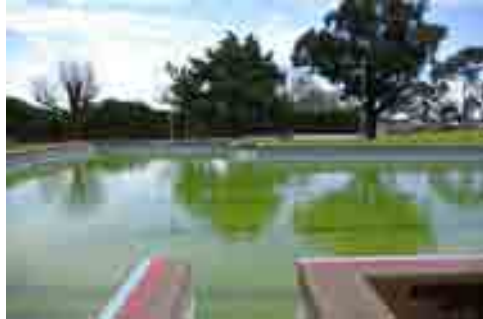
- 31) Hand rails required to steps.
- 32) The 50m pool with plant room in the back ground.

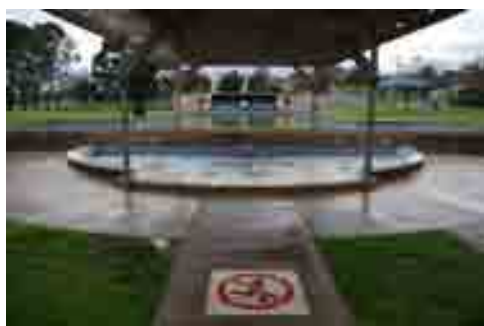
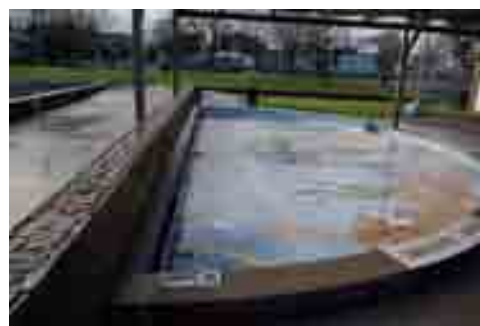
- 37) Toddler's pool recommended to be removed.
- 38) Toddler's pool signage in fair condition.

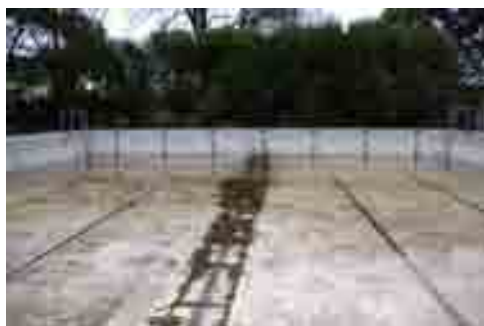
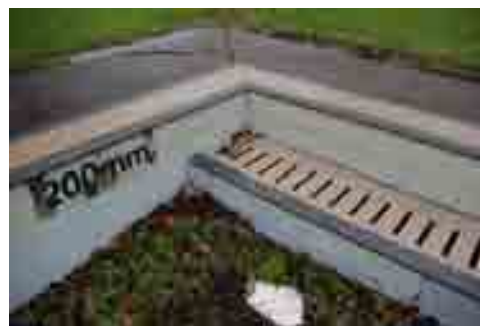
- 39) 25m pool in poor condition – recommend to be removed.
