## Aquatic Development Strategy

## Volume 1: Technical Assessments & Probable Capitals Costs

## Site Investigation Report

Site:	<b>Balmoral &amp; District Swimming Pool</b>	Date visited:	30 <sup>th</sup> June 2009 FINAL ISSUE
Project:	South Grampians Council – Aquatic Facility Development Strategy	Project No:	EJ-0763
Client:	Southern Grampians Shire Council	Representative:	Mr Craig Halley
Investigation undertaken by:	Sean Stone Mike Pettigrew	Company:	Etch Architectural Solutions David Powick & Associates
Copies to:	Steve Pallas	Company:	@Leisure
Weather Conditions:	Overcast conditions, high winds and frequent showers Cold		
Pages	<b>15 (including this page)</b>

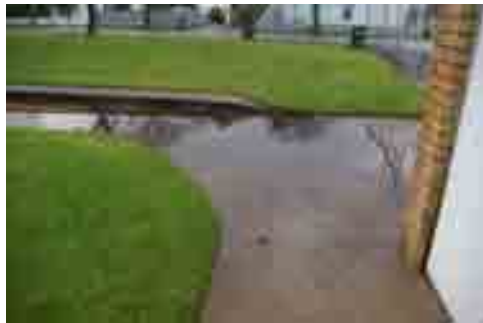
Pool - Concourse							
General visual condition <i>(see definitions below)</i>	Poor		Fair	<b>X</b>	Reasonable		Good
Comments: <ul style="list-style-type: none"> <li>• Overall condition of the pool concourse appears in reasonable condition. Several expansion joints have widened over time - due to settlement and expansion.</li> <li>• The average width of the concourse is 2000mm wide. This complies with RLS Facility Design section FD2.</li> <li>• Several sections of the paving have been grinded level to minimise any potential tripping hazard.</li> <li>• Sections of paving subject to flooding.</li> <li>• Pit lids appear in poor condition – corroded on edges.</li> <li>• Signage in fair condition. Recommend new signage around pool to comply with NARSSM.</li> <li>• Perimeter seating in poor condition and should be removed.</li> <li>• Pool concourse lighting in poor condition – several poles and fittings damaged and recommend all to be replaced with new.</li> </ul>

- 41) Sections of pool concourse subject to flooding.
- 42) Corroded pit lids.

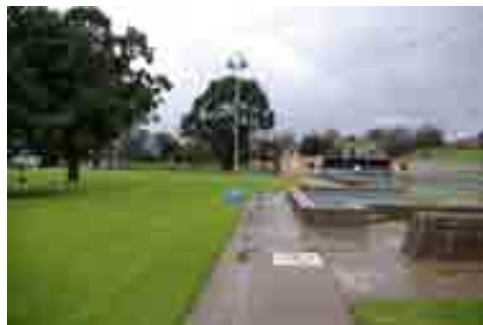
- 43) Main pool concourse in reasonable condition. Width complies with RLS minimum requirements.
- 44) Pool lighting in poor condition.

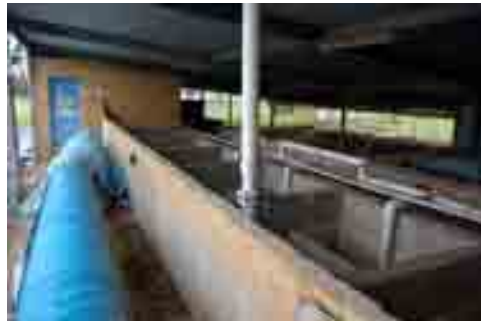
Filtration Plant (undertaken by David Powick & Associates)							
General visual condition <i>(see definitions below)</i>	Poor		Fair	<b>X</b>	Reasonable		Good
<p>Comments:</p> <ul style="list-style-type: none"> <li>• The filtration plant comprises a 6 cell suction sand filter system. It serves this pool adequately but falls short of currently accepted standards relating to water turnover rates. We would not suggest however that it be upgraded in the short term unless the bathing load increases to a level that requires filtration supplementation.</li> <li>• The gas chlorination installation does not comply with dangerous goods handling and storage regulations and should be replaced immediately.</li> <li>• The gas fired heating system has failed as has the solar heating. We have reviewed the reports by both Zane and W.J. Pratt and we advise that the W.J. Pratt document is reasonable and we agree with the recommendations contained in it. The Zane document is less useful and contains errors. Note that if any solar panels are installed they will require elevated wire netting protection to avoid destruction by birds.</li> <li>• The pipe work for the heating side stream should be altered to improve heating efficiency.</li> </ul>

- 45) External gravity sand filters in reasonable condition.
- 46) Typical pipe work condition.

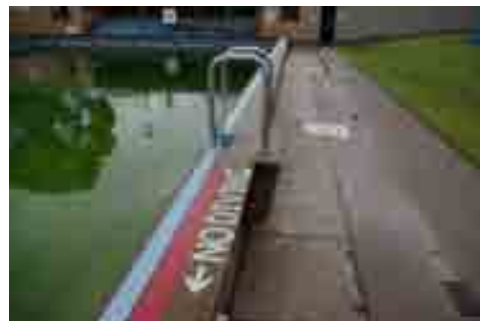
- 49) Main entry signage – clear from street.
- 50) Typical signage around pools.

Signage						
General visual condition <i>(see definitions below)</i>	Poor	Fair	<b>X</b>	Reasonable	Good	
<p>Comments:</p> <ul style="list-style-type: none"> <li>• Signage in fair condition. Recommend new signage around pool to comply with NARSSM.</li> <li>• Signage to entry – visible from entry, however not visible from rest of facility.</li> <li>• Amenity signage to change rooms and first aid room is in poor condition and does not comply with current regulations. All amenity signage is required to include Braille tactile.</li> </ul>

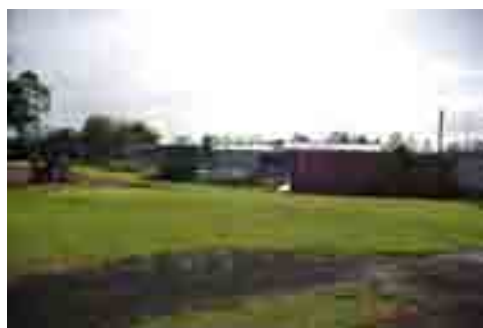
- 1) Penshurst pool – open parkland adjacent to swimming pool site (view from car park).
- 2) Main entry to pool – no clear signage or direct path from main car park.

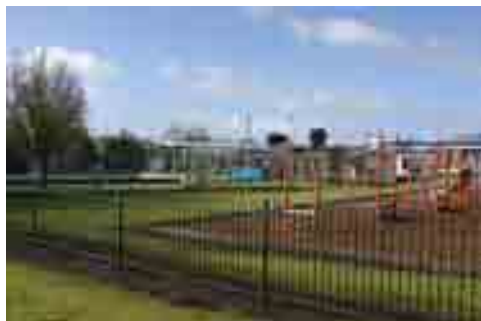
- 3) Main view of pool from play ground.
- 4) Penshurst botanic gardens – precinct (swimming pool included within the gardens).

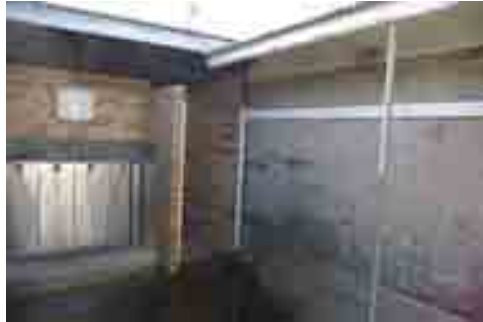
Buildings – Change Rooms						
General visual condition (see definitions below)	Poor	X	Fair	Reasonable	Good	
<p><i>Comments:</i></p> <ul style="list-style-type: none"> <li>• Change rooms and entry buildings – brick masonry construction with timber framed roof (corrugated metal roof sheeting) over entry/ office &amp; showers only.</li> <li>• Overall condition – tired and requires refurbishment.</li> <li>• All internal brickwork to change rooms has been rendered in areas (a concrete ‘bagged’ finish), not aesthetically pleasing, and looks tired and dark.</li> <li>• General brickwork in fair condition (externally), several locations show evidence of cracking and steel lintels require replacing as they are corroded.</li> <li>• Floor, exposed concrete slab – graded main door (slab following the slope of the hill) – water run-off via main access. Overall condition fair.</li> <li>• Access into change rooms not wide enough for BCA compliance and disability access. Maximum width is 800mm – minimum width requirement is 1000mm.</li> <li>• No disabled facilities.</li> <li>• No roof to change rooms – portion of roof over pan/ shower area is in a poor condition and requires replacing.</li> <li>• Doors / frames to external access from showers and toilet cubicles – timber framed and rotten, and do not comply with BCA (with removable hinges, indicator bolts, etc)</li> <li>• Showers and toilet cubicles not wide enough to cater for disability access.</li> <li>• Bench seating – brick construction. Fair condition.</li> <li>• Signage in poor condition. Should be replaced with new.</li> <li>• Urinal step – not compliant for disability types.</li> <li>• Population (occupancy rates) versus number of fittings, BCA Part F2 “sanitary and other facilities”. In reference to table F2.3 Penshurst Pool, the average population per day is 16 patrons. This equates that the current amenity numbers are compliant with the BCA. <b>Male</b> – 1 pan equates to 1 -100 patrons, 1 basin equates to 1 -50 patrons and 2 urinals equates to 51 – 100 patrons. <b>Female</b> – 2 pans equates to 26 -50 patrons, 1 basin equates 1 – 50 patrons.</li> </ul>

- 5) Change rooms – mixture of clean and rendered brickwork.
- 6) Concrete seating and exposed concrete slab.

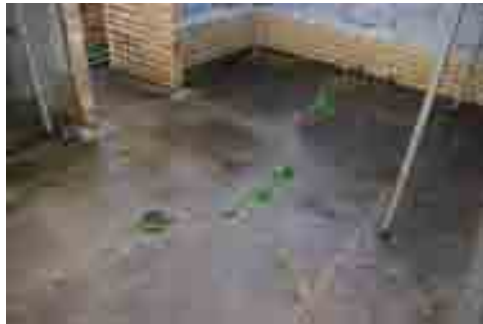
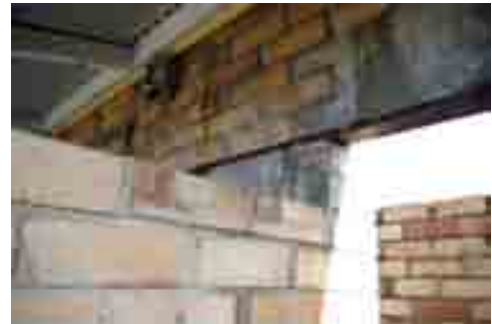
- 7) Concrete flooring to female change – cracked. Potential structural cracking and settlement to slab.
- 8) Corroded steel lintel and damaged lighting.

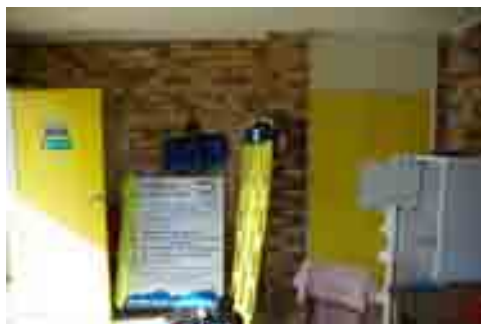
- Signage to entry – visible from entry, however not visible from rest of facility(including first aid signage located on door)
- Clear visibility from office to main pool site, while restricted visibility to part of the shallow pool and change room entries.
- No floor covering to rooms. Recommend a safety vinyl.

- 9) Main entry / office/ first aid room & kiosk? Internally not well labelled.
- 10) External access to main office. No signage stating first aid (other than door – when closed (see above image)

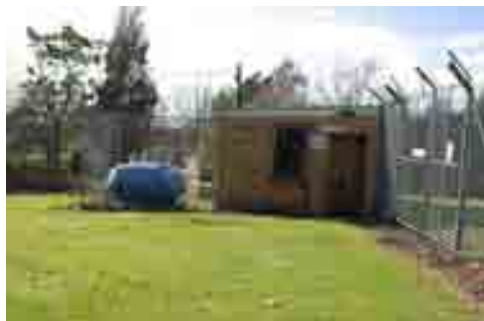
<b>Buildings – Plant Room</b>								
General visual condition (see definitions below)	Poor		Fair		Reasonable	<b>X</b>	Good	
<b>Comments:</b> <ul style="list-style-type: none"> <li>• Isolated building located at rear of pool site and in close proximity to deep end of the 25 pool.</li> <li>• Overall condition of the plant room is in reasonable condition.</li> <li>• Eave boards in poor condition – recommend to be sanded back to confirm overall condition of the timber.</li> <li>• Sand filters located externally at rear of building.</li> <li>• Electrical meter board / switch board is a mixture of ‘old’ and ‘new’. May contain asbestos. Recommend to be upgraded to meet current electrical regulations.</li> <li>• Chain wire fence in reasonable condition.</li> <li>• No solar heating system.</li> </ul>

- 11) Pool plant room – with external sand filters.
- 12) Pool plant rooms internally with Hypo tank.

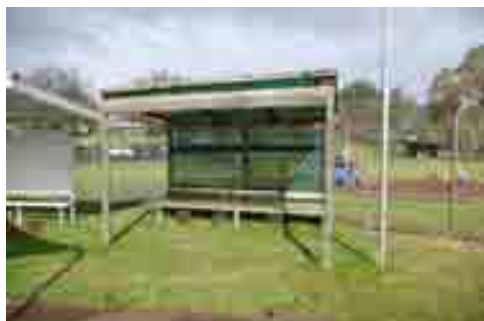
Buildings – Sun Shade Structures						
General visual condition (see definitions below)	Poor		Fair	<b>X</b>	Reasonable	Good
Comments: <ul style="list-style-type: none"> <li>• Main toddler’s pool sun shade in reasonable condition. Fabric cover appears stretched and has sagged over time – recommend to be replaced.</li> <li>• Steel structure.</li> <li>• Main fixed sun shade structure is a mixture of steel and timber framed with a fixed metal sheet roof. Overall in a fair condition, however not aesthetically pleasing. Recommend to be replaced.</li> </ul>

- 13) Fixed timber sun shade structures adjacent to pools – poor condition. Looks unattractive.
- 14) Sun shade structure to toddler’s pool.

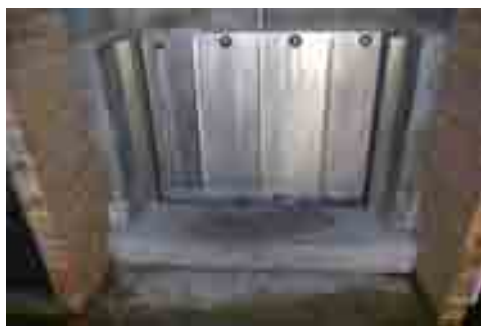
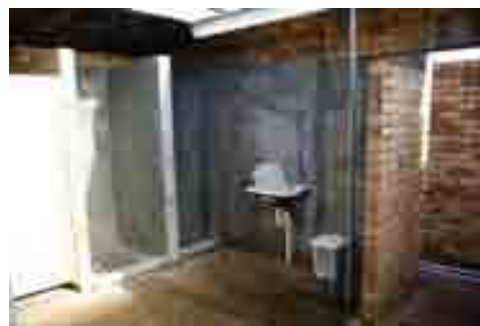
- 15) Corroded men’s urinal.
- 16) Female change rooms – steps to showers, original enamel basin.

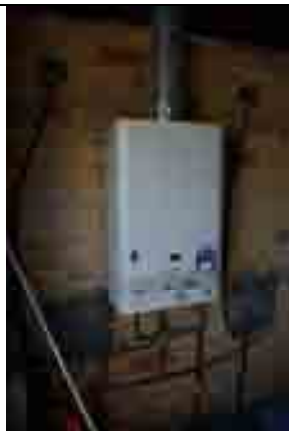
- 17) Gas hot water unit – good condition.
- 18) Boiling water unit – adjacent to sink and joinery unit.

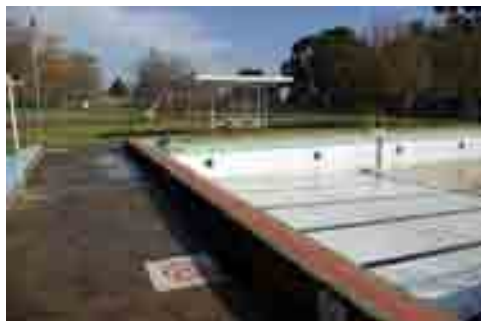
- 19) Main 25m pool – signage around pool – reasonable condition. Recommend to be upgraded.
- 20) Pool evident of leaking.

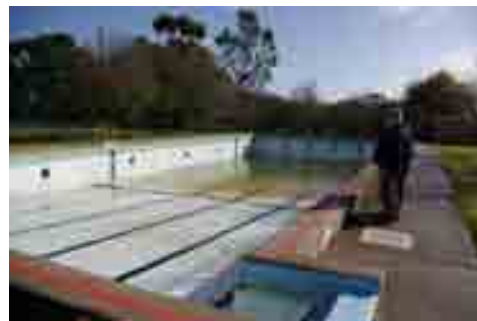
Pool – Main Pool						
General visual condition (see definitions below)	Poor	<b>X</b>	Fair		Reasonable	Good
Comments: <ul style="list-style-type: none"> <li>• Painted concrete pool shell appears in fair condition. Council representatives have confirmed that the pool is leaking (evident by the amount of water ‘not’ residing in the pool compared to the other council outdoor pools).</li> <li>• Main pool concourse is too narrow, approx 1800mm. A large section of the concourse has been reinstated – possibly due to settlement.</li> <li>• Pool ladders appear in fair condition – bases of the ladders are corroded.</li> <li>• No disability access into the pools.</li> <li>• No handrail to steps from pool.</li> <li>• Signage in a reasonable condition.</li> <li>• The main pool has been reported as leaking significantly. Apart from this, the structure is in good condition. It shouldn’t be assumed that the leakage comes from the structure as the most likely point of leakage will be pipe work.</li> <li>• In any event, repair of the leakage is the main priority for this pool facility.</li> <li>• The glass portholes housing lights should be filled-in if the opportunity presents itself as they don’t work and may only offer an opportunity for water loss.</li> <li>• The depth and warning signage should be upgraded as it does not comply with RLSSA guidelines.</li> <li>• External steps should be provided at the back of the entry steps to facilitate access to the pool as the step up to the beam around the perimeter of the pool is too high.</li> </ul>

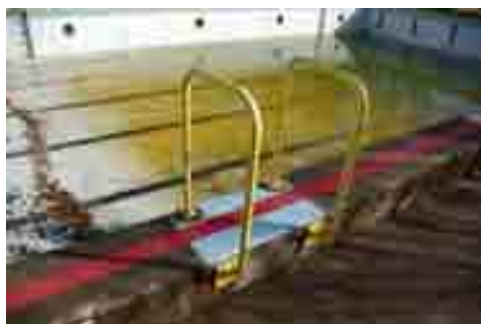
- 21) Access ladders – corroded at base. Recommend to be replaced with new.
- 22) No handrail to narrow steps

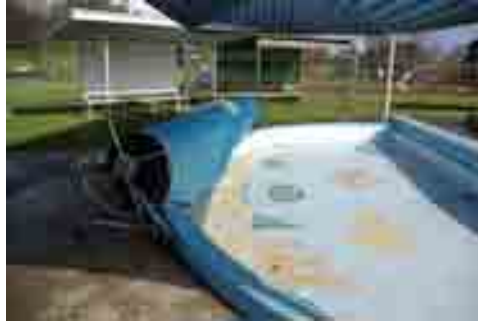
- 23) Toddler's pool with main pool solar blanket
- 24) Minimal signage to pool.

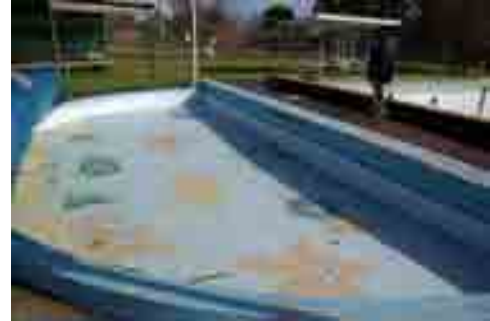
Pool – Toddler’s Pool							
General visual condition (see definitions below)	Poor		Fair	<b>X</b>	Reasonable		Good
Comments: <ul style="list-style-type: none"> <li>Pool appears in fair condition.</li> <li>The depth and warning signage should be upgraded as it does not comply with RLSSA guidelines. Note that the toddler’s pool has no visible depth markings at all.</li> <li>A separation barrier should be installed between the main and toddler’s pools to restrict access by toddlers to the deep water in the main pool.</li> <li>The toddler’s pool should have an internal step to facilitate access by small children. This should be supplemented by the addition of a rail at the step entry.</li> </ul>

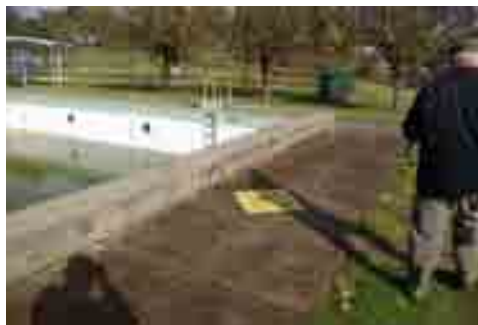
Pool - Concourse						
General visual condition (see definitions below)	Poor		Fair	<b>X</b>	Reasonable	Good
Comments: <ul style="list-style-type: none"> <li>• Main pool concourse is too narrow, approx 1800mm. This does not comply within RLS Facility Design section FD2.</li> <li>• A large section of the concourse has been reinstated – possibly due to settlement.</li> <li>• Several sections of the paving surrounding the two pools show evidence of slip or settlement, as they have sunken from their original 'curing' location adjacent to the pool shell.</li> <li>• Pit lids appear in reasonable condition.</li> <li>• Signage in fair condition. Recommend new signage around pool to comply with NARSSM.</li> <li>• Concourse width around the toddler's pool is too narrow – 1200mm.</li> <li>• Paving from shallow pool to change rooms – gradient is too steep to comply for disability access.</li> </ul>

- 25) Typical signage around pool. Portion of this concourse has settled 'down' from main pool.
- 26) Section of pool concourse replaced with new (very recently).

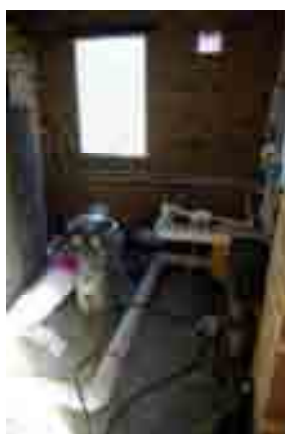
<b>Filtration Plant</b> (undertaken by David Powick & Associates)							
General visual condition (see definitions below)	Poor		Fair		Reasonable	<b>X</b>	Good
Comments: <ul style="list-style-type: none"> <li>• Filtration is provided by two Chadson MHS 1500 filters in reasonable condition.</li> <li>• Automatic dosing is included in this centre and this is in good condition.</li> <li>• The bulk storage container for liquid chlorine is not compliant with current requirements and should be upgraded.</li> <li>• The Hypo dosing pump is too high and as such presents an OH&amp;S issue. We presume the height is based on an attempt to stop syphoning, but this can be controlled by other means.</li> </ul>

27) Pool Filtration plant – ‘Hypo- tank’ storage unit with additional chemical store.  
 28) Filter and main pool pump.

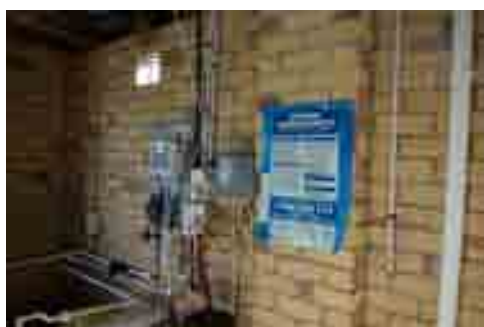
29) Current dosing system  
 30) Chlorine pump – to high.

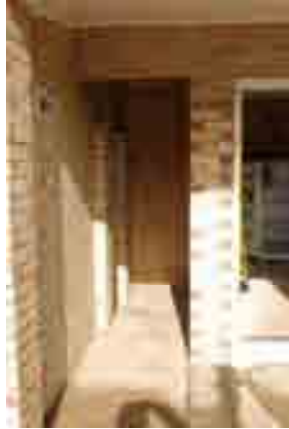
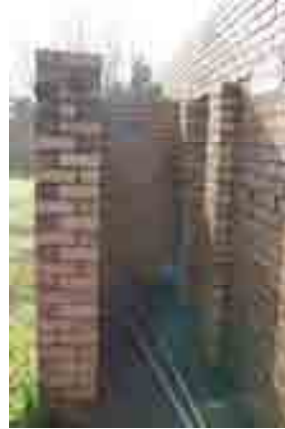
33) Access width to both Male & Female Change rooms – too narrow. Does not comply with BCA or AS 1428.1 (door width and door landings)

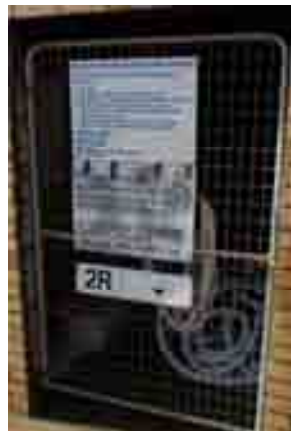
34) Signage to store room in poor condition. Recommend to be replaced with new.  
35) Signage to change rooms in poor condition.

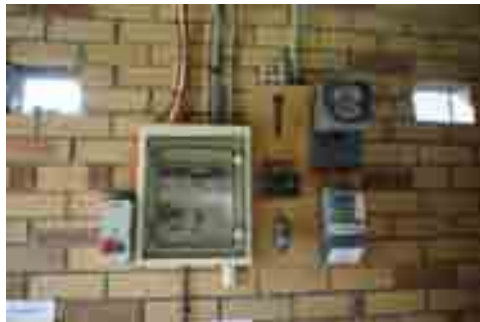
- On visual review of the electrical meter board and switch board located in the pool filtration plant room and the approximate age of the structure, it is very likely that asbestos may be located.

36) Electrical switch / meter board may contain traces of asbestos.
