# CORRYONG COMMUNITY CONNECTIONS

## Corryong Pool and Skate Park Concept Plan

July 2014

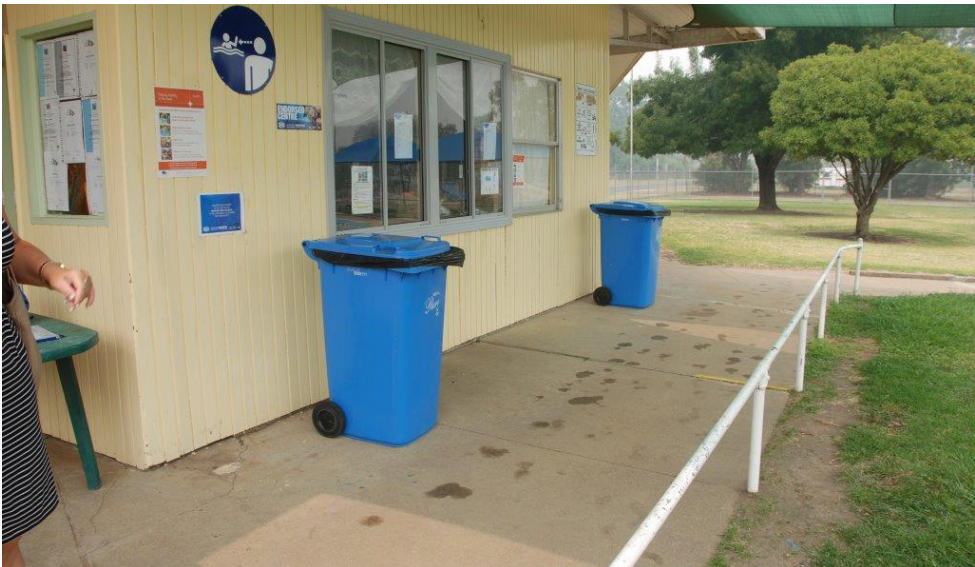
The kiosk is small, and no longer fit-for-purpose. The entrance is cluttered and not DDA compliant.

The canteen does not meet health requirements for food preparation, even though only heated and packaged foods are currently available. The urn in the canteen is the only hot water on site. The kiosk houses the PA system (owned by the swimming club).

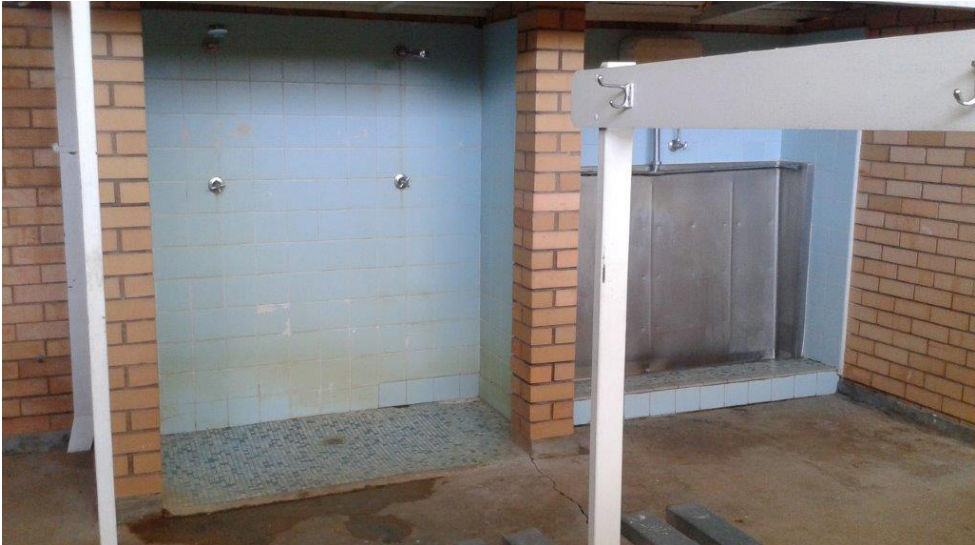
The showers and toilet facilities require upgrades, hot water added, the floors to be resurfaced and lights installed to the cubicles.

There are two showers in each room. These are tiled insets without doors or shower curtains. The tiles are in poor condition and are heavily stained. The showers have a distinct lack of privacy.

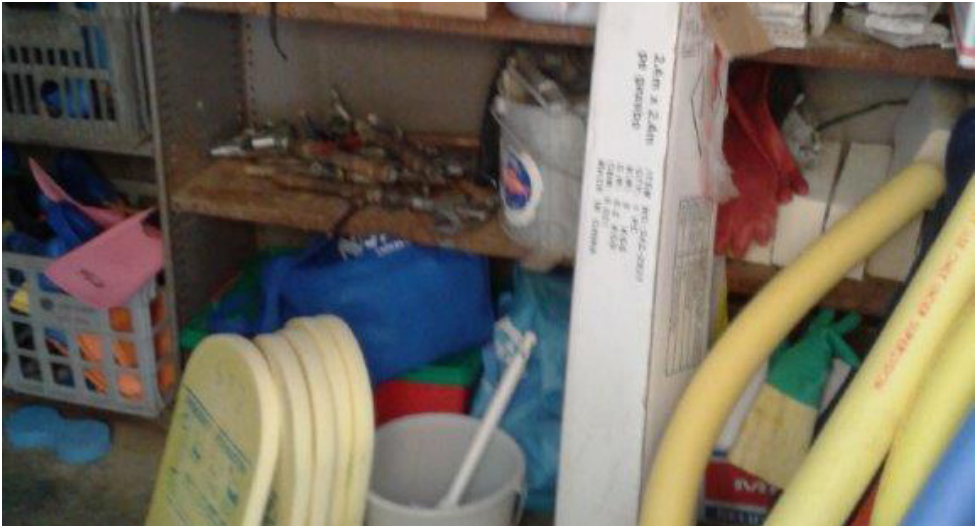
There is insufficient storage for front-of-house purposes.

The storeroom is crowded and not of a sufficient size to house the front-of-house stock and Swimming Club equipment. This means that some pool equipment (lane ropes) have to be stored outside.

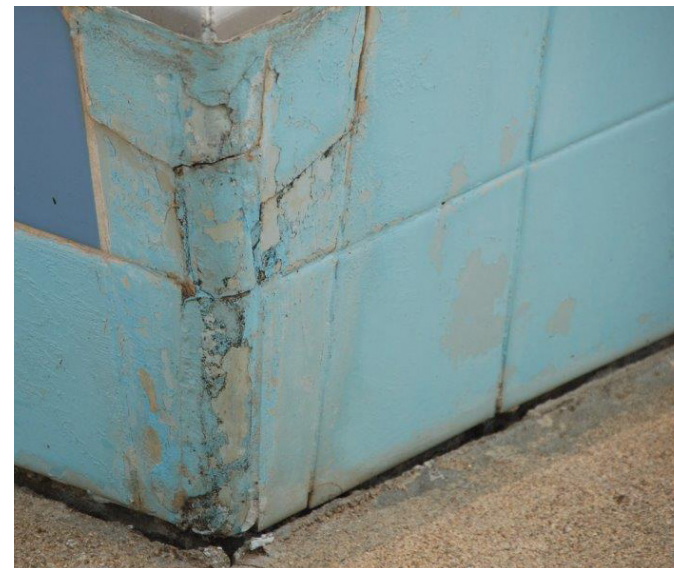
Pool tiles (internal and external to the pool) are broken and unsafe.

Council officers report that the pool is considered to be structurally sound, however, a number of repairs are required. Items in need of repair include; the raised edges, the tiles (many are missing, broken and/or have sharp edges), and the steps into the pool.

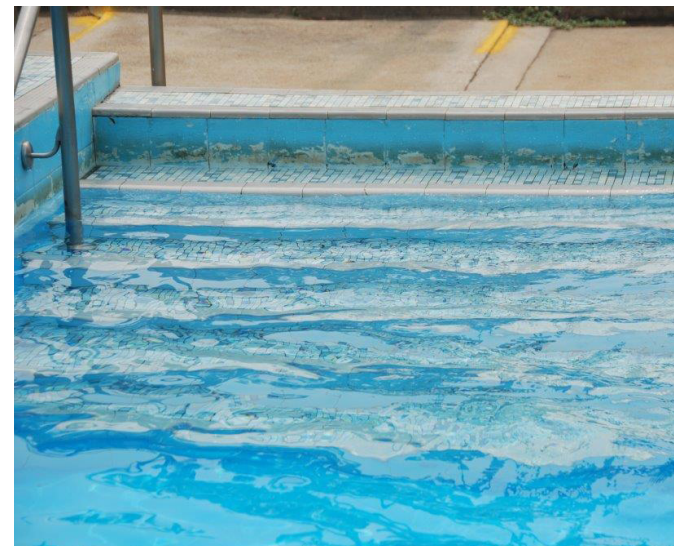
There are steps and a handrail into the big pool, however, the rail is too high.

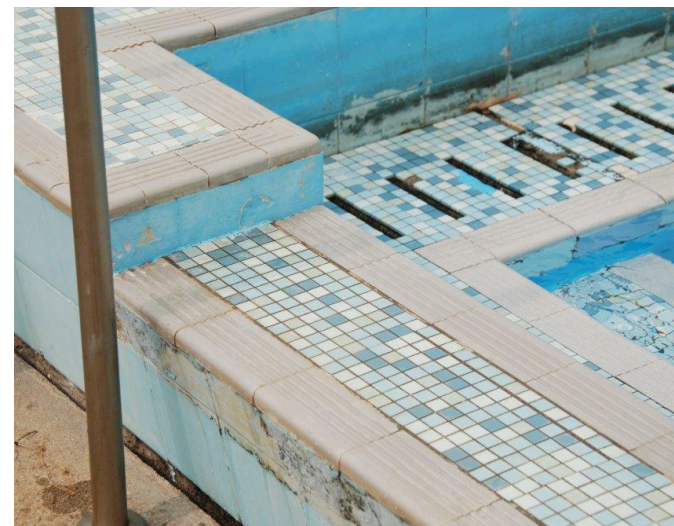
The pool edge is raised on all sides, limiting surveillance.

There is a raised ledge around the pool, this obstructs views into and from the pool.

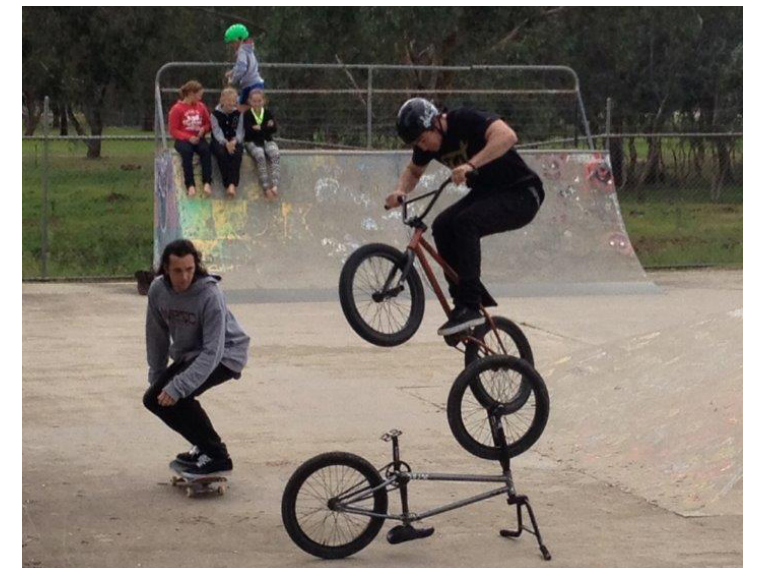
The skate park is small with limited/no street skate options. There is limited shade and access to water.

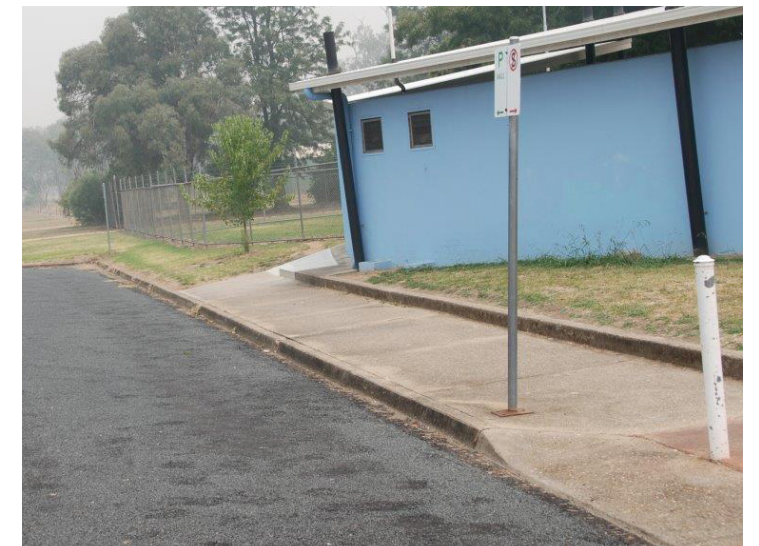
The car park is not DDA compliant and without shade. There is no connection to the adjacent park.

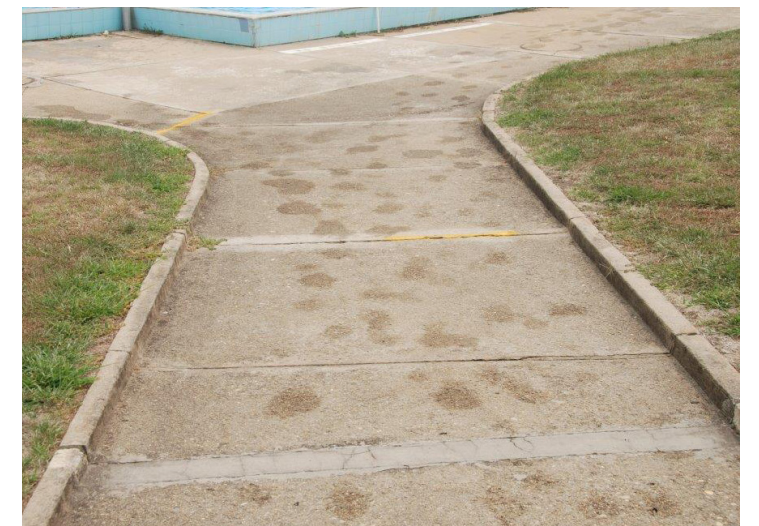
Pathways throughout the complex varying in width and quality. Many paths are slippery and not wide enough.

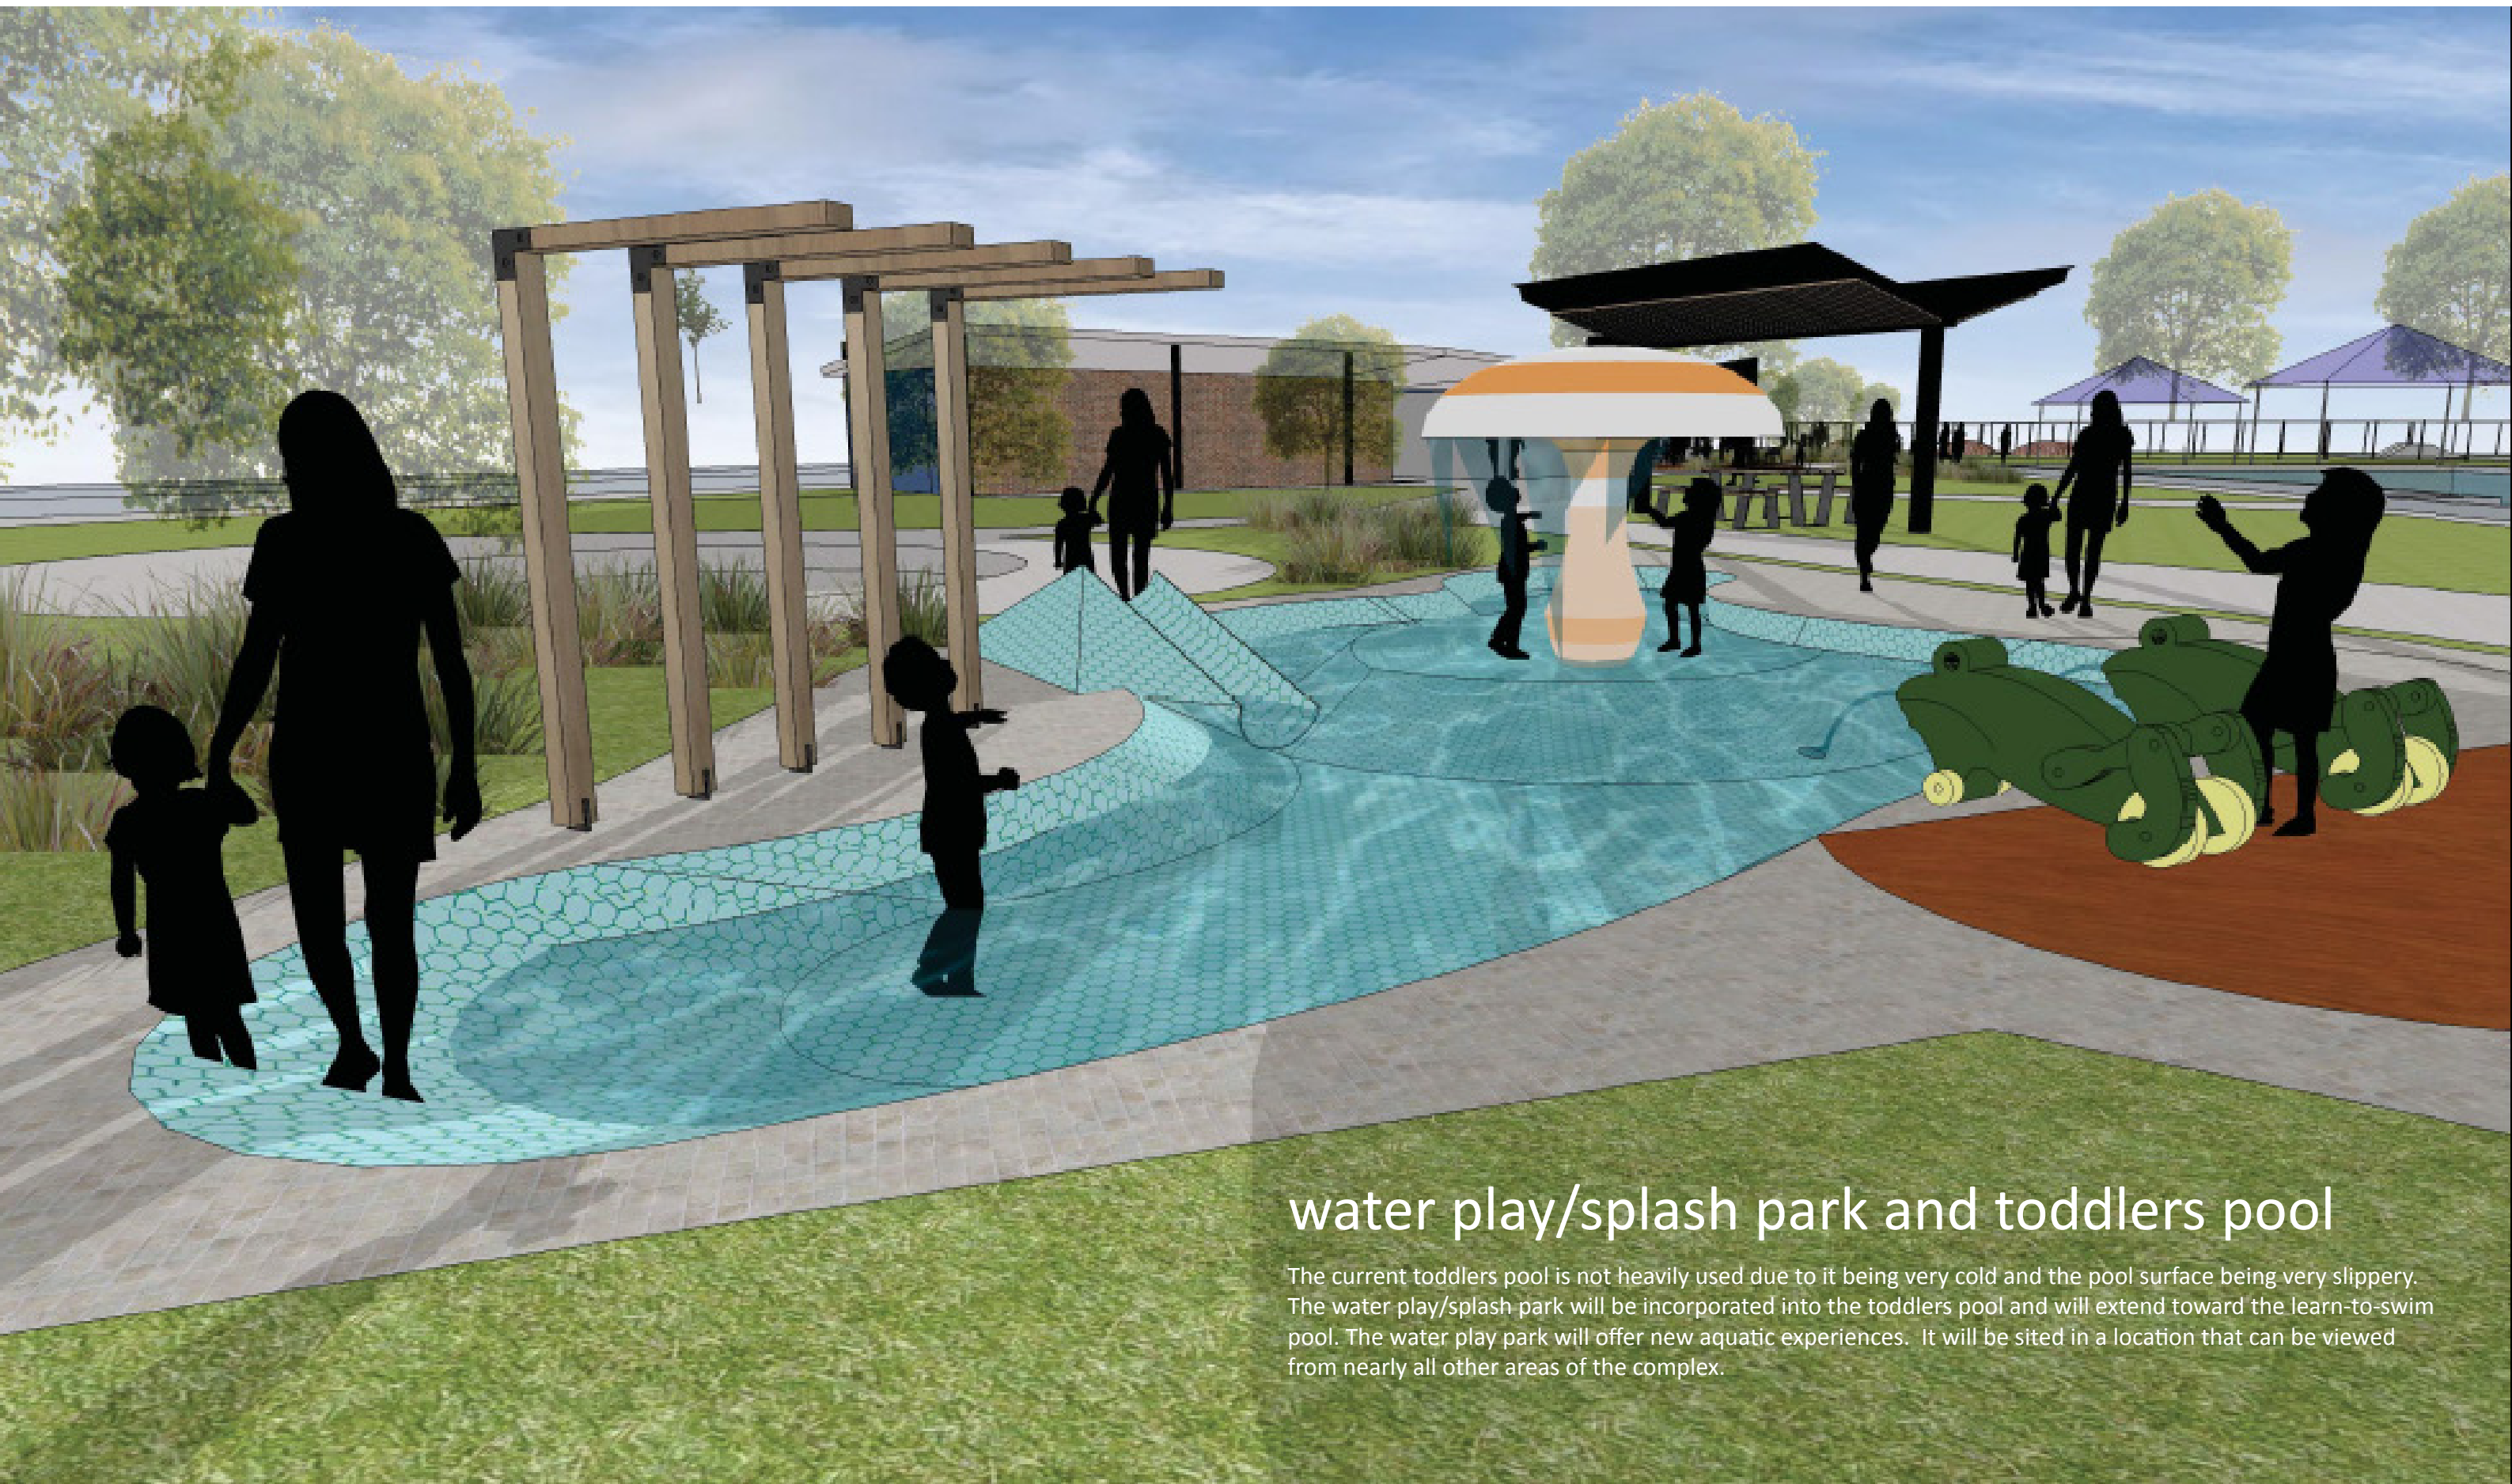
## Master Plan Perspectives - Splash Play

### water play/splash park and toddlers pool

The current toddlers pool is not heavily used due to it being very cold and the pool surface being very slippery. The water play/splash park will be incorporated into the toddlers pool and will extend toward the learn-to-swim pool. The water play park will offer new aquatic experiences. It will be sited in a location that can be viewed from nearly all other areas of the complex.

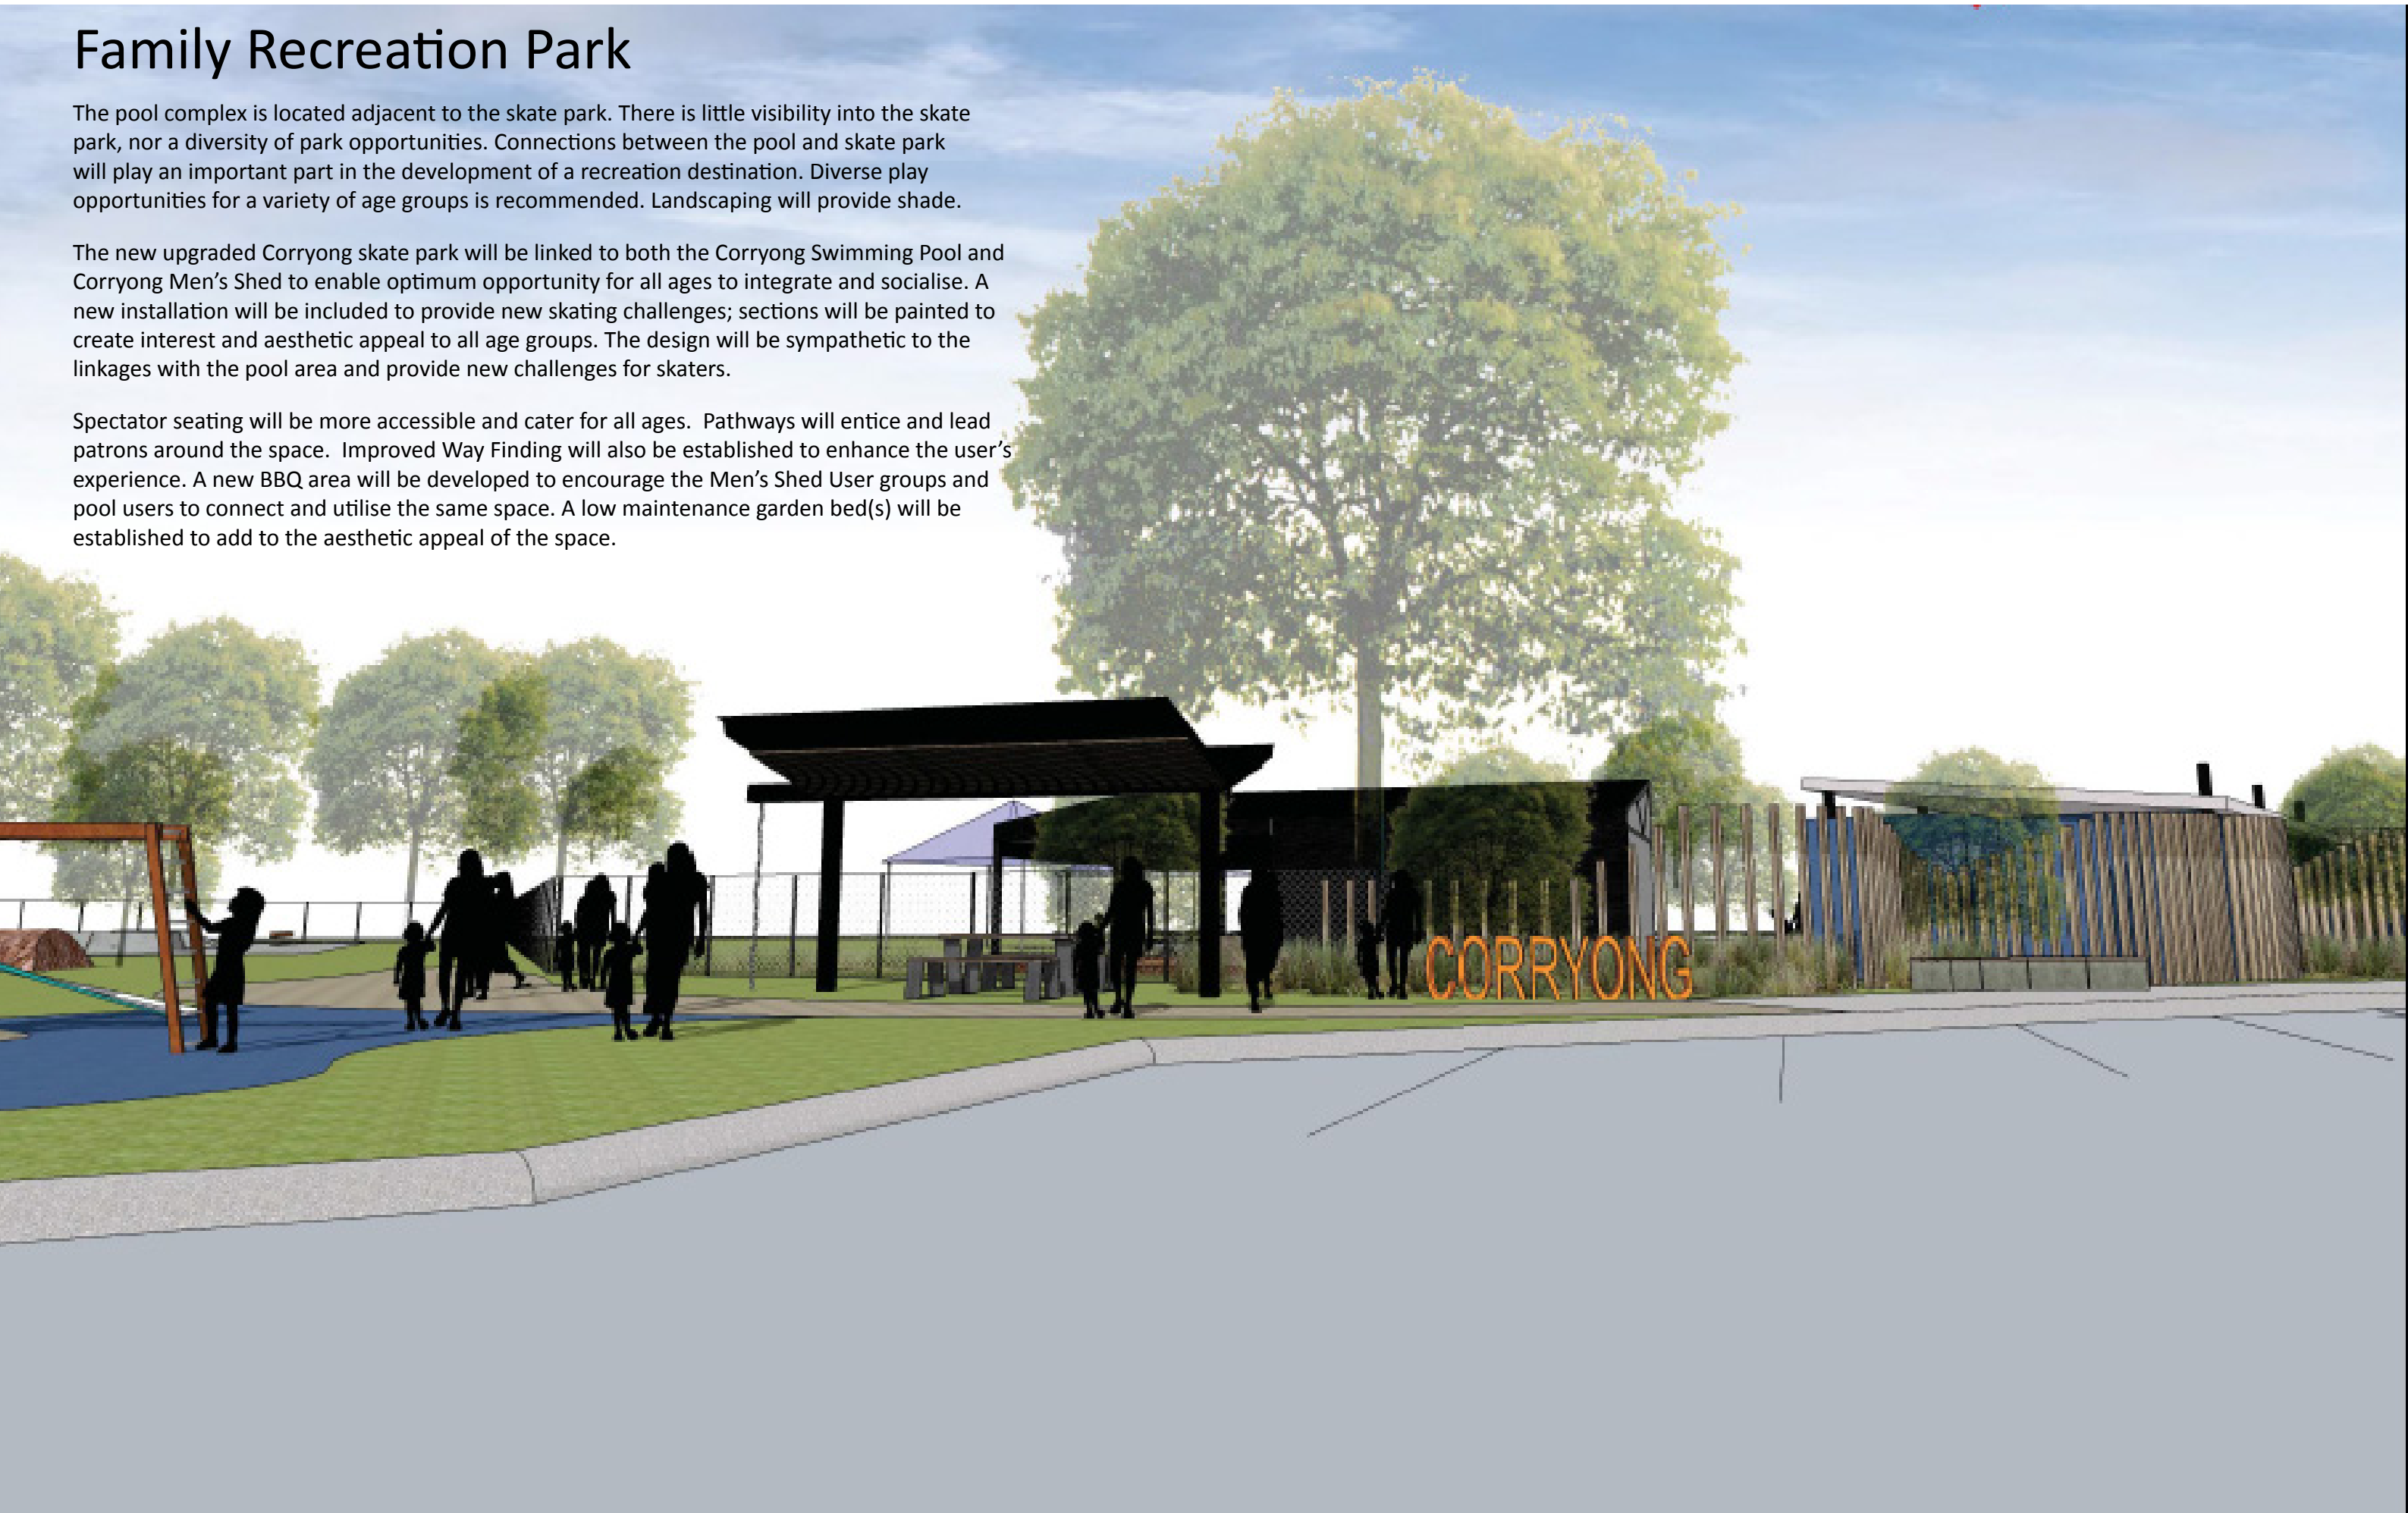
## Family Recreation Park

The pool complex is located adjacent to the skate park. There is little visibility into the skate park, nor a diversity of park opportunities. Connections between the pool and skate park will play an important part in the development of a recreation destination. Diverse play opportunities for a variety of age groups is recommended. Landscaping will provide shade.

The new upgraded Corryong skate park will be linked to both the Corryong Swimming Pool and Corryong Men's Shed to enable optimum opportunity for all ages to integrate and socialise. A new installation will be included to provide new skating challenges; sections will be painted to create interest and aesthetic appeal to all age groups. The design will be sympathetic to the linkages with the pool area and provide new challenges for skaters.

Spectator seating will be more accessible and cater for all ages. Pathways will entice and lead patrons around the space. Improved Way Finding will also be established to enhance the user's experience. A new BBQ area will be developed to encourage the Men's Shed User groups and pool users to connect and utilise the same space. A low maintenance garden bed(s) will be established to add to the aesthetic appeal of the space.

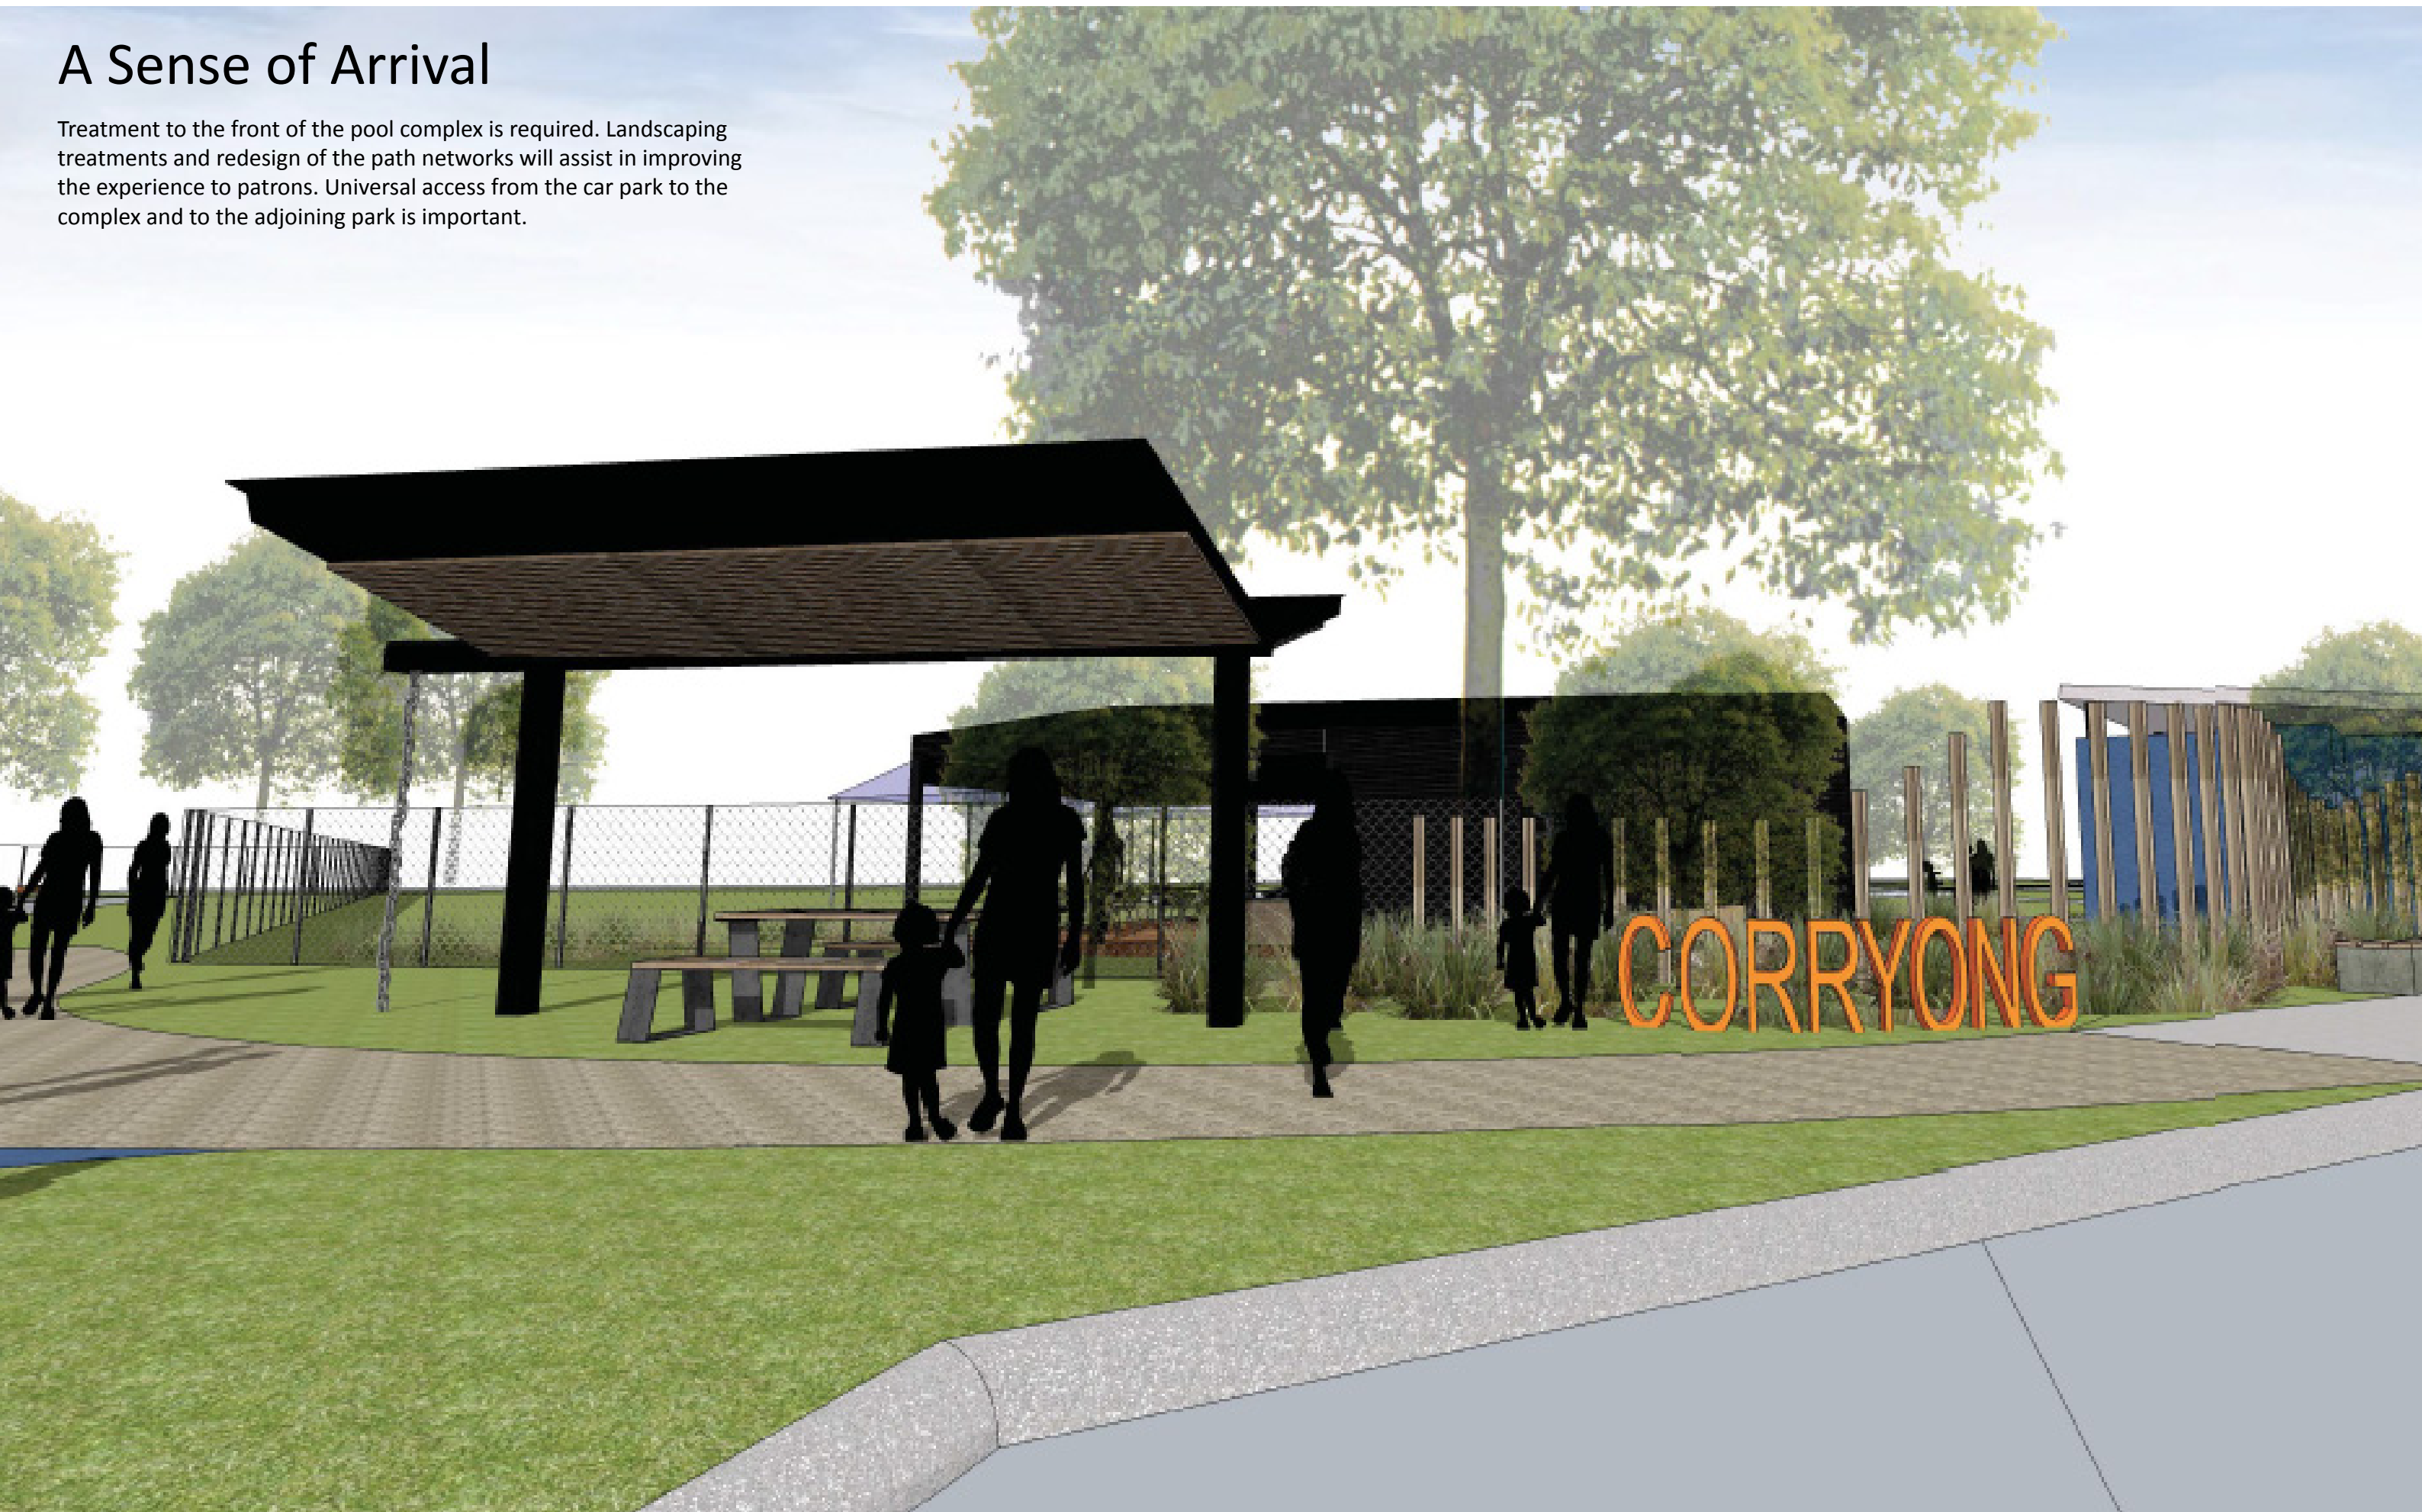
## A Sense of Arrival

Treatment to the front of the pool complex is required. Landscaping treatments and redesign of the path networks will assist in improving the experience to patrons. Universal access from the car park to the complex and to the adjoining park is important.

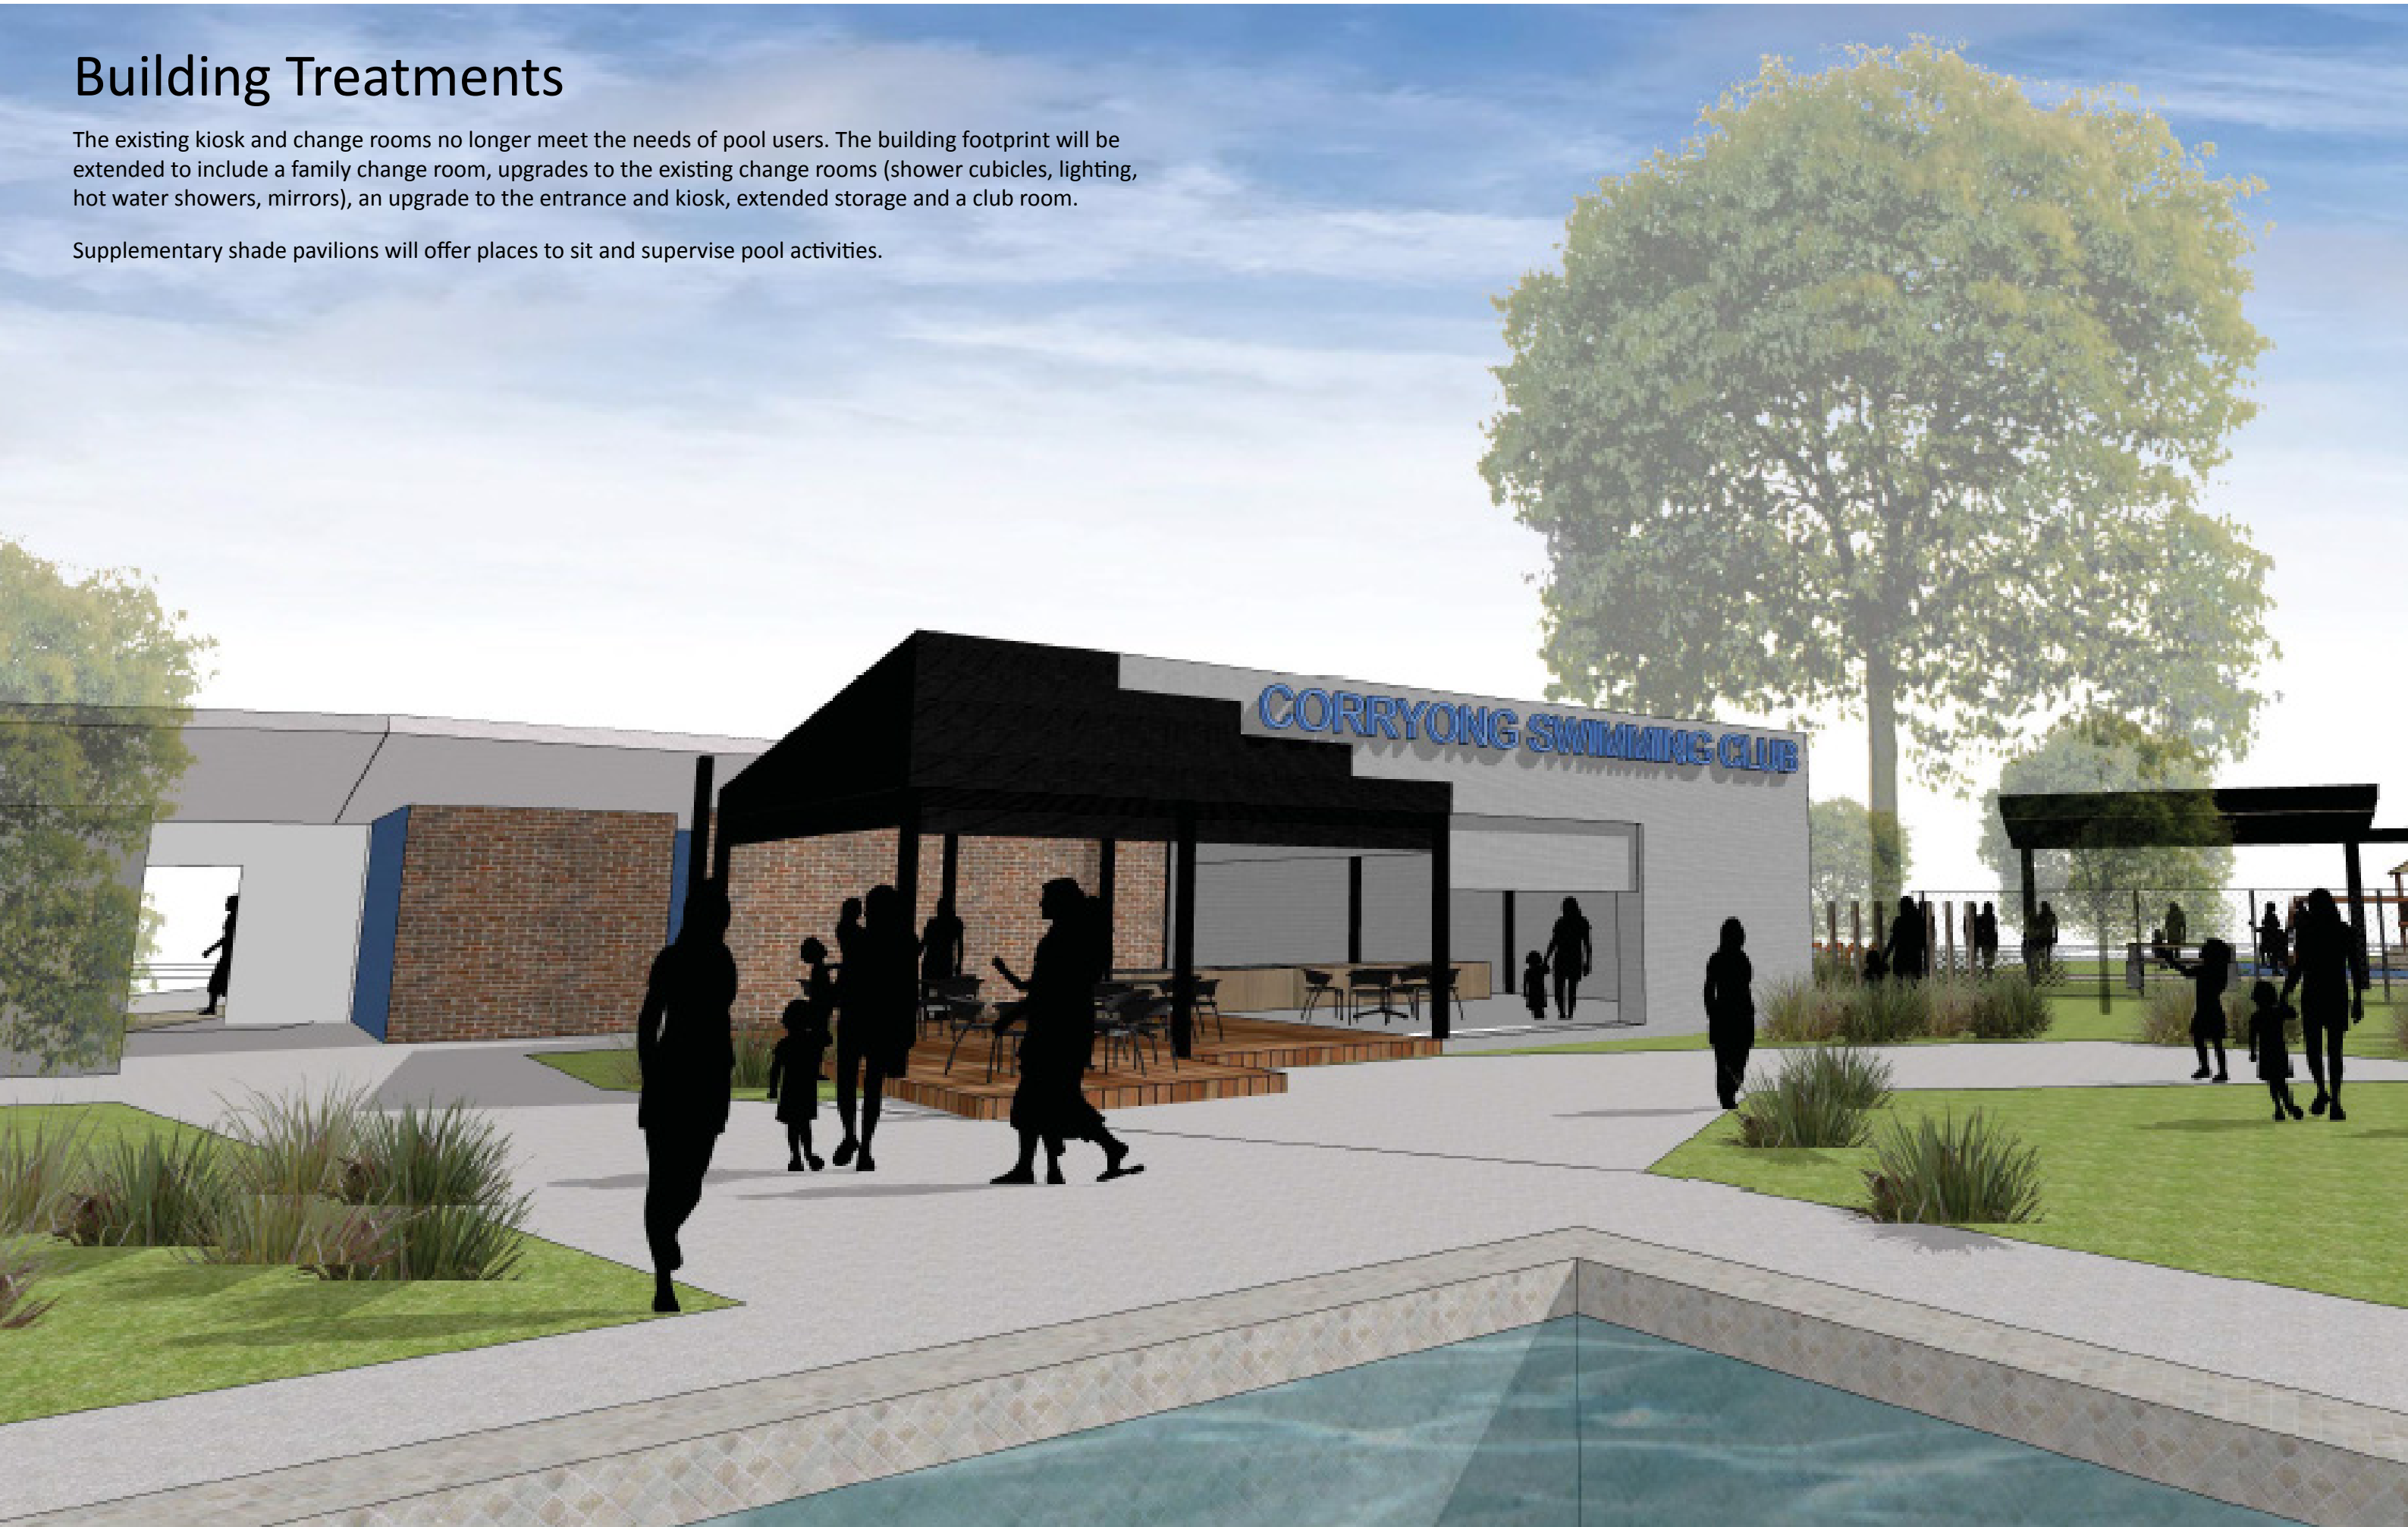
## Building Treatments

The existing kiosk and change rooms no longer meet the needs of pool users. The building footprint will be extended to include a family change room, upgrades to the existing change rooms (shower cubicles, lighting, hot water showers, mirrors), an upgrade to the entrance and kiosk, extended storage and a club room.

Supplementary shade pavilions will offer places to sit and supervise pool activities.
