Aquatic Development Strategy

Volume 1: Technical Assessments & Probable Capitals Costs

Site Investigation Report

Site:	Balmoral & District Swimming Pool	Date visited:	30 th June 2009 FINAL ISSUE
Project:	South Grampians Council – Aquatic Facility Development Strategy	Project No:	EJ-0763
Client:	Southern Grampians Shire Council	Representative:	Mr Craig Halley
Investigation undertaken by:	Sean Stone Mike Pettigrew	Company:	Etch Architectural Solutions David Powick & Associates
Copies to:	Steve Pallas	Company:	@Leisure
Weather Conditions:	Overcast conditions, high winds and frequent showers Cold		
Pages	15 (including this page)

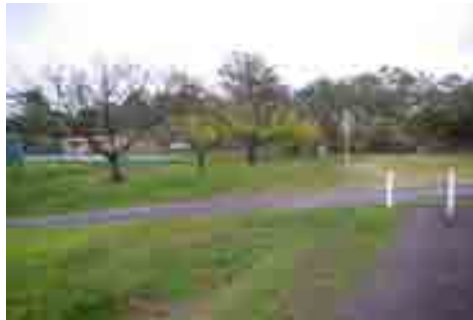
- 3) Main view of pool from main road (from township) – no visible signage.
- 4) Permeable car park at rear of pool facility – no designated disabled car spaces.

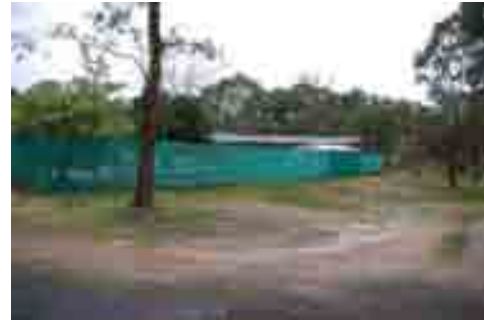
- Car park at rear – permeable (gravel) in fair condition.
- No designated disabled parking sign evident on site walk.
- External access gates on perimeter fence line, with no signage of clear trafficable path to them (no driveway).

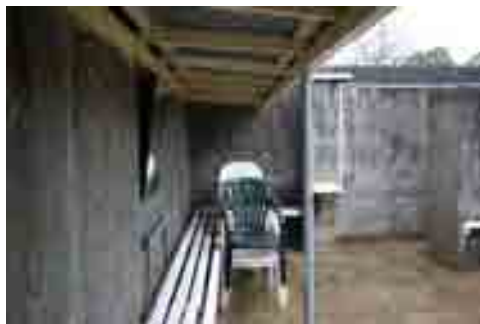
- 5) Typical condition of the change rooms – exposed to the weather.
6) Rendered concrete wall finish and exposed concrete flooring.

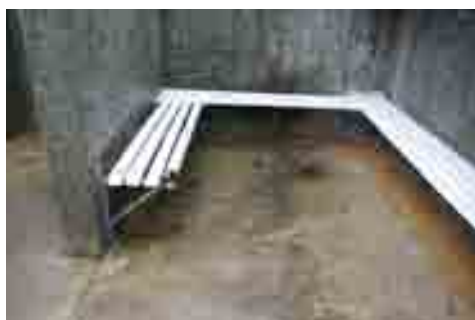
- 7) Typical condition of all bench seating.
8) Typical condition of toilet partition doors.

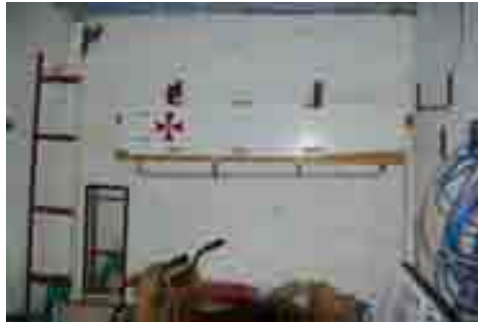
Buildings – First Aid Room & Store							
General visual condition (see definitions below)	Poor	X	Fair		Reasonable		Good
Comments: <ul style="list-style-type: none"> • Originally first aid – now a store room. Store room observed in a complete mess. • First aid room not compliant to RLS Safe Pool operation guidelines FA3 and should a minimum of 15 sq.m in size. • No clear visibility to the pool and / or office if one pool attendant is operating the facility. • Signage not adequate for this room. The only signage is located on the door and can not be seen if opened. • No ceiling in room. • Brickwork in fair condition.

11) Typical condition of the first aid room / store.

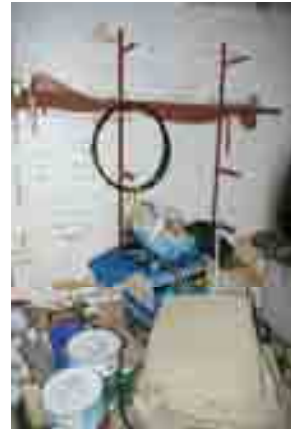
12) Typical condition of the first aid room / store – rubbish dump.

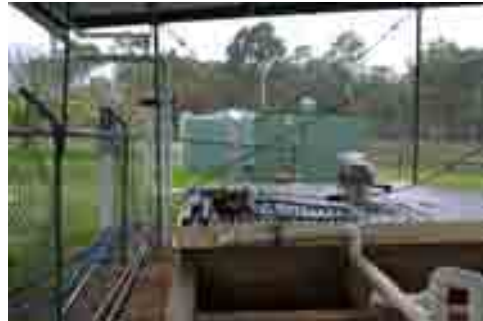
Buildings – Plant Room								
General visual condition (see definitions below)	Poor	X	Fair		Reasonable		Good	
Comments: <ul style="list-style-type: none"> Overall condition of the plant room is poor, especially from pool side. Observed on the day in a complete mess. Chemical storage bins exposed and not secure (as gate and door to plant room unlocked). Structural cracking within the brick work and mortar joints suggests a portion of the floor is moving or sinking at the corner. Chain wire fence in reasonable condition – barb wire should be removed. Switch board and meter board appears original. May contain asbestos. Recommend to be upgraded to meet current electrical regulations. Doesn't appear that the store room has sufficient exhaust, as the room is being used as a chemical store, as well as filtration room. No actual delivery access – driveway to access gate. Windows – timber framed (poor condition) and glass louvered panels missing. Solar heating system appears in good condition.

- 13) State of plant room from view of main pool.
14) View from main road. No clear access from roadway for deliveries.

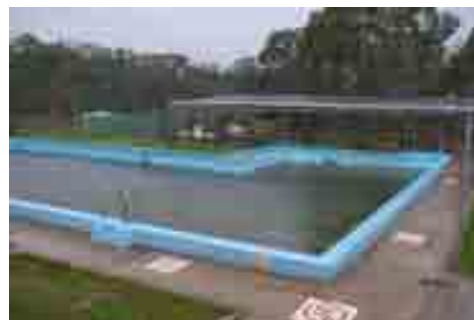
- Disabled ramp into pool does not comply to current BCA and AS 1428.1 regulations due to its width, hand rail design and no hand rail at the entry for ramp at pool concourse level (this section of ramp may be deemed a trip hazard and dangerous).

- No tactile indicators apparent on this section of ramp.
- Step from pool concourse to pool steps (adjacent to ramp) is not wide enough to suit the width of the steps within the pool. Should be replaced with new.

20) Main pool showing the existing ramp into the pool.

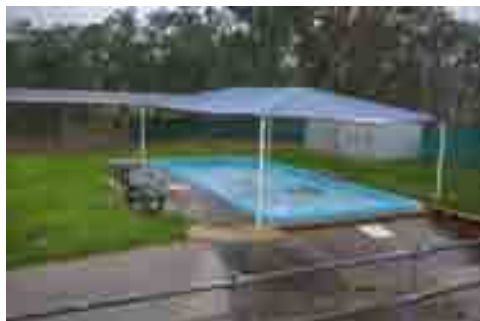
- 21) Toddler's pool – view from main entry. Note the steep gradient to the concourse paving.
22) Typical signage around pool. Note several steps into pool – not recommended.

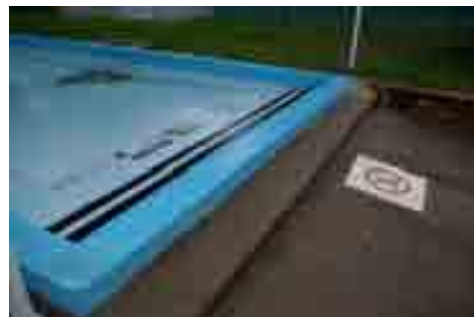
- Existing grated pit lids corroded and recommend to be replaced.
- Depth and warning signage is not in accordance with RLSSA recommendations.
- Concourse width around the pool is narrow – 1200mm. Concourse path only around three sides of the pool (other side includes a step into the pool – height not BCA compliant).
- Remove step to one side of concourse.
- Gradient of path adjacent to pool is too steep. May be deemed not safe.
- Painted concrete pool shell appears in reasonable condition.

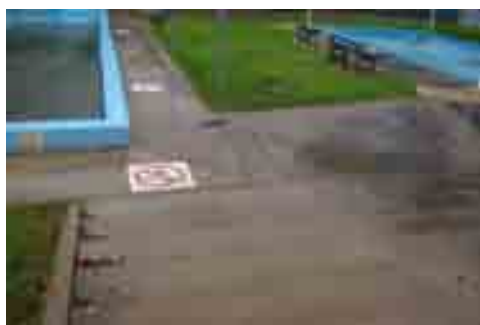
Pool - Concourse							
General visual condition (see definitions below)	Poor	X	Fair		Reasonable		Good
Comments: <ul style="list-style-type: none"> Overall condition of the pool concourse appears in poor condition. Several expansion joints have widened over time - due to settlement and expansion. Main pool concourse too narrow, approx 1500mm. This does not comply within RLS Facility Design section FD2. Numerous trip hazards plus some extreme slopes/grades in places. Several sections of the paving have been grinded level to minimise any potential tripping hazard. Pit lids appear in reasonable condition. Signage in fair condition. Recommend new signage around pool to comply with NARSSM. Steps to pool concourse are not BCA compliant and AS 1428.1 compliant. No handrails, no tactile indicators. Perimeter seating in poor condition and should be removed. Concourse width around the toddler's pool is too narrow – 1200mm. Concourse path only around three sides of the pool (other side includes a step into the pool – height not BCA compliant).

- 23) Steps from main entry to pool levels – not BCA / AS 1428.1 compliant.
24) Width of main pool concourse – too narrow.

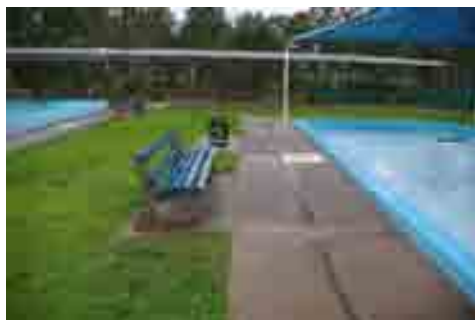
- 25) Toddler's pool – narrow pool concourse. Seating in poor condition, recommend to be replaced.
26) Pool concourse adjacent to toddler's pool – too steep.

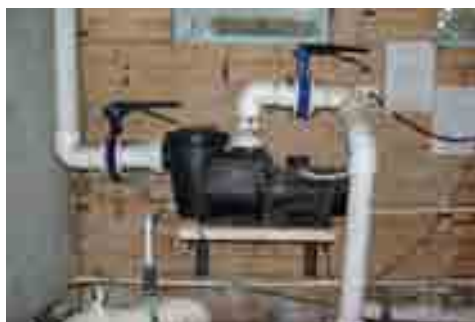
- 27) Elevated pump.

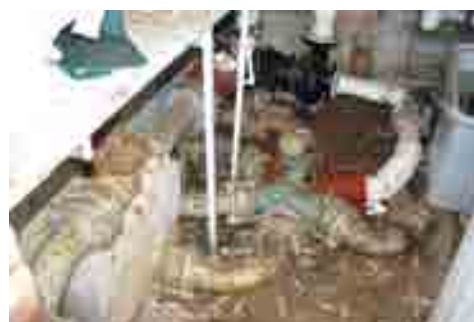
28) General pipe work in fair condition.

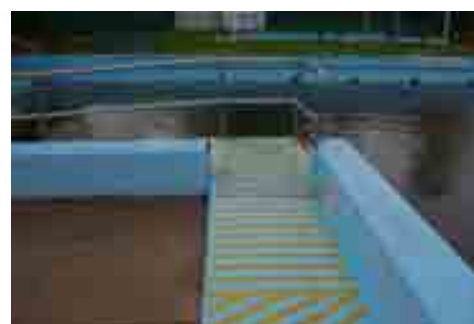
30) Section of pool ramp above water line is not BCA compliant and is deemed dangerous

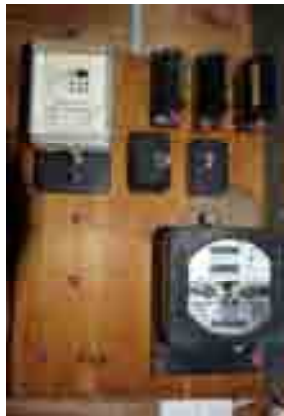
- On visual review of the electrical meter board and switch board located in the pool filtration plant room and the approximate age of the structure, it is very likely that asbestos may be located.
- On the condition of the pipe work associated within the filtration room and the age of the facility – asbestos lined pipes may have been used in its construction.

33) Switch board / meter board – may contain asbestos, due to its age and condition.

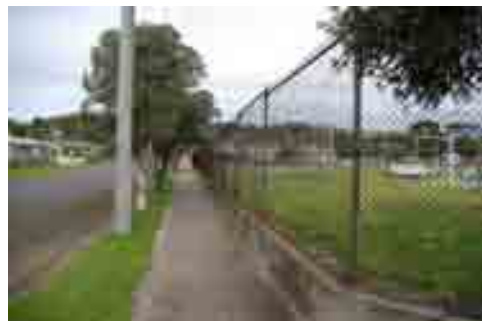
- 3) Pool site – visually linked to Gage Street & Mcconchie Street).

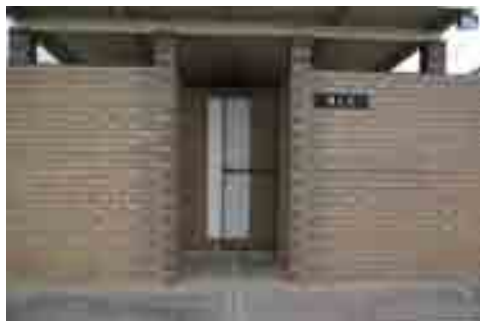
- 4) Main entry to change rooms.
- 5) Female change room – floor grading to floor waste. Structural cracks to slab evident.

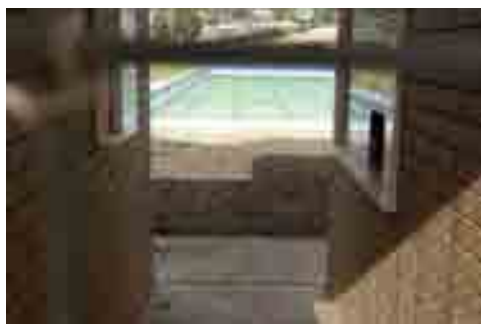
- 8) Main entry access into pool facility – too narrow to cater two-way pedestrian traffic.
- 9) Corroded truss junction between entry and change rooms – also poor condition of signage.

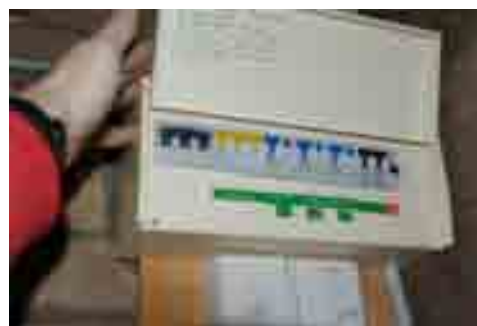
- 10) Main joinery to office / entry room. Very tired and in fair condition
- 11) Existing switchboard, reasonable condition. Current circuit breakers and RCD (safety) switch.

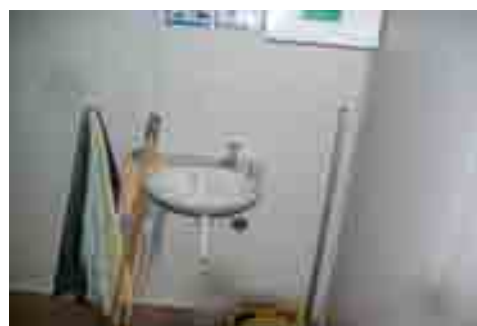
- 12) Access to first aid room – not BCA compliant. Structural crack to landing. (narrow door to room)
13) First Aid room – appears more like a store room.

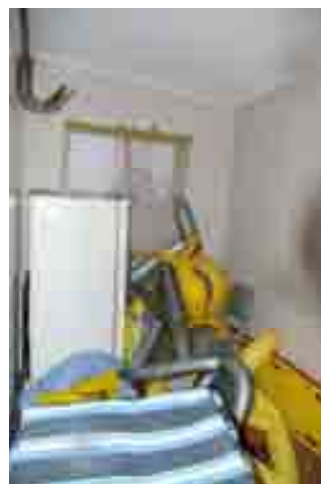
- 14) Passage way from entry door to first aid room – too narrow (max. 900mm width)
15) First Aid room – appears more like a store room.

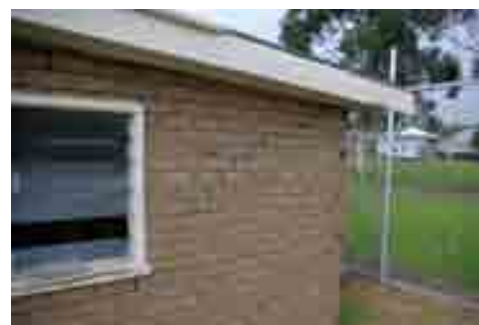
General visual condition (see definitions below)	Poor	X	Fair		Reasonable		Good	
Comments: <ul style="list-style-type: none"> Overall condition of the plant room is poor. Structural cracking within the brick work and mortar joints suggests a portion of the floor is moving or sinking at the corner. Safety shower well located at entry of main doors to plant room. The timber frame window requires replacing – evidence of dry rot and several panes of glass are missing. Doesn't appear that the store room has sufficient exhaust, as the room is being used as a chemical store. Sislation (Thermo-foil) to roof to be replaced with new. Thermo-foil to be taped and sealed. Step into the pump house of the plant room – deemed not safe. No clear signage stating hazard and step risers not compliant to BCA (higher than 255mm). No handrail to steps noted above.

- 16) Plant room / Filtration room appears in a poor condition (internally / externally). Safety shower compliant.
- 17) External window – very poor condition and structural cracking to brickwork.

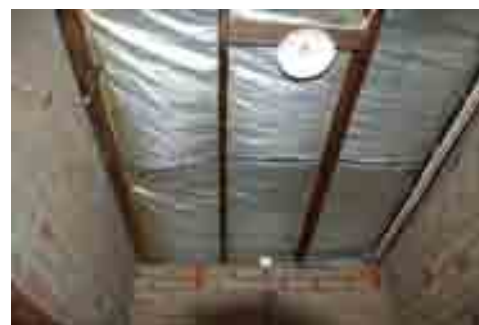
- 18) Step into filtration room too steep – not BCA compliant. No visible warning of step.
- 19) Exposed sislation (thermo – foil). Foil should be taped and sealed. Poor condition.

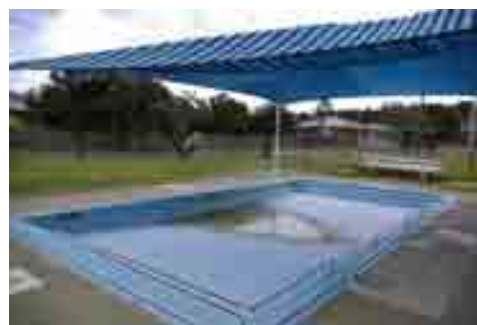
- A number of steel framed structures – which consist of a stretched sun shade cover. None of which are aesthetically pleasing and may create obstructions to view lines for staff to the pool and to patrons around the facility.
- The size and location of these sun shade structures does not allow for localised public communal areas, rather segregated (localised) areas within the pool facility.
- Main toddler's pool sun shade in reasonable condition.

- 20) Fixed sun shade structures – along pool concourse.
21) Main toddler's pool – sun structure.

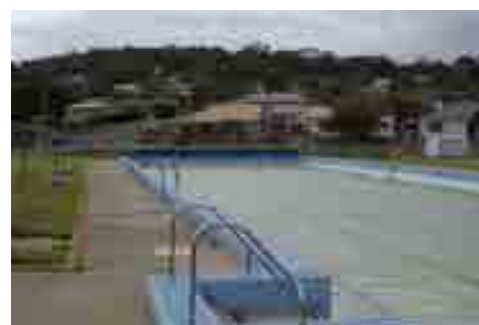
27) Main 50m pool in reasonable condition, including hand rails.

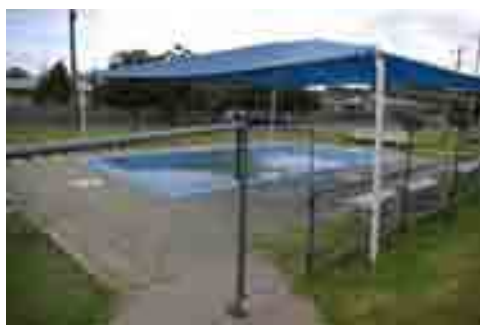
- 30) Toddler's pool and pool fence. Fence in fair condition – probably not really required.
31) Toddler's pool with hand rail – could be deemed a tripping hazard and should be removed.

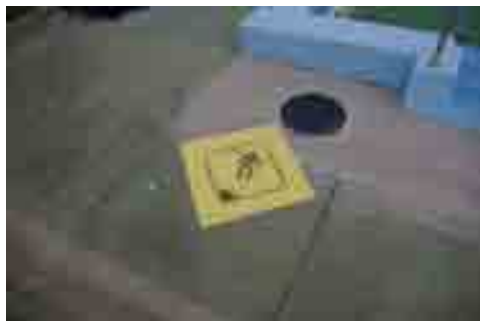
- 32) Signage to main pool concourse in fair condition.
- 33) Pool blankets – recommend being a minimum 1000mm further away from deep end for clear circulation.

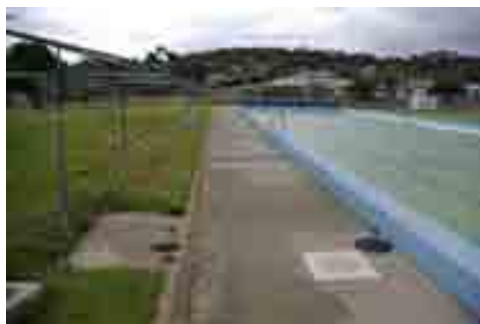
- 34) Main pool concourse in reasonable condition. Width complies with RLS minimum requirements.
- 35) Sections of the pool surface have been grinded, including around pit lids.

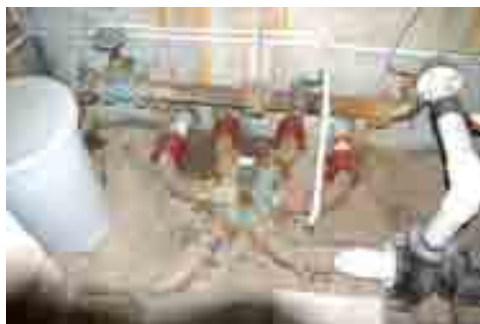
36) Typical pipe work condition.

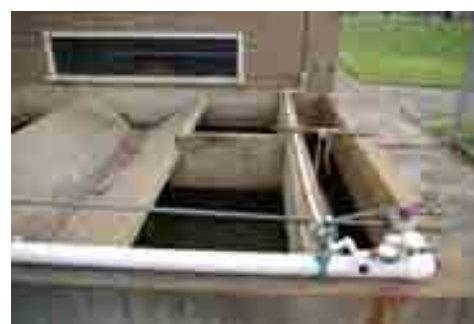
37) External gravity sand filters in reasonable condition.

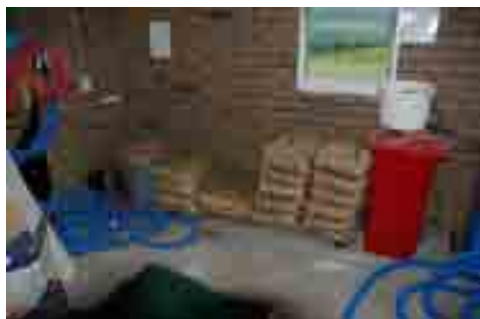
38) Typical storage condition for pool chemicals – may be deemed dangerous.

investigated. If they do not comply, the situation should be rectified immediately or the gas should be replaced with another form of chlorination.

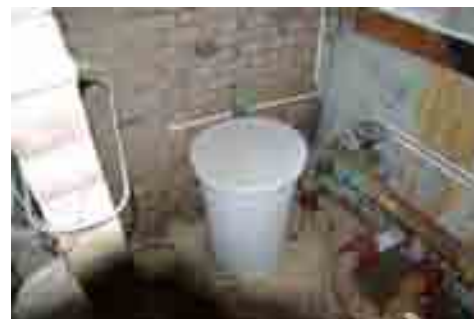
39) Typical pipe work condition and filter.

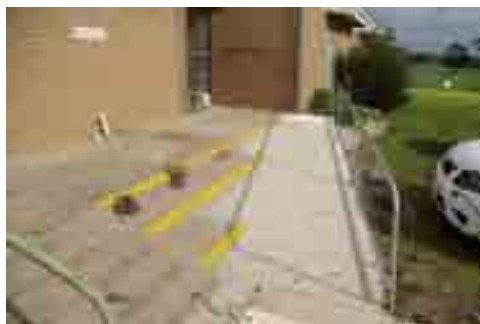
40) Main entry – disabled ramp not compliant. Trip hazard evident and handrail not compliant.

- Toilet cubicles not wide enough – recommend removing the brick work and replacing with nominal toilet partitions.
- Ramp at entry not BCA (A/S 1428.1) compliant. Exposed steps to side of ramp are deemed a hazard and can be deemed a trip hazard.

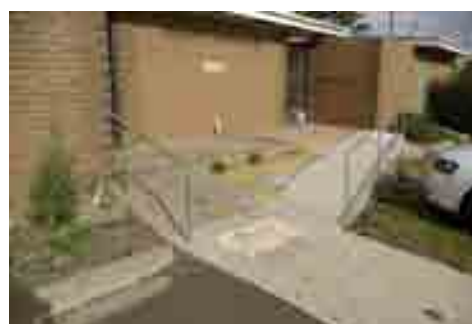
41) Ground tactile indicators not installed as per AS 1428.4 .Tactile indicators face the wrong ramp.

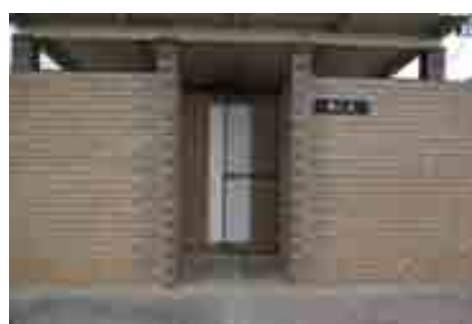
43) Directory signage to be replaced to comply with current requirements

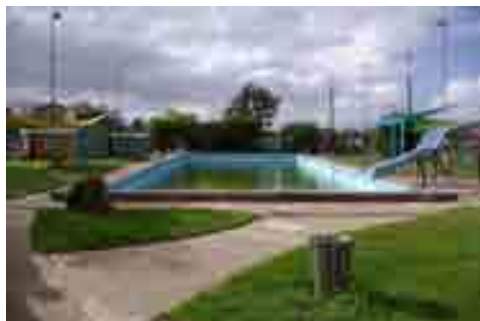
- 3) Main view of the 25m pool from the southern end of the facility- plant room in the background.
- 4) Main car park of pool also linking with Bowls & Tennis clubs.

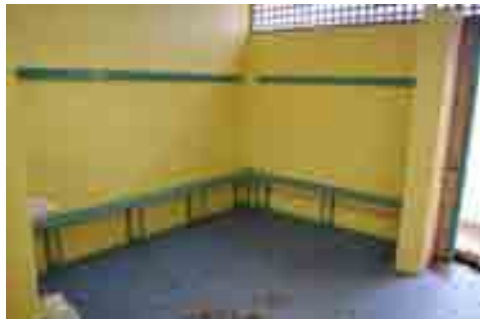
- 5) Change rooms – typical layout in good condition – epoxy paint floor treatment and typical bench slat seating.
- 6) No insulation to roof.

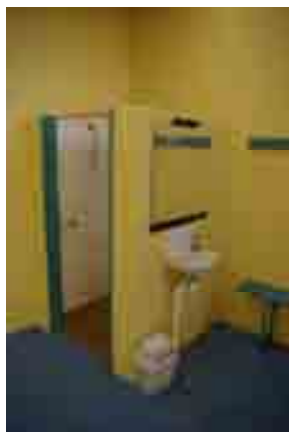
- 7) Showers too small to accommodate disabled requirements and BCA occupancy rates
- 8) Men's urinal in good condition.
- 9) Typical pan & toilet partition to change rooms.

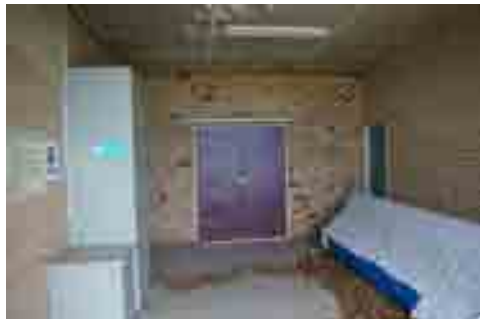
- 10) Main entry & first aid 'area' in large cup board – unacceptable. Exposed in main entry

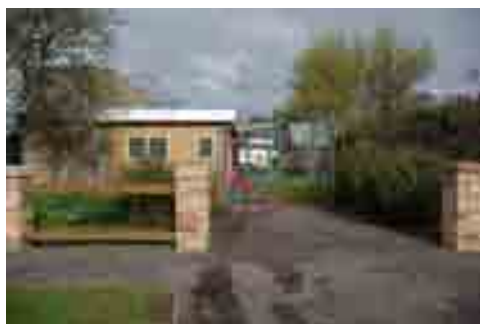
- 11) Pool plant room – main access from highway – signage clearly visible
12) Extent of sand filter above existing plant room. No visible link from highway to pool.

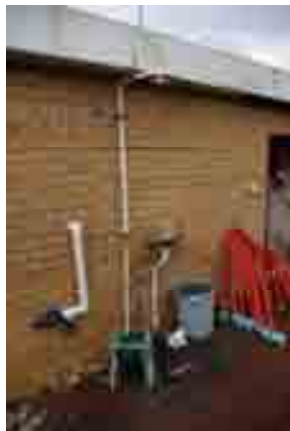
- 13) Safety shower and eye wash in close proximity to plant room entry – poor condition of roof
 14) Gravity feed – sand filter in fair condition.

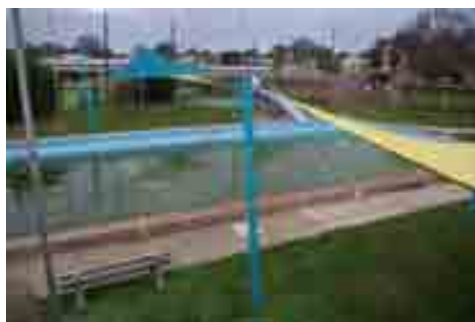
- 15) Main sun shade structures to pool facility in good condition and should remain.
 16) Light weight – southern perimeter shading – not aesthetically pleasing

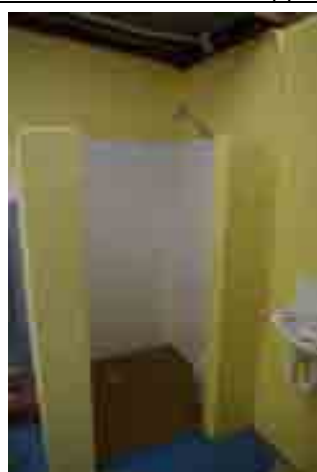
17) Water saving shower rose already installed. Showers in good condition – space restricted.

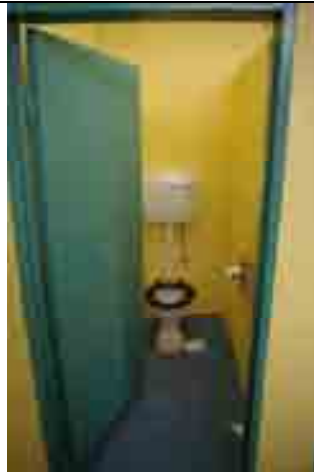
18) Typical pan and toilet partition. Note paper dispenser corroded.

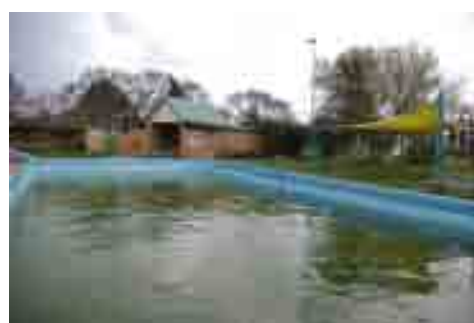
- 21) Main 25m pool in good condition. Ladder access in good condition.
22) Main 25m pool – view over pool towards the change rooms.

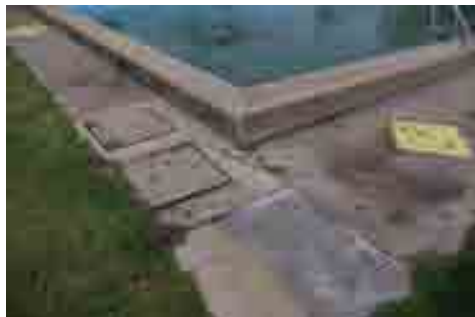
- 23) Pool signage in a poor condition. Recommend to be replaced. Pool concourse in poor condition at this corner.
24) Area adjacent to expansion joint where the reinforcing has been.

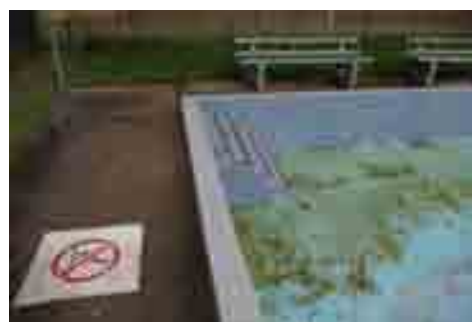
- 25) Toddler's pool with step entry.
26) Minimal signage to around pool. Stair access requires handrails (to both ends of the pool).

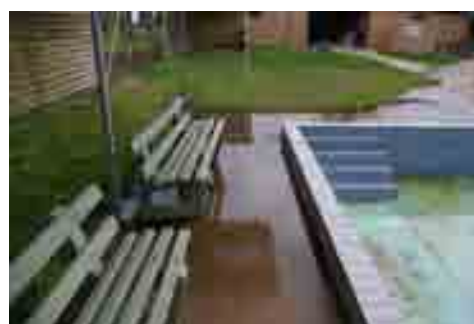
28) Section of pool concourse recently grinded to minimise trip hazards.

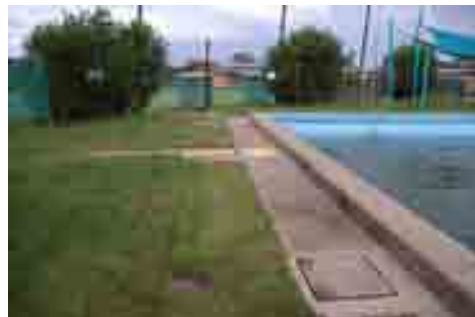
- 29) Existing light poles removed. Screened by seating. These areas restrict the pool concourse width.
30) Evidence of pool concourse cracking and expansion joint repairs.

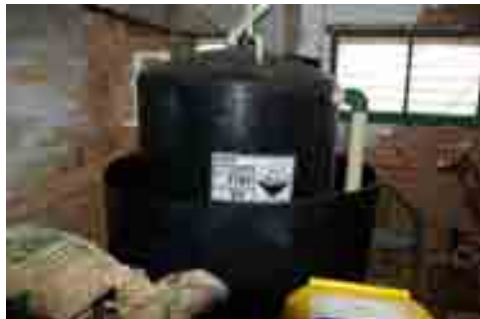
- 31) Hypo tank – restricted access around tank.
32) Additional chemical storage – directly adjacent to Hypo tank bund – not recommended.

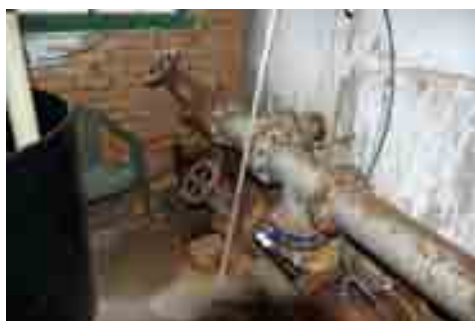
- 33) Typical condition of existing pipe work
34) Above ground – gravity fed sand filters – reasonable condition.

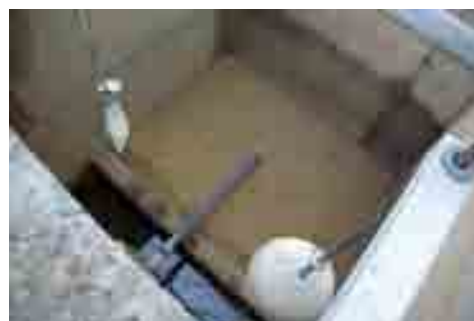
Filtration Plant (undertaken by David Powick & Associates)								
General visual condition (see definitions below)	Poor	X	Fair	X	Reasonable		Good	
Comments: <ul style="list-style-type: none"> The gravity sand filter system is in need of renovation. It has a new pump and 1 new valve but requires further work. It should be re-furbished rather than replaced unless there are major issues with the cell structures. The backwash routine requires manipulation of the float operated modulation valve to overfill the pool by around 300mm prior to backwashing as the balance tank appears to be too small to provide the necessary backwash water. We have not investigated this fully and rely on advice from the plant operator. This matter should be reviewed. The bulk storage facility for the Sodium Hypochlorite is not up to standard and should be upgraded. There is insufficient flow to the small pool and there may be a need to install a side stream pump to lift turnover rates to the small pool. Automatic dosing control should be added – presently done by a test kit plus guesswork and this contravenes health regulations. The Hypo pump is too high and as such presents an OH&S issue. We presume the height is based on an attempt to stop syphoning, but this can be controlled by other means.

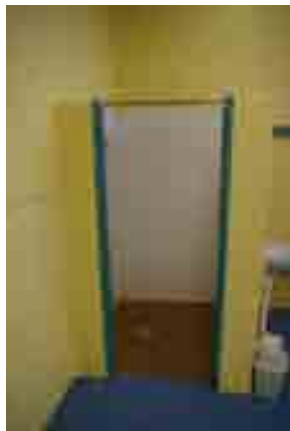
Access Conditions - Disability							
General visual condition (see definitions below)	Poor	X	Fair		Reasonable		Good
Comments: <ul style="list-style-type: none"> No disabled / assisted facilities are located within the facility. No disabled designated car park evident in close proximity to the pool facility. Access into change rooms sufficient for wheel chair access. No ground tactile indicators to all steps and ramps above water line of pools. All amenity and directory signage to comply with relevant codes. No disabled access into the pools. No disabled access into the first aid room (actually no first aid room) Toilet/ shower cubicles not wide enough – recommend removing the brick work and replacing with nominal toilet partitions. Door hardware to change rooms not disabled compliant (with removable hinges, indicator bolts, self closers, door handles). Main step from pool concourse to pool is too high (over 200mm). Not BCA compliant (maximum height for a riser is 190mm).

- 35) Restricted access into showers.
36) Basins not compliant for assisted access.

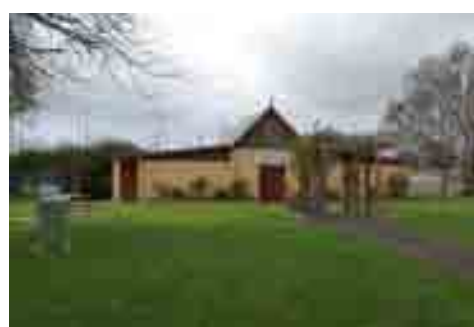
- 37) Signage to store room in a poor condition. Recommend to be replaced with new.
38) Main signage to entry of pool facility – directly visible from park only. No direct signage from street (highway).

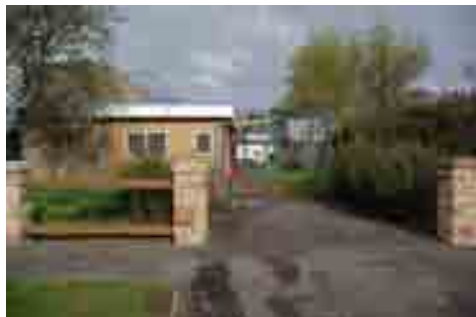
39) Main signage of pool from main highway – not inviting.

- filtration plant. It is also recommended to be moved away from main highway to allow for better visibility.
- Provide more prominent signage for this facility.

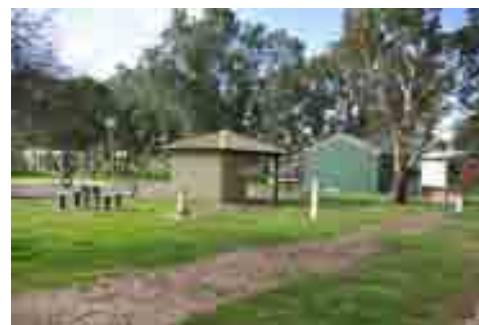
- 1) Main view from service road to main entry. No visible path to pool entry.
- 2) Adjacent Lions Club Park next to Glenthompson pool.

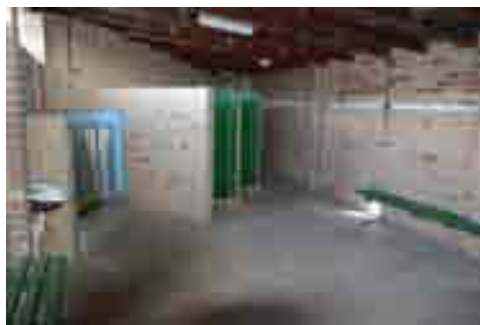
- 5) Change rooms – Male. Clean brickwork, exposed concrete slab and exposed roof (no insulation)
- 6) Corroded urinal and high step. Step is not BCA compliant.

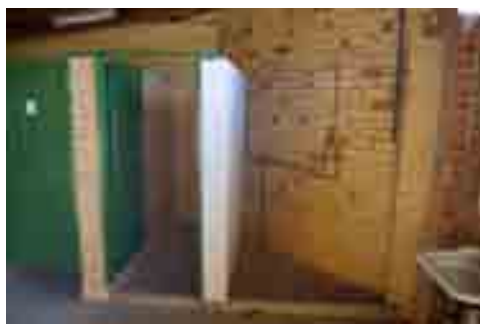
- 7) Female change – very restricted showers (with step).
- 8) Female Change rooms – very similar to male change. Very basic finishes.

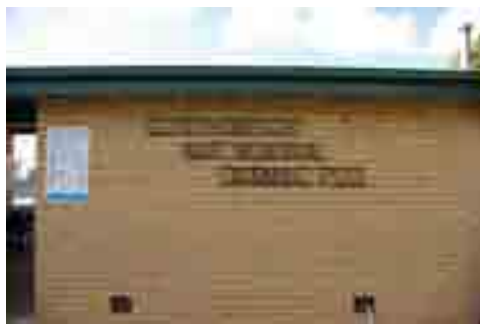
- 9) Typical signage to main entry. Not clearly visible from the street.
 10) Typical office / entry / first aid room. Roller Door used for kiosk and no joinery.

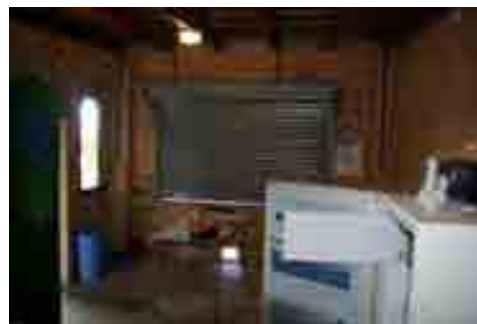
- No joinery – only collection of tables.
- Clear visibility from office to entire pool site.
- No floor covering to rooms. Recommend a safety vinyl.

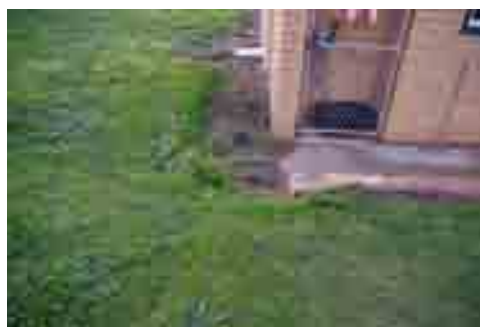
- 11) Pool plant room – main access from pool grounds and plant room. Sloped ground and no clear path from pool.
- 12) Pool plant room – with external sand filters, and main gate access.

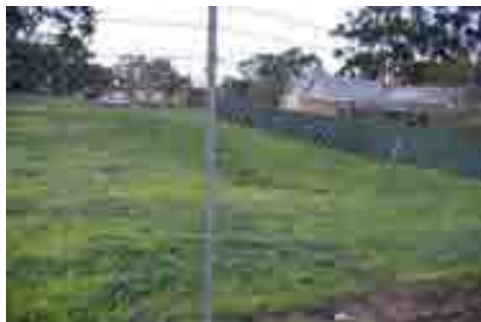
- 13) Main plant room access driveway (the raised grassed area).

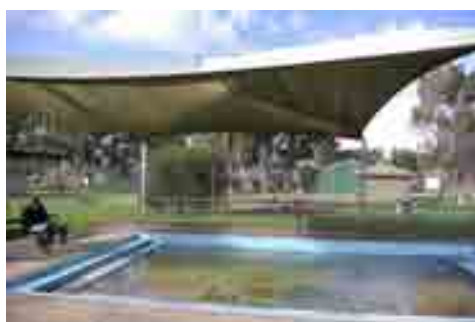
Buildings – Sun Shade Structures							
General visual condition (see definitions below)	Poor		Fair	X	Reasonable		Good
Comments: <ul style="list-style-type: none"> • Main toddler's pool sun shade in reasonable condition. Fabric cover appears stretched and has sagged over time – recommend to be replaced. • Steel structure. • Main fixed sun shade structure is a mixture of steel and timber frame with a fixed metal sheet roof. Overall in fair condition, however not aesthetically pleasing. Recommend to be replaced.

- 14) Sun shade structure to toddler's pool.
- 15) Typical fixed sun shade structure adjacent to the main pool.

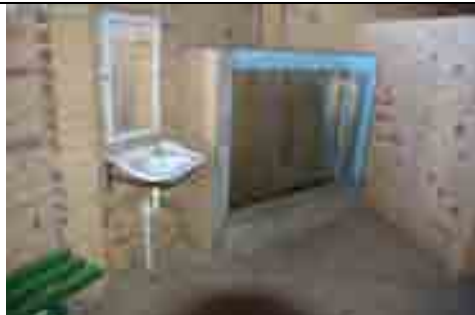
- 16) Corroded men's urinal and original cast iron / enamel basin (basins typical to both change rooms)
17) Gas hot water unit – not sure on its condition. General appearance – reasonable.

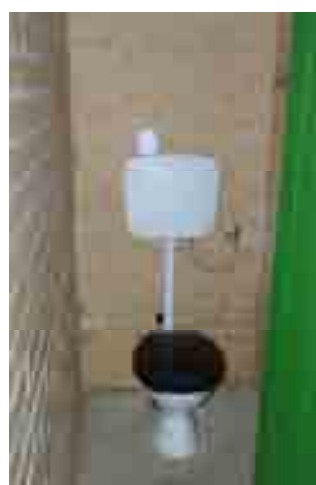
- 18) Showers to both change rooms – poor condition. Both not BCA compliant and no disabled access.
19) Typical pans with new cisterns.

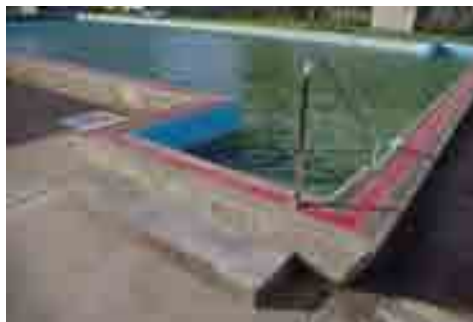
- 20) Main 25m pool in good condition. Handrail to main steps compliant.
21) Main 25m pool – signage around pool – reasonable condition. Recommend to be upgraded

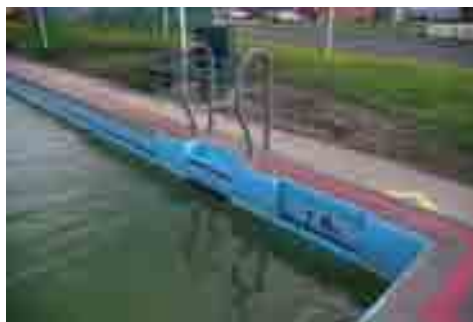
- 22) Clear pool signage. Step ladder appears in good condition.
23) Deep end to pool and hand rail – in good condition. Pool shell has held water (minimal water lost).

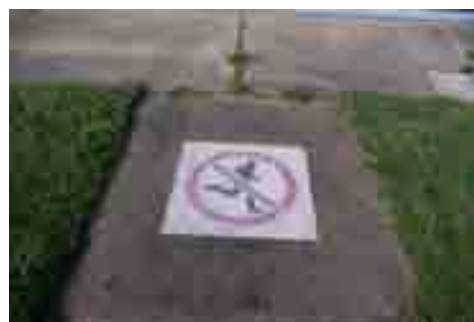
- 24) Toddler's pool with step entry.
25) Minimal signage to around pool.

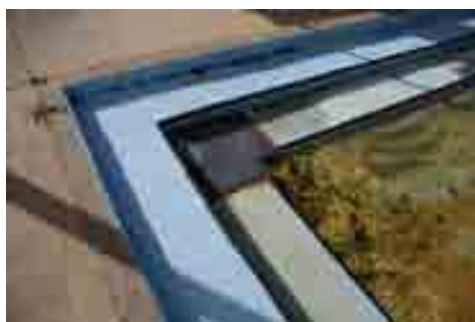
- 26) Grate plates – corroded. May create trip hazard.
27) Corroded plates to overflow grate to toddler's pool.

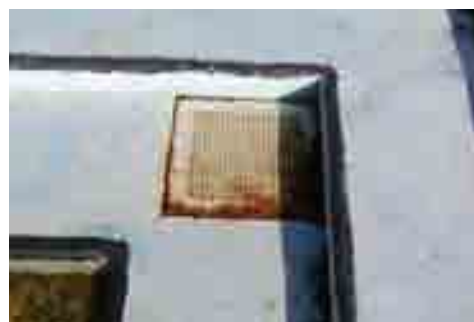
Pool – Toddler's Pool							
General visual condition (see definitions below)	Poor		Fair	X	Reasonable		Good
Comments: <ul style="list-style-type: none"> Pool appears in fair condition. This pool appears to have water overflow outlets at the corners of the internal steps making a very shallow pool. The outlet covers appear loose and present a sharp edge that could cause cuts and other injuries. There are no depth or warning signs in or around this pool. This matter should be addressed.

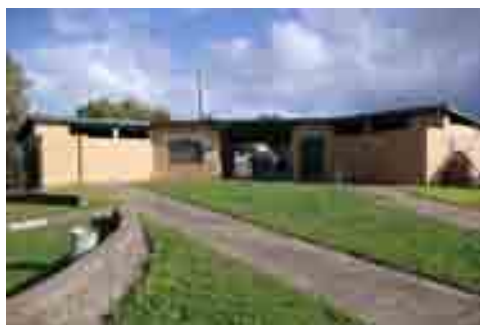
28) Main path – grading to main pool concourse.

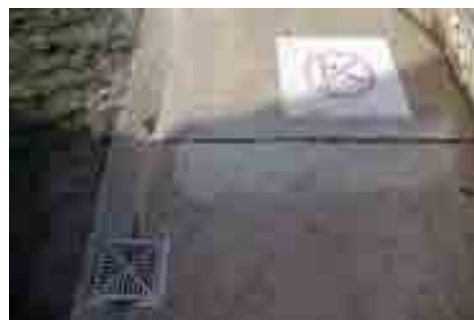
29) Section of pool concourse recently grinded to minimise trip hazards.

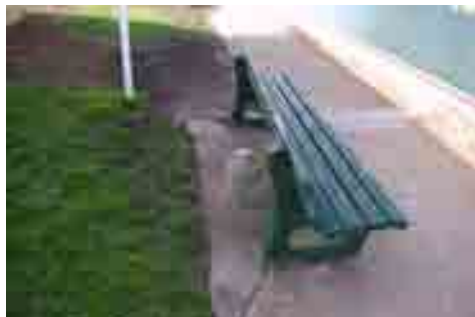
- 30) Existing light poles removed. Screened by seating. These areas restrict the pool concourse width.
31) Evidence of pool concourse cracking and expansion joint repairs.

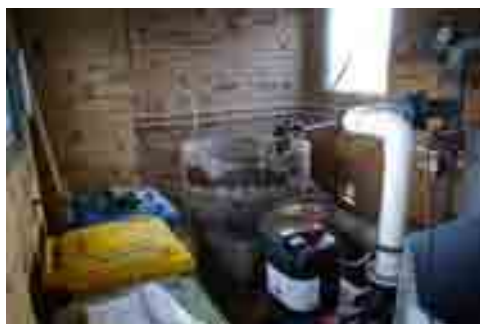
- 32) Pool Filtration plant – typical chemical storage area and sump.
33) Main pool filter with main pump (notice half the pump is located under 'hypo – tank').

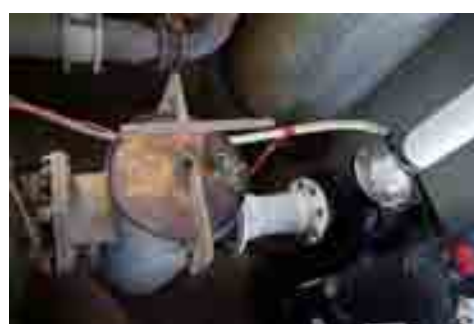
Filtration Plant (undertaken by David Powick & Associates)							
General visual condition (see definitions below)	Poor		Fair	X	Reasonable		Good
Comments: <ul style="list-style-type: none"> The bulk storage tank for the liquid chlorine sits in a chipboard bund partly over pipe work and a pump. This bund is of no benefit at all as it could not withstand a collapse of the Hypo tank and it is too close to the Hypo tank to contain outflow from any penetration type failure. The tank should be re-positioned in a new enclosure in a bund that complies with current regulations. There is no automated control of water chemistry and this contravenes health department regulations. Automatic controllers should be fitted. There appears to be inadequate flow to the toddler's pool. Provision to adjust the flow is not apparent and this should be addressed. The pump and hair and lint strainer should be replaced in the short term.

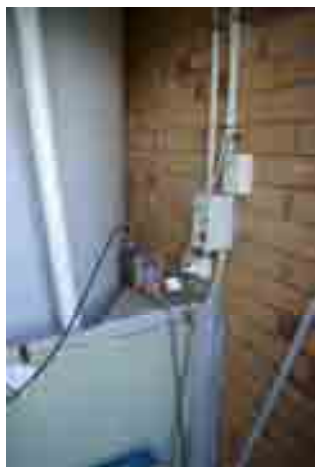
- 34) Hypo tank – close proximity to electrical switch / circuits illegal, including chlorine pump.
- 35) Hypo – tank bund consists of 18mm plywood with fibre-glass resin (with no base) – not compliant and illegal. Not Safe.
- 36) Hypo-chloride supply tap to tank located adjacent to sand filter.

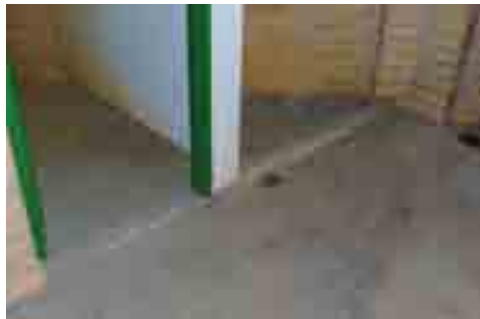
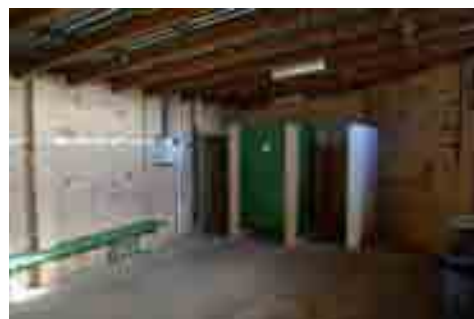
- 37) Restricted access to showers – remove step.
- 38) Change area large enough to allow for refurbishment and disabled compliance.

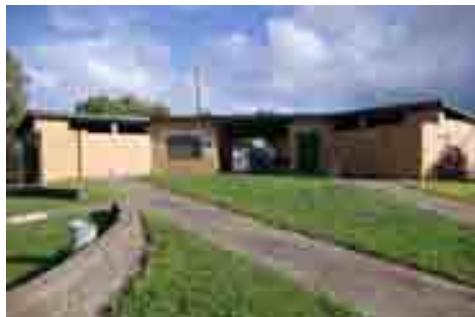
41) Signage to change rooms in poor condition.

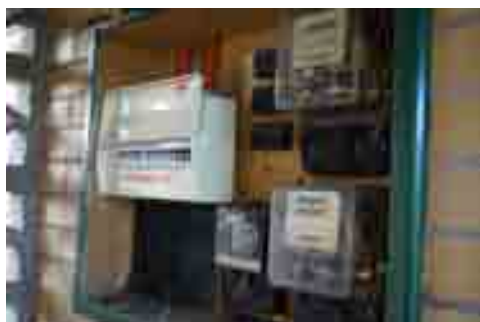
- On visual review of the electrical meter board and switch board located in the pool entry and the approximate age of the structure, it is very likely that asbestos may be located.

42) Main switch board and meter board backing may contain asbestos.

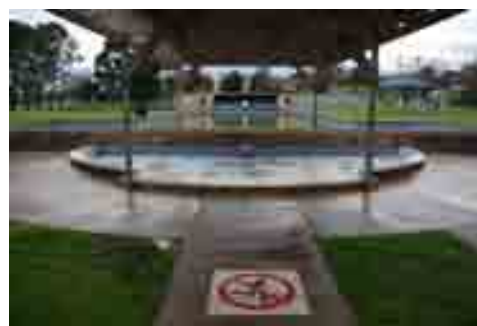
- 1) Hamilton pool – relatively flat site with significant trees located throughout – note playground in the background.
- 2) Main axis from the main entry looking over the toddler's pool, main pool to the plant room.

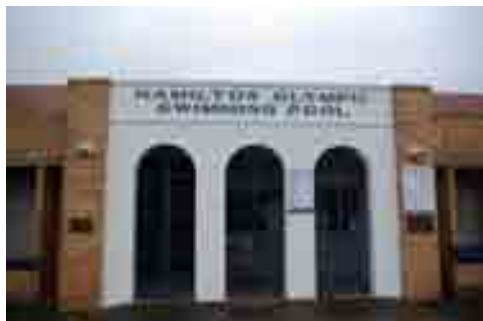
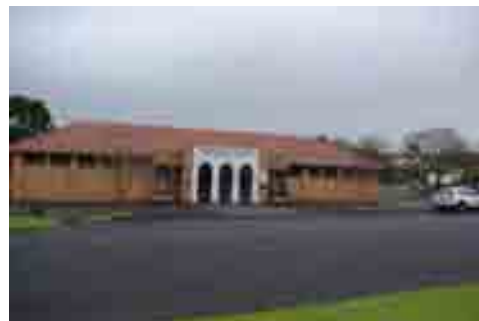
- 3) Pool site – visually linked to Gage Street & McConchie Street).
- 4) Very prominent main entry – existing 1950's building. Consider preserving?

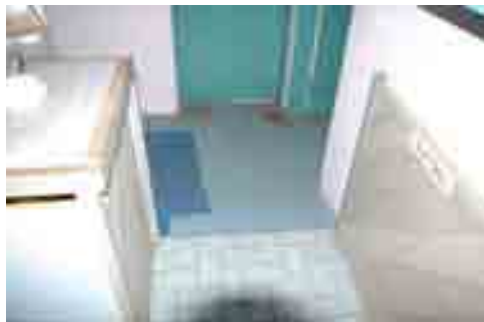
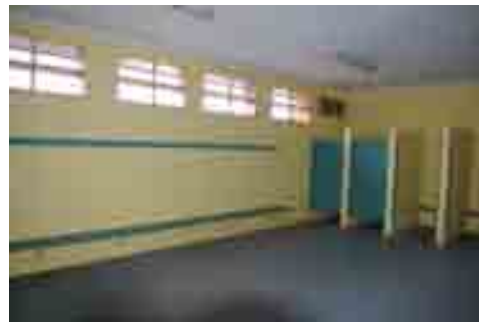
- 5) Floor into change rooms, dangerous, too steep and no colour variance (typical to both.)
- 6) Female change room – typical view showing 'private' change areas and slat bench seating.

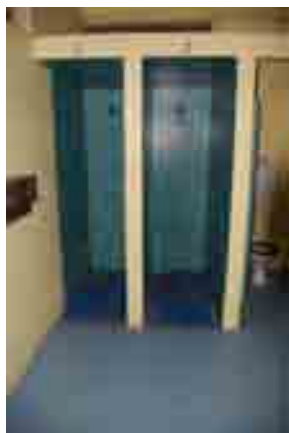
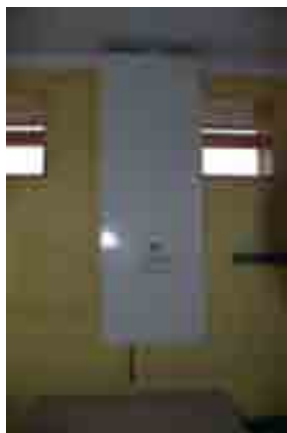
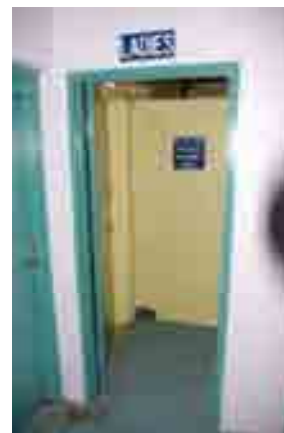
- 7) Typical showers – no door and too narrow.
- 8) Exposed hot water unit in both change rooms – may be deemed dangerous.
- 9) Typical change room entry – note cannot really see variance in floor slope.

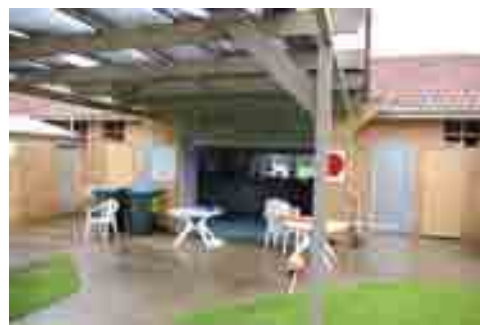
- 12) Main meter board in reasonable condition.
13) Main entry to pools from entry building – access way very low due to roller door behind.

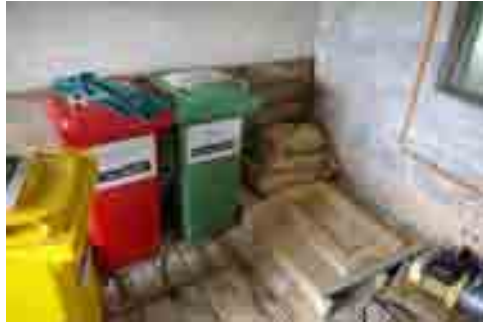
15) Chemical store in poor condition.

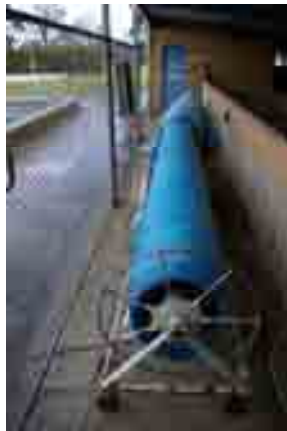
17) Pool blankets appear in reasonable condition.

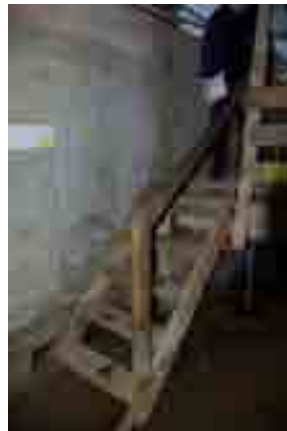
18) Timber access steps – reasonable condition – poor design and construction.

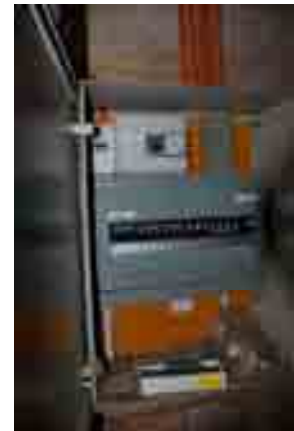
19) Plant room switch board appears in good condition.

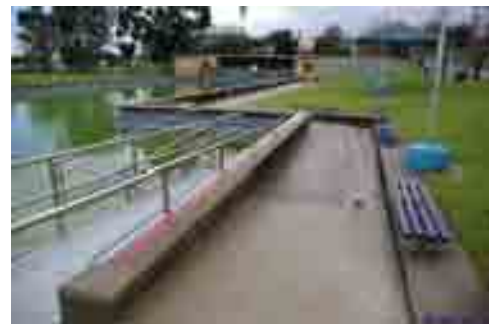
21) View from 50m pool of plant room.

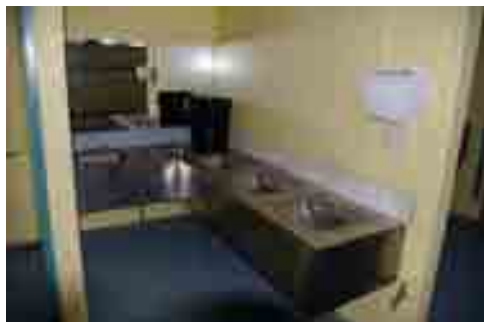
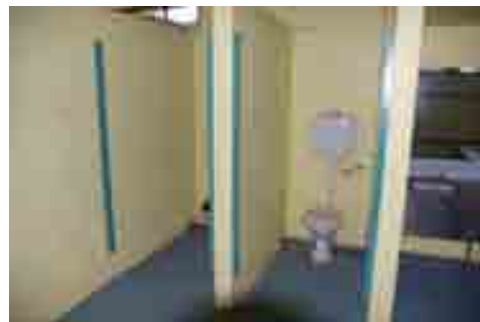
- 24) Stainless steel wall mounted basins to female change – too close and restricted.
25) Typical pan in change rooms.

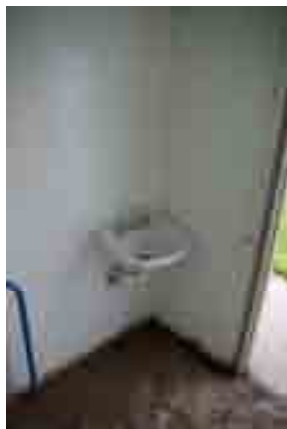
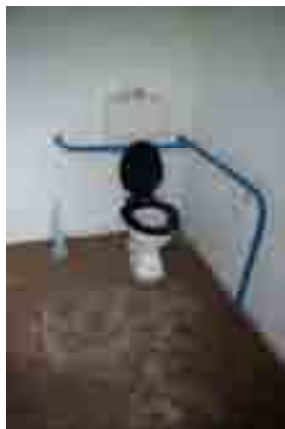
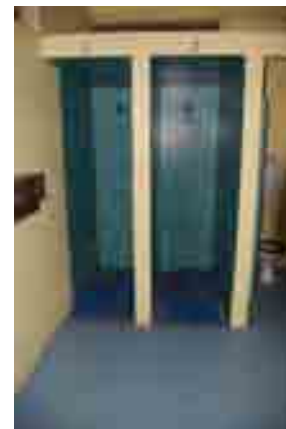
- 28) Disabled pan – not compliant due to proximity to side wall. Note floor subject to flooding.
 29) Typical disabled pan – appears compliant. Note floor subject to flooding.
 30) Shower area – use of water saving shower rose – very tight in area – no partitions.

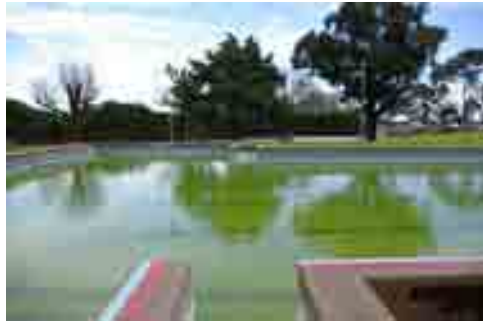
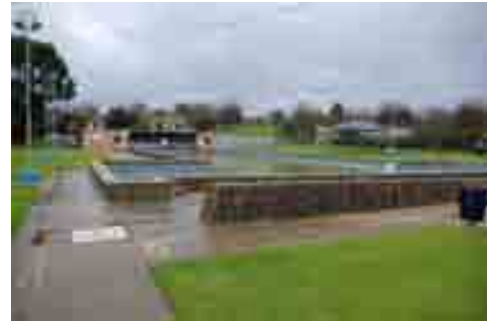
- 31) Hand rails required to steps.
- 32) The 50m pool with plant room in the back ground.

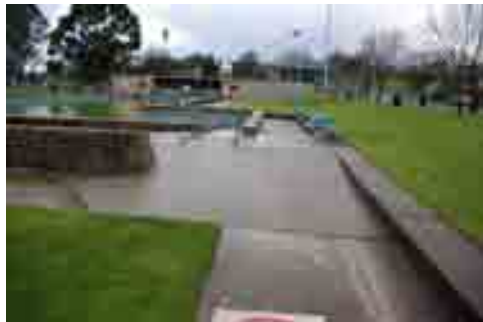
- 33) Pool concourse graded to pool ramp – not compliant.
- 34) Disabled ramp – not compliant – note potential hazard with portion of wall open.

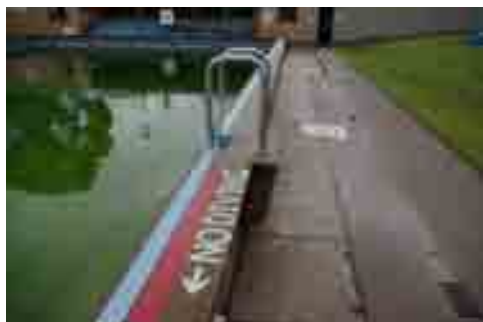
- 35) Typical access ladder – no step from pool concourse.
- 36) Portion of pool shell to be repaired.

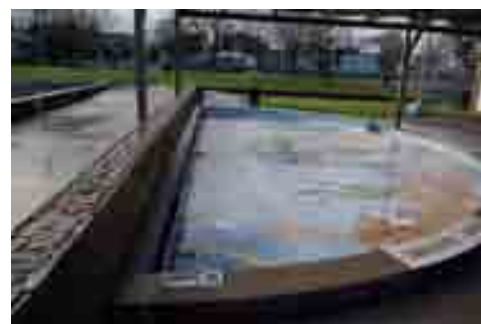
- 37) Toddler's pool recommended to be removed.
38) Toddler's pool signage in fair condition.

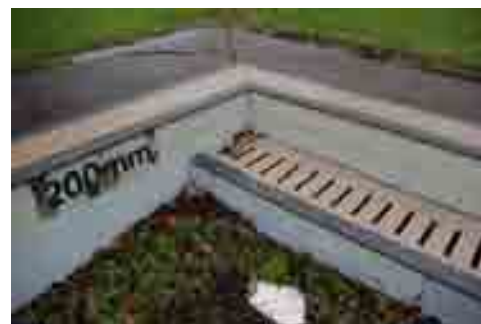
Pool – 25m Pool							
General visual condition (see definitions below)	Poor	X	Fair		Reasonable		Good
Comments: <ul style="list-style-type: none"> This pool has been abandoned and should be filled-in for safety reasons. Depth and warning signage does not comply with RLSSA recommendations.

- 39) 25m pool in poor condition – recommend to be removed.

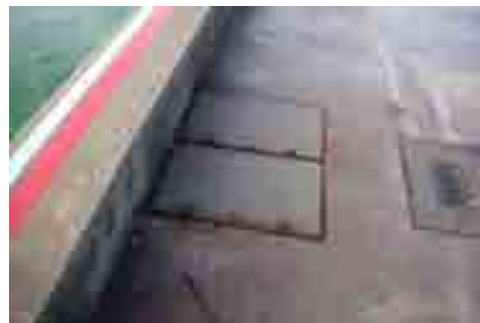
- 41) Sections of pool concourse subject to flooding.
42) Corroded pit lids.
