Aquatic Development Strategy

Volume 1: Technical Assessments & Probable Capitals Costs

Site Investigation Report

Site:	Balmoral & District Swimming Pool	Date visited:	30 th June 2009 FINAL ISSUE
Project:	South Grampians Council – Aquatic Facility Development Strategy	Project No:	EJ-0763
Client:	Southern Grampians Shire Council	Representative:	Mr Craig Halley
Investigation undertaken by:	Sean Stone Mike Pettigrew	Company:	Etch Architectural Solutions David Powick & Associates
Copies to:	Steve Pallas	Company:	@Leisure
Weather Conditions:	Overcast conditions, high winds and frequent showers Cold		
Pages	15 (including this page)

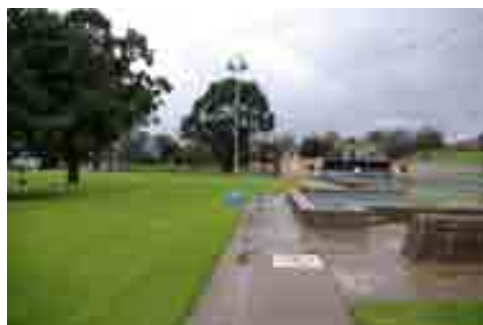
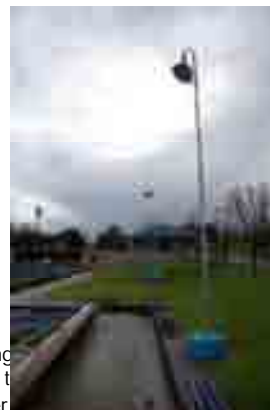
- 43) Main pool concourse in reasonable condition. Width complies with RLS minimum requirements.
44) Pool lighting in poor condition.

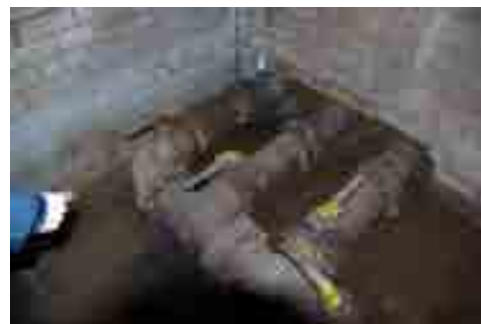
- 45) External gravity sand filters in reasonable condition.
46) Typical pipe work condition.

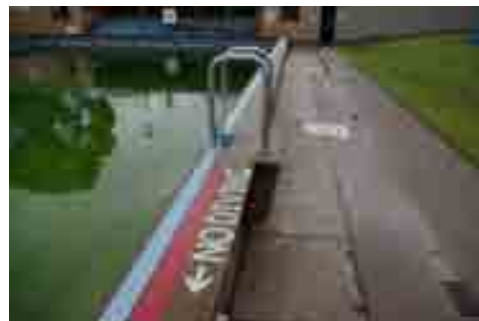
50) Typical signage around pools.

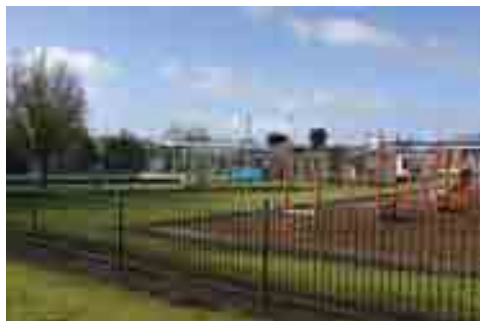
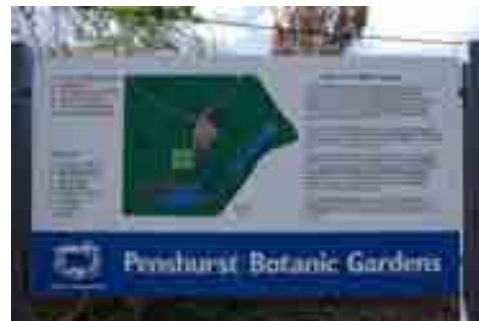
- 3) Main view of pool from play ground.
- 4) Penshurst botanic gardens – precinct (swimming pool included within the gardens).

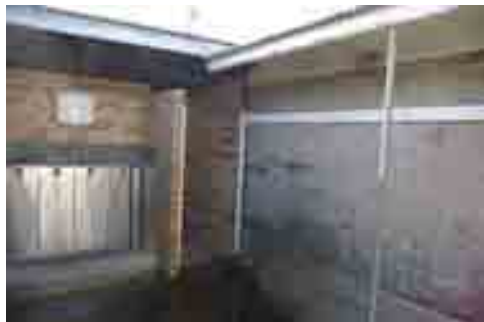
- 5) Change rooms – mixture of clean and rendered brickwork.
- 6) Concrete seating and exposed concrete slab.

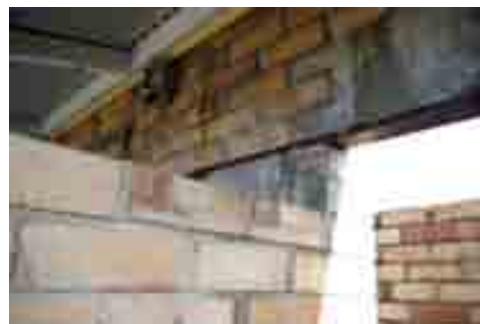
- 7) Concrete flooring to female change – cracked. Potential structural cracking and settlement to slab.
- 8) Corroded steel lintel and damaged lighting.

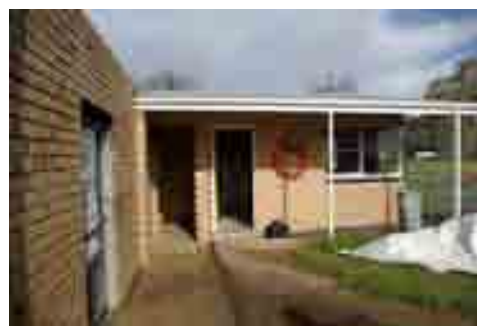
- 9) Main entry / office / first aid room & kiosk? Internally not well labelled.
- 10) External access to main office. No signage stating first aid (other than door – when closed (see above image))

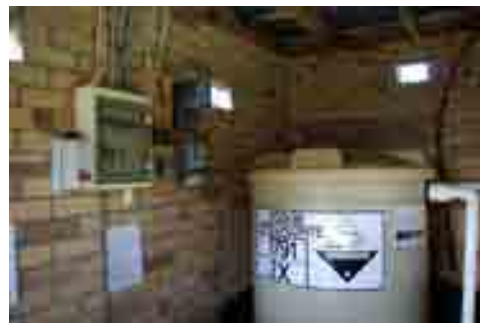
- 11) Pool plant room – with external sand filters.
- 12) Pool plant rooms internally with Hypo tank.

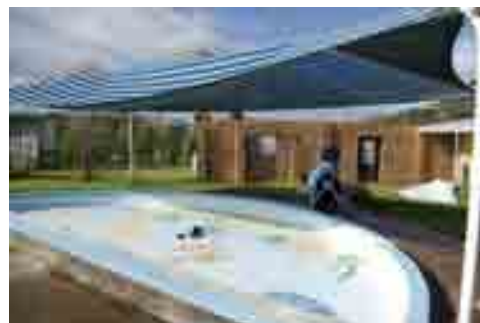
- 13) Fixed timber sun shade structures adjacent to pools – poor condition. Looks unattractive.
- 14) Sun shade structure to toddler's pool.

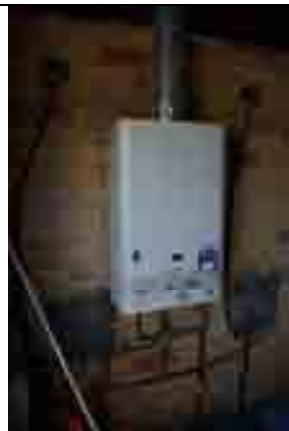
- 17) Gas hot water unit – good condition.
18) Boiling water unit – adjacent to sink and joinery unit.

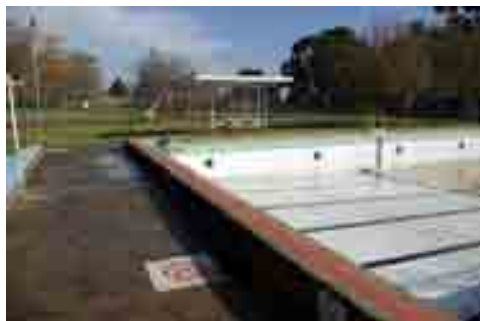
- 19) Main 25m pool – signage around pool – reasonable condition. Recommend to be upgraded.
20) Pool evident of leaking.

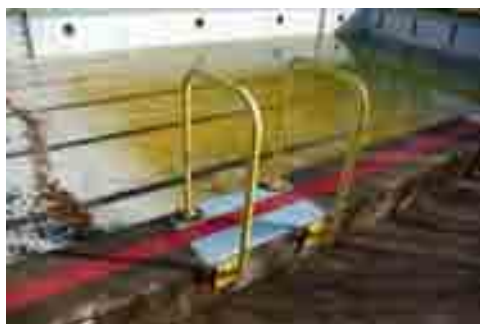
- 21) Access ladders – corroded at base. Recommend to be replaced with new.
22) No handrail to narrow steps

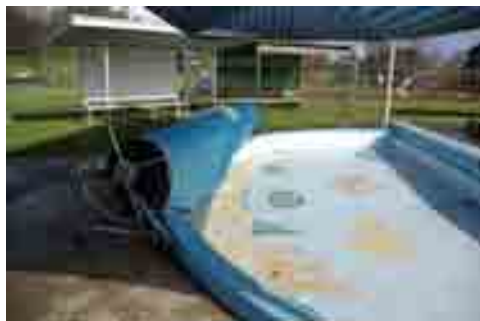
- 23) Toddler's pool with main pool solar blanket
24) Minimal signage to pool.

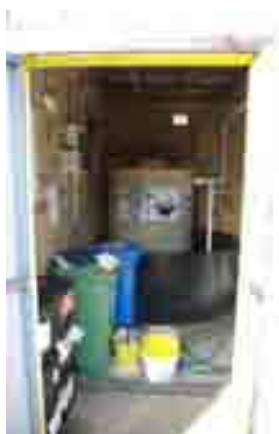
- 27) Pool Filtration plant – ‘Hypo- tank’ storage unit with additional chemical store.
28) Filter and main pool pump.

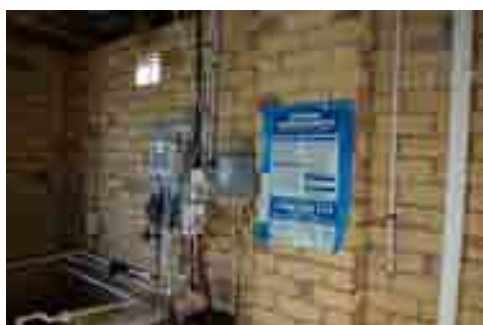
- 29) Current dosing system
30) Chlorine pump – too high.

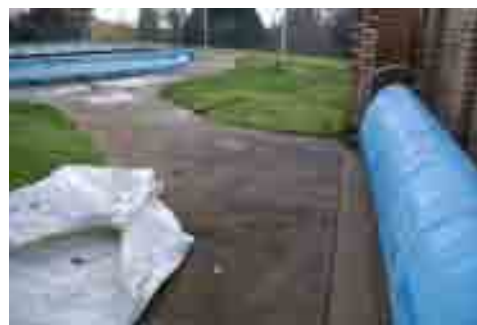
- 31) Restricted access adjacent to entry – too narrow for wheel chair or two-way pedestrian access.
32) Pavement from toddler's pool to change rooms too steep as gradient appears excessive to BCA.

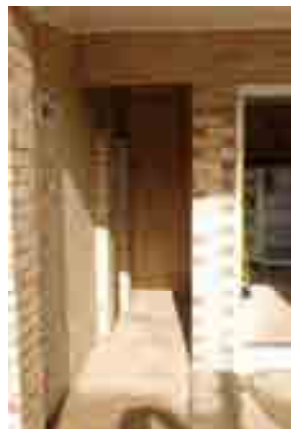
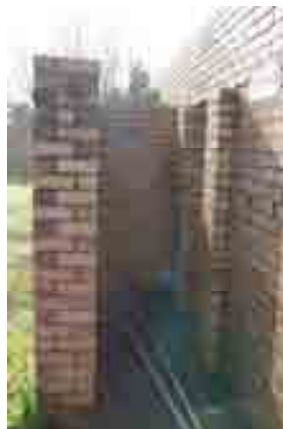
- 33) Access width to both Male & Female Change rooms – too narrow. Does not comply with BCA or AS 1428.1 (door width and door landings)

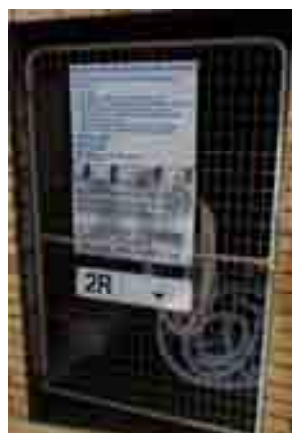
- 34) Signage to store room in poor condition. Recommend to be replaced with new.
35) Signage to change rooms in poor condition.

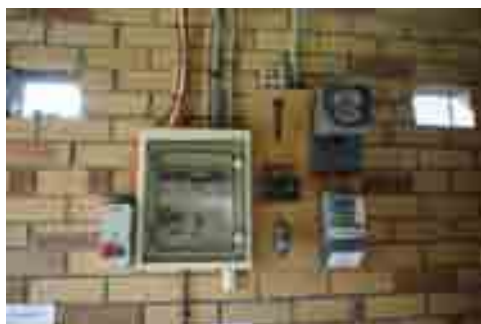
- On visual review of the electrical meter board and switch board located in the pool filtration plant room and the approximate age of the structure, it is very likely that asbestos may be located.

36) Electrical switch / meter board may contain traces of asbestos.
